Construction and materials of Visby medieval city wall – risk of damage

BALKSTEN KRISTIN¹, THELIN CARL²

ABSTRACT:

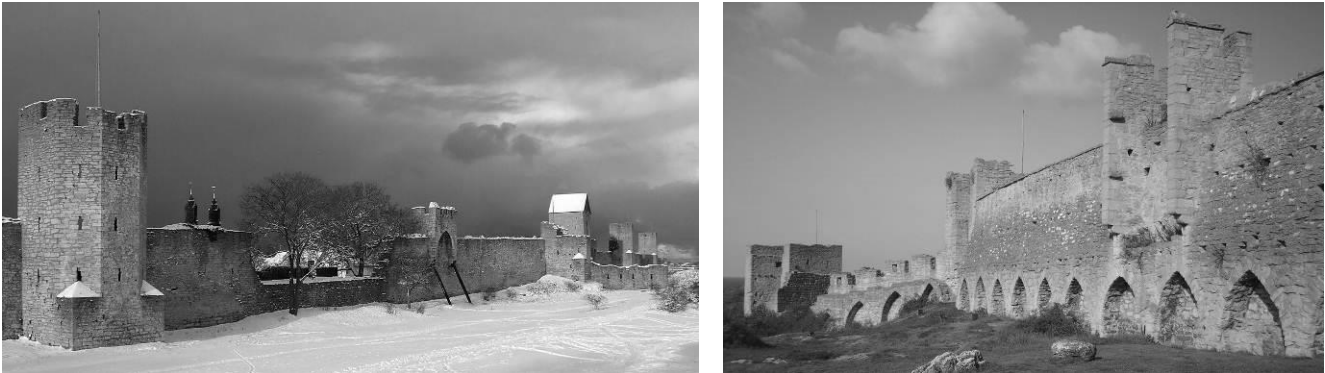
Figure 1. Visby City Wall seen from outside and inside. The smaller wall towers are riding on top of the wall. In many places one can see old collapses as well as different kinds of reinforcing structures.

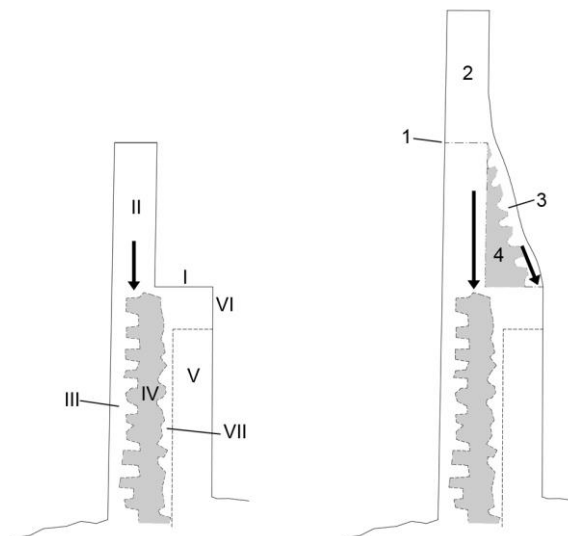
Figure 2. Simplified sections of the land wall. The section to the left show the land wall before it was heightened and the section to the right shows it after the heightening and how it is today. The arrows show the eccentric loading of the outer leaf and the thrusting force from the bottle neck shape. I) Rampart walk. II) Parapet. III) Outer masonry leaf. IV) Core with clay mortar and no bond. V) Openings of inside arches. VI) Top of inside arches. VII) Thin masonry leaf inside arches. 1) The height of the original wall (left image). 2) Heightening of the wall in solid masonry. 3) Masonry leaf of bottle neck shaped masonry. 4) Upper core inside former parapet wall.

The lower oldest part of the wall has a thin outer masonry leaf and a weak core of limestone and clay mortar. There are no through stones and few stones binding the leaf into the core. The arcade on the inside initially carries its own load and the load of the rampart walk, and it provides an inner support for the core. The former parapet wall (now outer leaf of the upper middle part of the wall) is thicker than the lower leaf and is therefore standing both on the core and the outer leaf. Since the lower core is weak deform under loading, the loads from the former parapet will be concentrated to the outer leaf of the lower part of the wall and the loading will be eccentric.

With the heightening of the wall 2-4 meters masonry was put on the former parapet and an inner leaning leaf wall was added on top of the former rampart wall. Since the parapet wall was used as an outer leaf in the raising of the wall there are no binding stones at all in this part. The raising of the wall led to more load needed to be carried by the thin outer leaf of the lower older part of the wall.

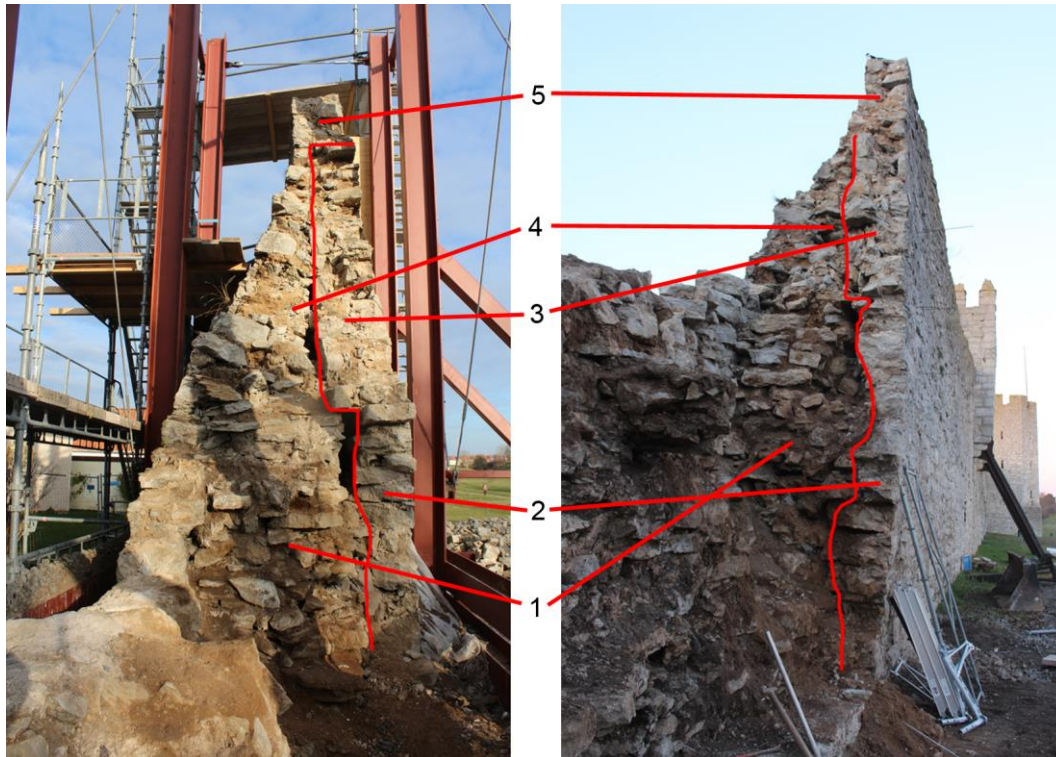
Figure 3. Two photos showing the same part of the wall at two different stages during dismantling of the collapsed part. 1) Lower core with clay mortar and no bond. 2) Thin outer masonry leaf. 3) Former parapet now outer leaf of middle part of the wall. 4) Upper core inside parapet wall. 5) Top with solid masonry.

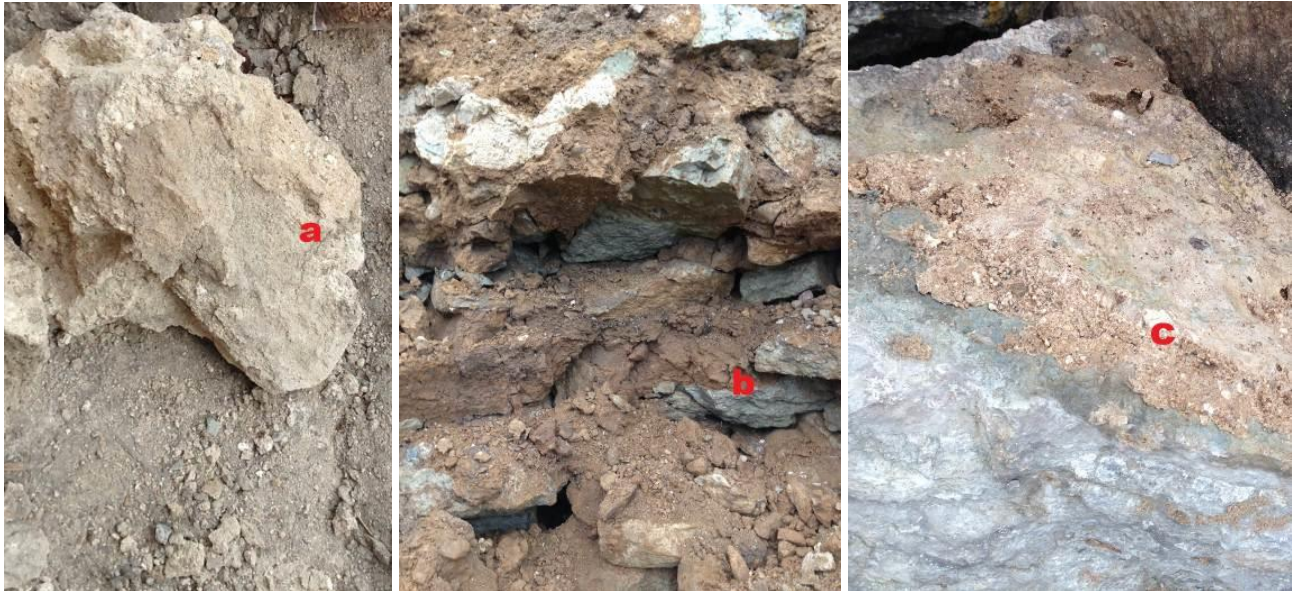
Figure 4. The fat lime mortar (a) is white and rather homogeneous. Lots of smaller lime lumps exist. It has a good adhesion to the limestone. The clay mortar (b) of the wall core is in good condition, powdering when dry and stable when wet. It has filled up the stone core very well. The type of mortar used in the second building phase (c) has a very good adhesion to the lime stone and is in general extremely well preserved despite its exposed position.

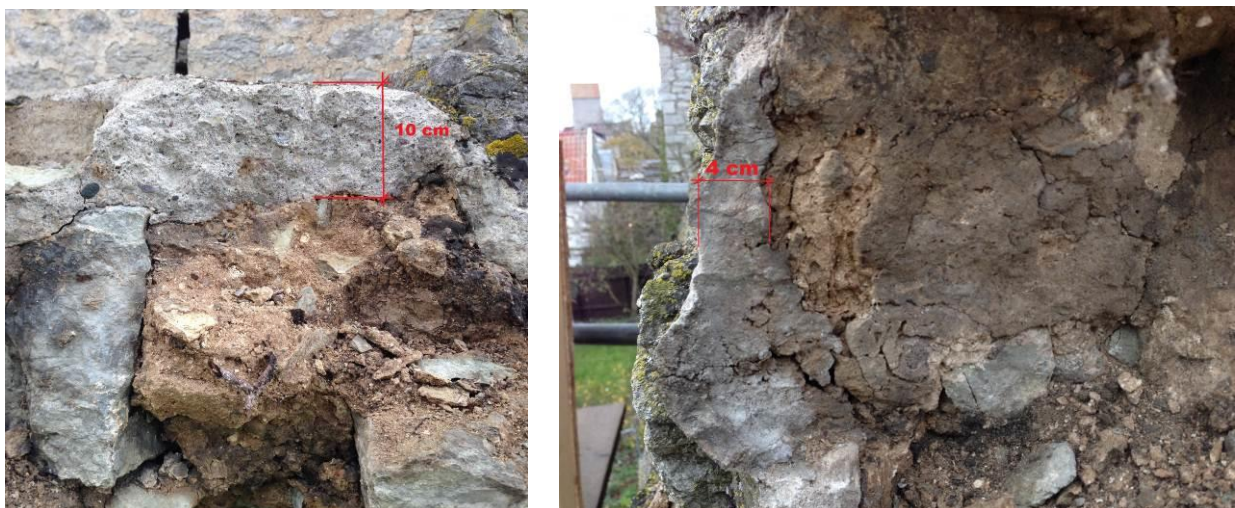
Figure 5. The first picture is showing the concrete cover on top of the wall, and directly beneath it is the type (c) mortar. Here this mortar was more deteriorated and more wet in approx. half a meter from the concrete layer than it was in general – not surprising for a 700 year old lime mortar situated on top of a wall. The second picture is showing the cement mortar covering the old lime mortar, showing the area of lime mortar just behind the cement as deteriorated in a thickness of approx. 5 cm.

approx. 10 cm to protect water from intruding the wall. The deterioration of lime mortar can mainly be seen just beneath the top layer of the wall or lower down behind joints of cement.

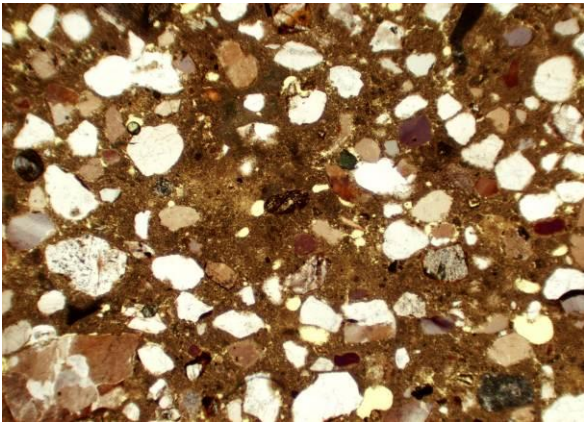
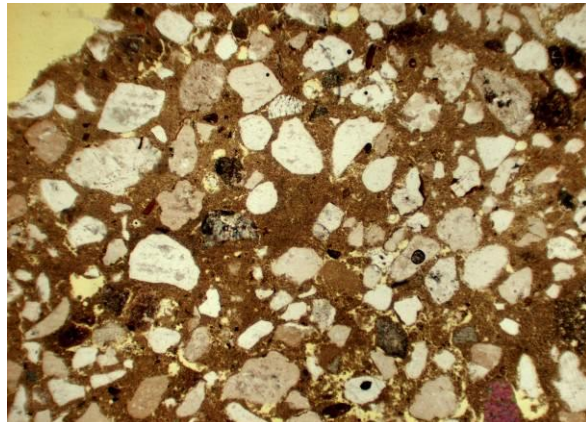
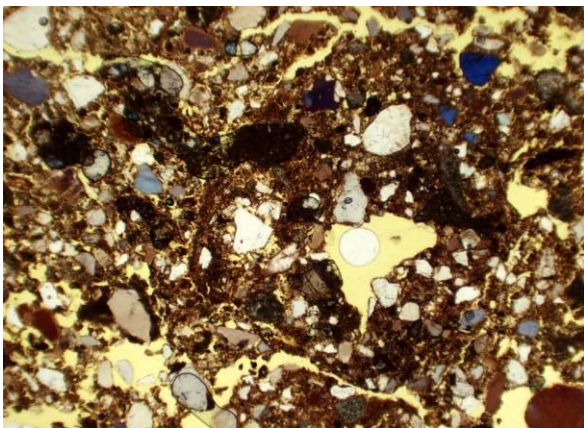
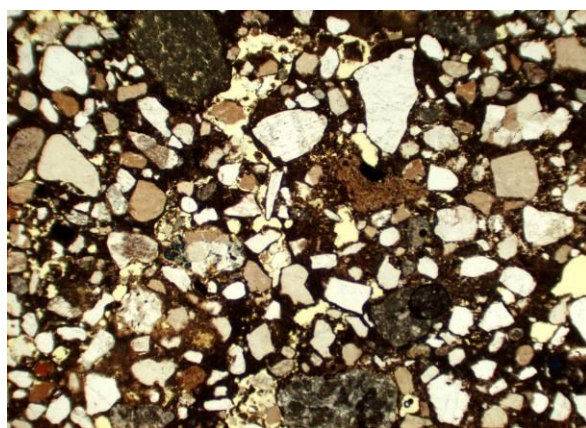
a1: Lime mortar from beneath the crenellations.

a2: Lime mortar from outside masonry leaf, in level with pathway.

b: Clay mortar from the lower wall core.

c: Lime mortar from the upper compact wall, above crenellations.

Figure 6. The samples a1 and a2 represent the type of fat lime mortars used in the first building phase of the wall; in the two leaves and in the compact masonry above the level of the rampart walk. It is a very fat lime mortar where the amount of lime is higher than the amount of sand, approx. 1.5:1 in volume [10, 11]. The sample (b) represents the clay mortar used in the wall core beneath the rampart walk. It is a clay soil containing sand giving a rather fat clay mortar. The sample c represent the type of lime mortar used in the second building phase, the mixing ratio is approx. 1:1.5 of lime and fine grained sand. The yellow colour shows the pore system, the brown colour shows the binder and the other particles show minerals from the sand. The width of each thin section is equivalent to 4.5 mm of the sample.

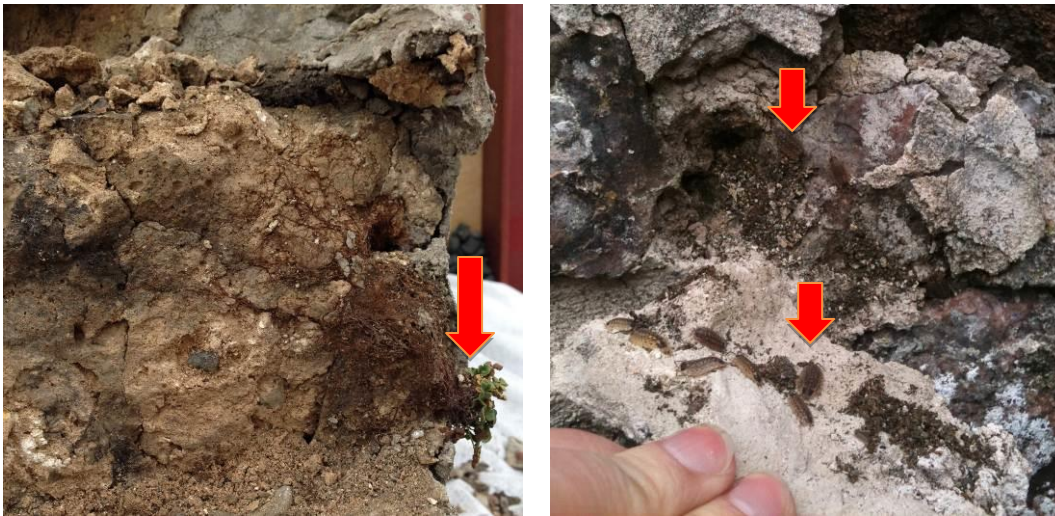
Porous materials such as limestone, cement mortars and lime mortars all have different properties when it comes to swelling and shrinkage due to temperature and moisture [17]. The thermal expansion coefficient of cement mortar can be two to three times higher than for limestone, and two times higher than for lime mortar [17, 18], at normal temperatures. The effect often seen at old masonry repointed with cement mortars is stiff cement mortars with cracks between the stone and mortar, giving no or low adhesion. As those cracks are thin they lead water inside by capillary transport. Having a moist environment and a soluble lime the life condition is excellent for the small crustacean “woodlouse” as well as for several plants. The woodlouse need the moisture as they breathe through gills, they need the lime to build their shells and they feed on decaying plants and leaves [19], producing humus. They live well in symbiosis with several plants and a small seed can easily grow in the moist environment behind the cement mortar. As the roots grow bigger they can cause damage far inside the wall and are almost impossible to remove, see figure 7. On the parts of the city wall where the joints still consists of original lime mortar no plants growing from inside the wall can be found [4].

Figure 7. a) A small plant with a large root system reaching far inside the city wall. It has been able to grow first after the joints were repointed with cement mortar. b) Woodlice found in the moist environment behind cement mortar.

For the rest of the wall there is a great need for further understanding the deterioration process and the weakness in structure. There is also a need for constant maintenance in order to remove plants and threes and diminish the conditions for plants to grow and in the same time prevent the bedding mortar from losing its binding effect starting with the exchange of cement pointing mortar. As long as the cement joint are left on the wall the increase of deterioration will be a fact.

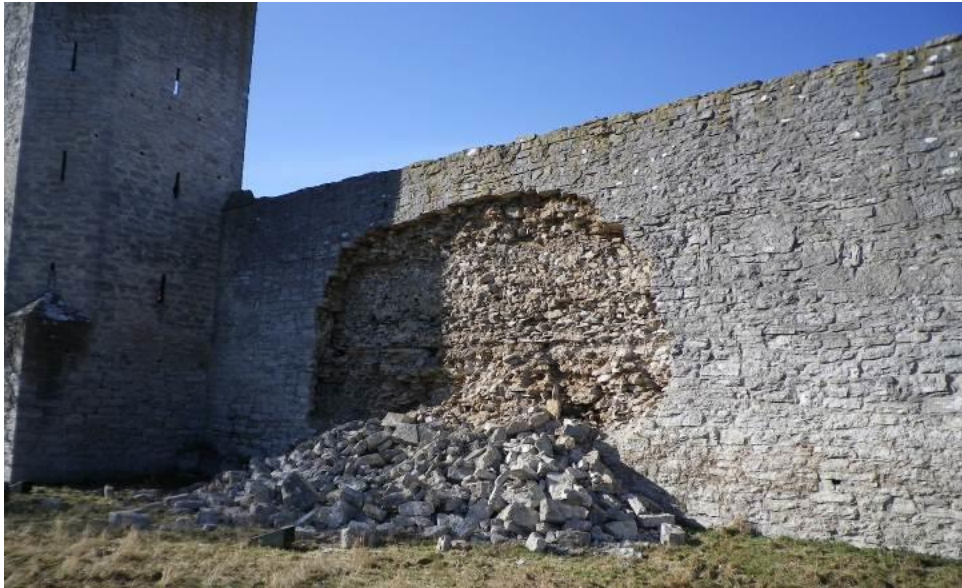
The collapse in 2012 resulted in the falling down of approximately 90 m² of the outer masonry leaf, see figure 6. The upper part of the wall consisting of solid masonry did not fall down and remained as an arch above the damaged part.

The collapse was most likely triggered by freezing of contained water. The load situation gave high stress in the outer leaf. In combination with a structure lacking through stones and insufficient binding stones and a weak adhesion in the bedding lime mortar in the lower part of the wall, it lead to a domino effect causing the extent of the collapse.

Figure 8. Visby City Wall in 26th of February 2012, a couple of days after the collapse.

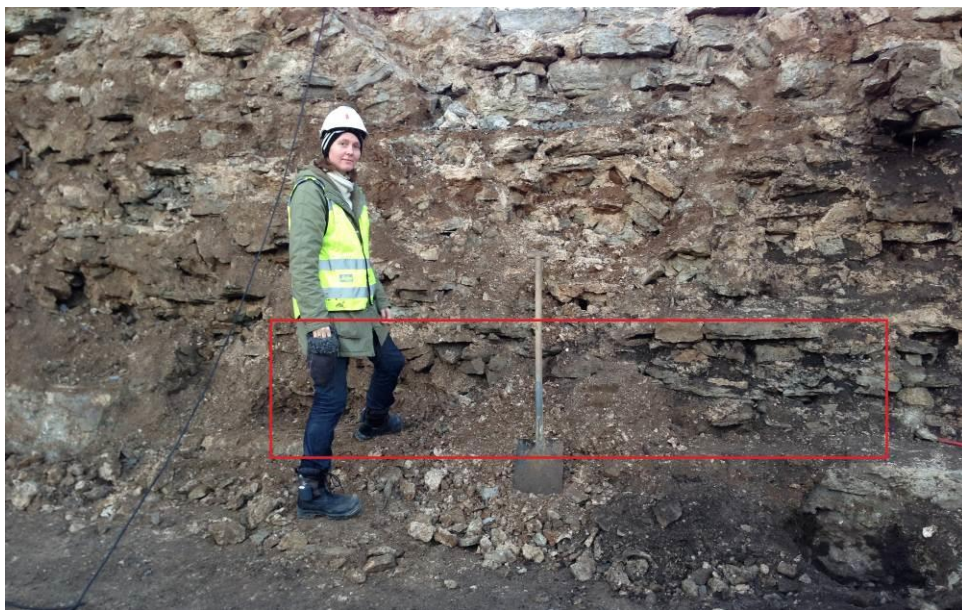
Figure 9. The area where the collapse probably started is a part of the wall where the masonry leaf was no thicker than a foot length, see the marked area. No binding stones were used in this part.
