PERFORMANCE OF UNREINFORCED STONE MASONRY BUILDINGS DURING THE 2010/2011 CANTERBURY EARTHQUAKE SWARM AND RETROFIT TECHNIQUES FOR THEIR SEISMIC IMPROVEMENT

By: Ilaria SENALDI¹, Guido MAGENES² and Jason INGHAM³

Summary

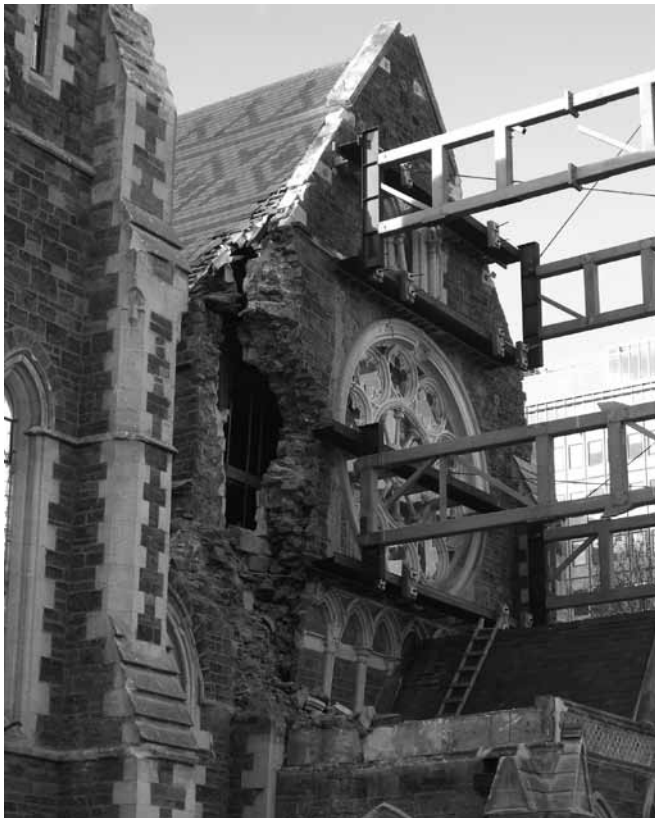
(a) Unstable front wall (prior to June 13)

**Figure 4: Christchurch Anglican Cathedral
– front façade damage**

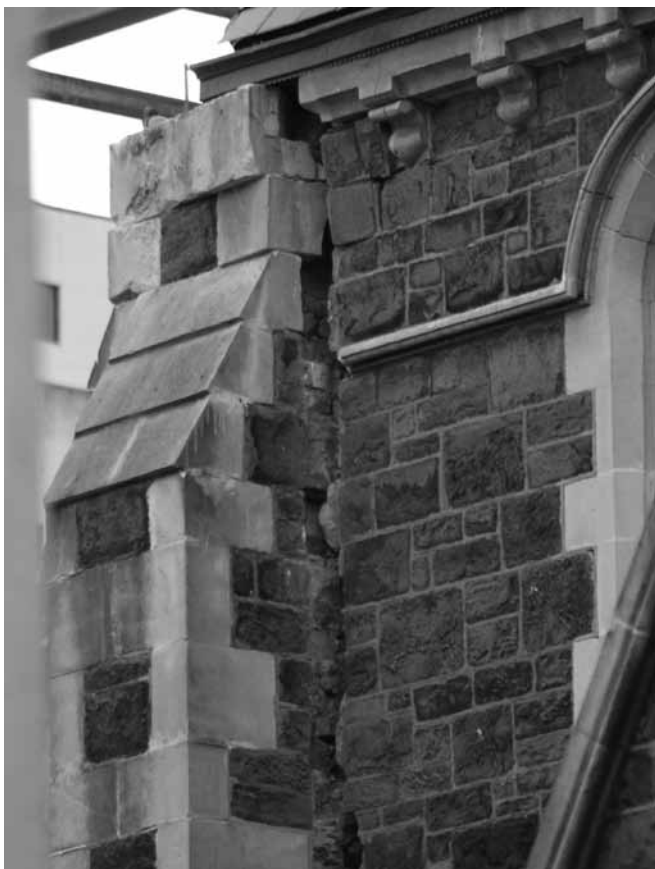
(b) Return wall separation

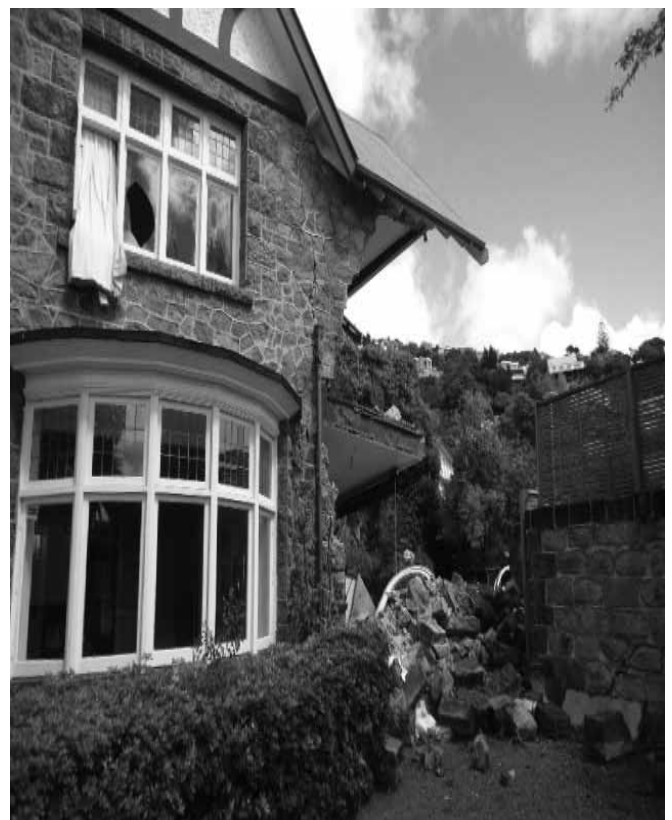
As expected for buildings having architectural features typical of the Gothic Revival style (long span façades, flexible floor diaphragms and weak connections between walls), partial or global overturning or instability of the façades was reported for most of the structures inspected, with damage ranging from moderate to severe and in some cases reaching collapse. Examples are shown in Figure 4 to Figure 6 relative to the main façade of the Anglican Cathedral (now partially collapsed after the 13 June 2011 earthquake and aftershocks), the Rockvilla dwelling that experienced complete collapse of the north and east façades, and the former Old Boy's High building in which the north façade was propped to avoid collapse due to out-of-plane failure. All of these buildings appeared to have poor connections between the walls at their corners, leading to return wall separation and subsequent out-of-plane failure of entire walls, as in the case of the Rockvilla house (see Figure 5).

**Figure 5: Rockvilla dwelling with complete
collapse of the north and east façades**

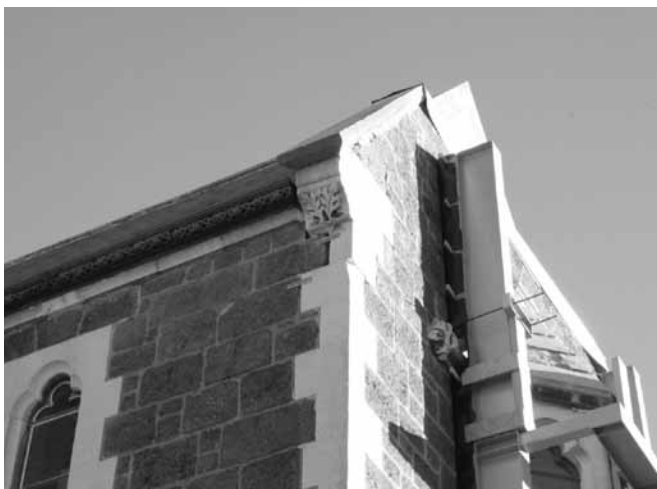
Figure 6: Christchurch Arts Centre (former Old Boy's High building), with severe damage due to instability of the façade at the second storey

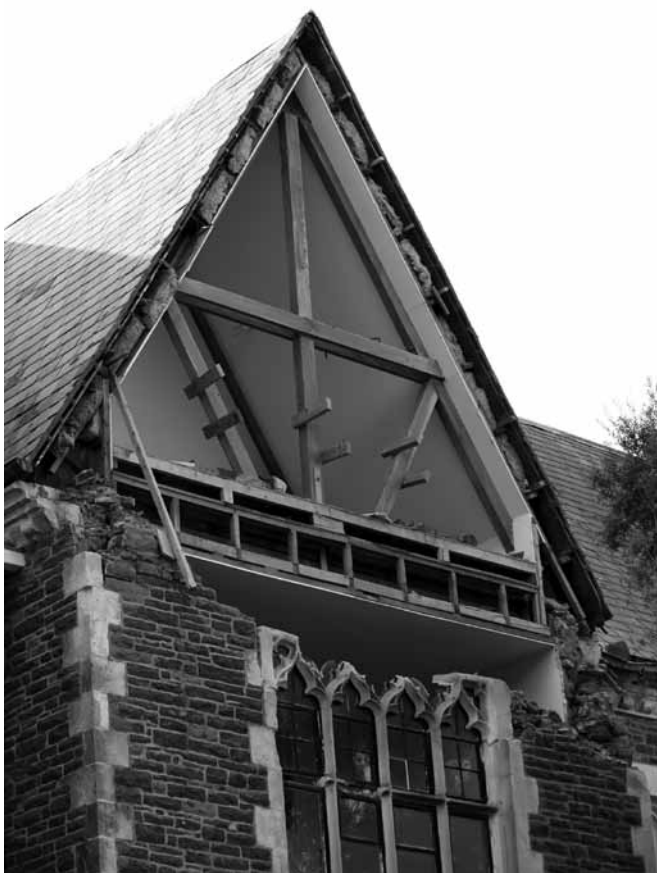
Many of the stone masonry buildings that were constructed in the Gothic Revival style sustained partial damage to their gable ends, with many cases of complete collapse of the gable. The absence of significant gravity loads and inadequate connection between the gable and roof trusses are primary contributing factors to this failure mode, along with increased accelerations experienced at the top levels of the structure (see Figure 7).

Figure 7: Cramner Court, showing complete collapse of a gable

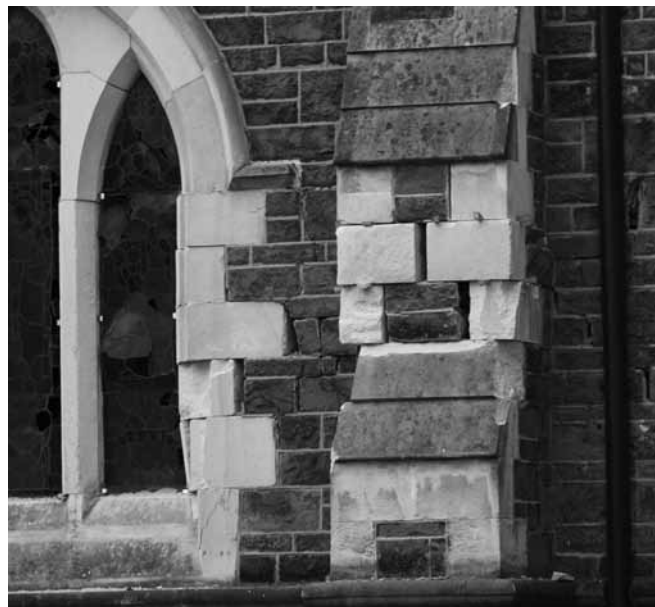
Because the 22 February 2011 earthquake was predominate in the east-west direction, and because many of the buildings in the CBD are primarily oriented in the same direction, evidence of in-plane wall damage in the east-west running walls (see Figure 8 and Figure 9) was reported in conjunction with overturning of façades oriented in the orthogonal direction (see Figure 4).

Figure 8: Christchurch Anglican Cathedral – diagonal cracks in the south façade piers

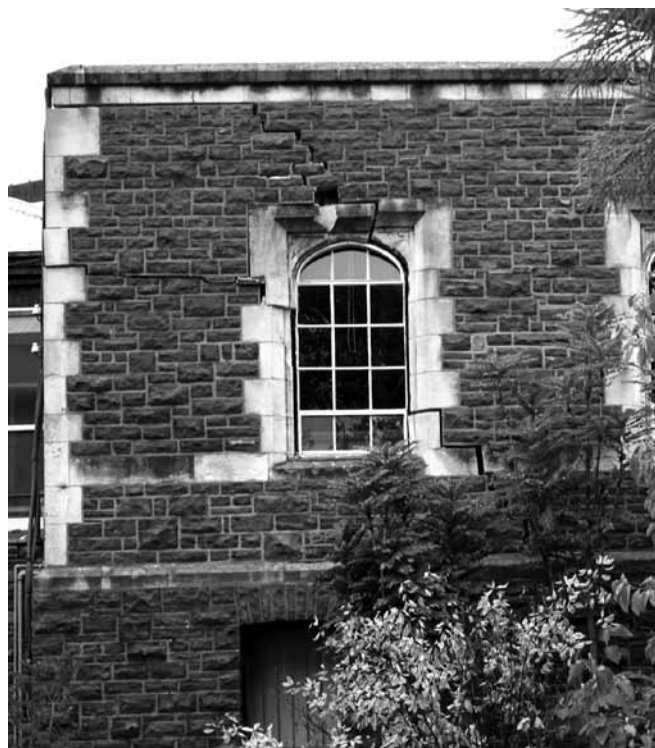
Figure 9: Canterbury Provincial Chambers – diagonal crack through entire south façade of the east annex

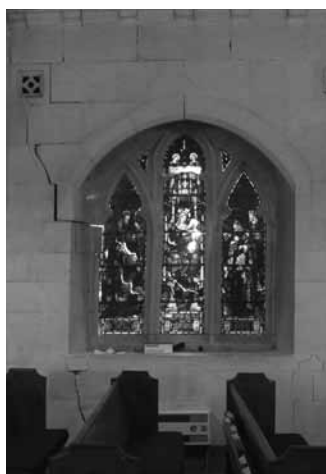
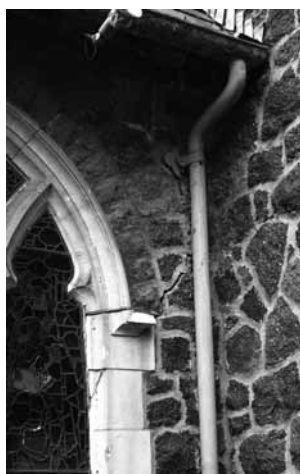
Damage that was attributable to plan irregularity was frequently observed, particularly for stone churches, due to interaction between adjacent structural elements at the intersections between walls. In most churches where the bell tower or low annexes are connected to the nave, damage developed at the intersection of the different structures (see Figure 10 and Figure 11).

Figure 10: St. Barnabas' Church, showing interaction between the nave and the bell tower

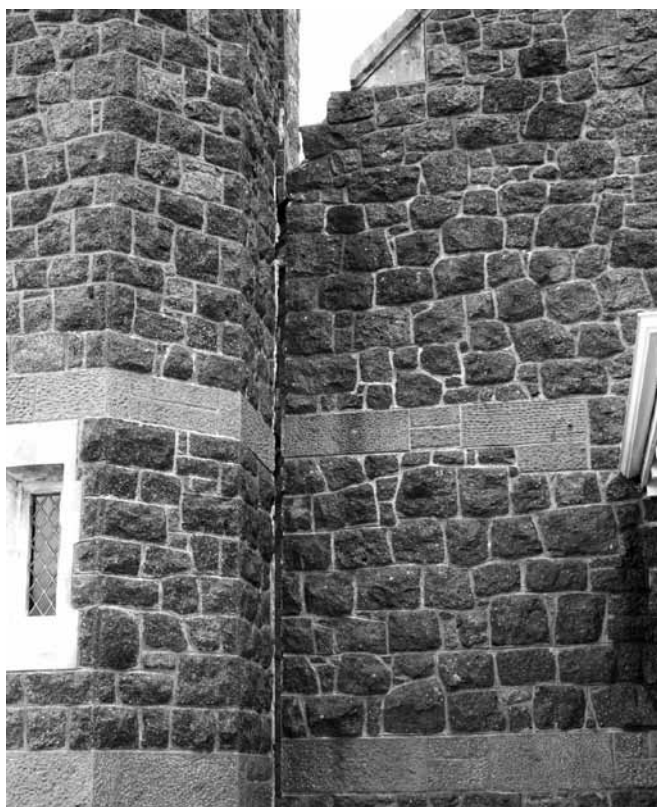
Figure 11: St. Mary's Anglican Church – detachment of the bell tower from the nave

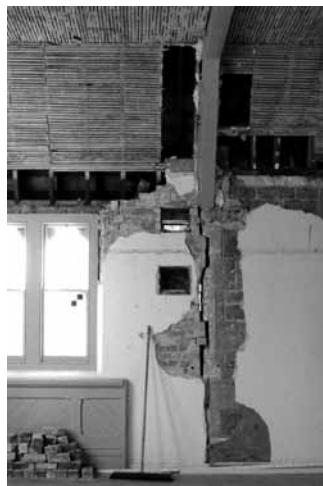
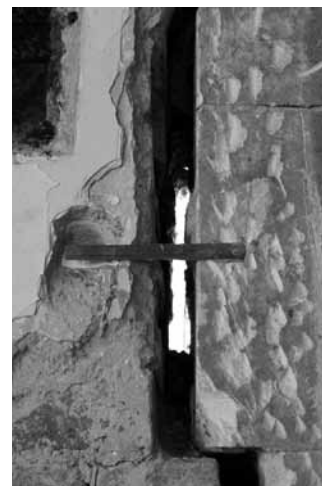
Another distinct example of damage due to plan irregularity in association with differential foundation settlement was observed at the former Old Boy's High building. Figure 12 shows the vertical crack that formed at the intersection between two buildings constructed in successive phases, attributable to the lack of connectivity between the structural walls and to their separate foundations.

Figure 12: Interior views of Old Boy's High, showing interaction between adjacent buildings

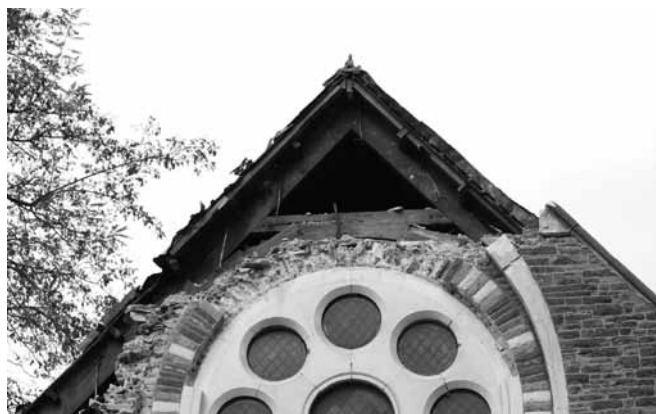
(a) Overturning of the front façade gable

Figure 13: Former Trinity Church, showing details of gable ended out-of-plane wall failure (continued)

Two cases are presented to show the different behaviour induced by the presence and effectiveness of anchoring. Figure 13(a) shows the damage resulting from overturning of the gable of the main façade of the former Trinity Church in the Christchurch CBD while the detail in Figure 13(b) illustrates how the anchoring was insufficient in size and spacing to secure the wall in place. Figure 14 shows some examples of successful wall-to-roof anchoring in the Arts Centre building.

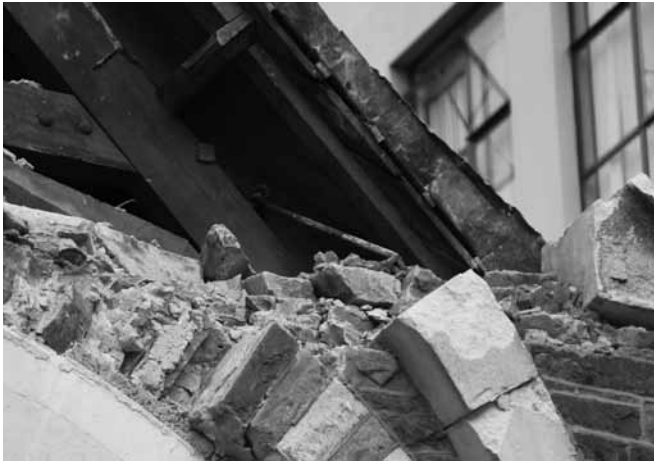
(b) Detail of failed wall-to-roof anchorage

Figure 13: Former Trinity Church, showing details of gable ended out-of-plane wall failure (concluded)

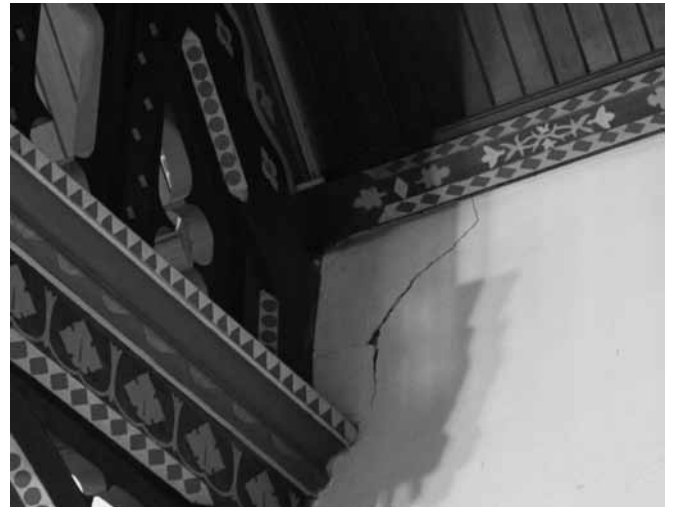
In the case of churches, pounding of roof trusses was reported as for the case of St. James' Church shown in Figure 15.

(a) Damage due to pounding of roof truss

Figure 15: St James' Church, showing pounding of roofing elements on the walls of the nave

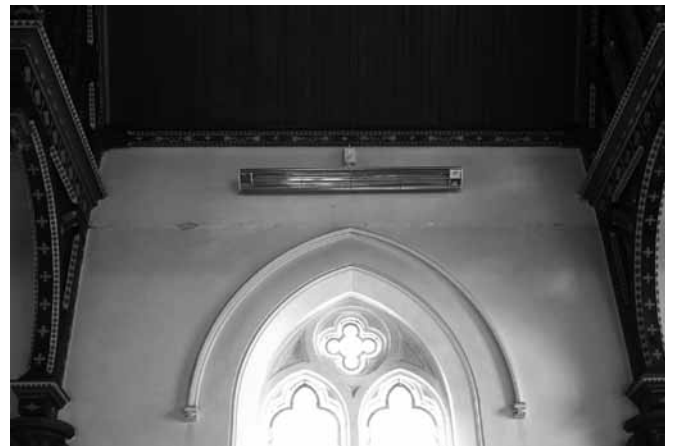
(b) Horizontal crack above arched window due to pounding of roof trusses

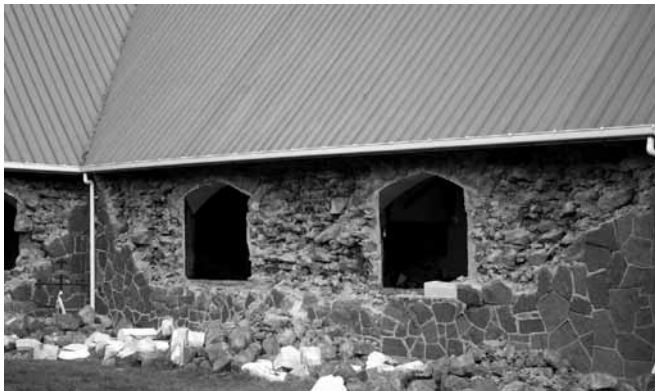
Figure 16: Lyttelton Holy Trinity Church showing damage induced by hammering of the roof

It was reported that after the 13th June 2011 earthquakes, the remaining parts of these two buildings, and several others in Lyttelton that were in a similar state of damage, completely collapsed.

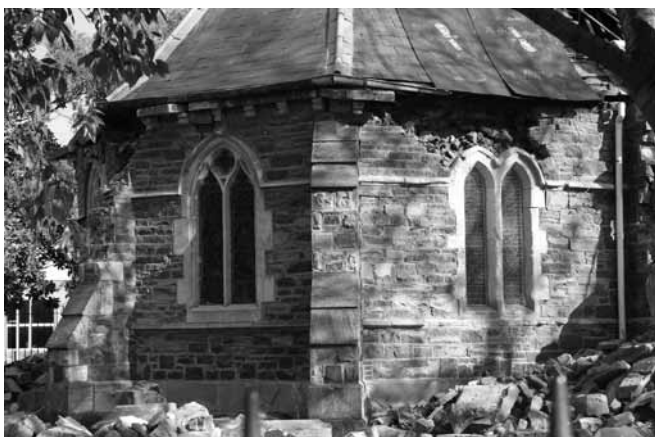
Figure 17: St. John's Baptist Church showing local collapse of the stone masonry walls

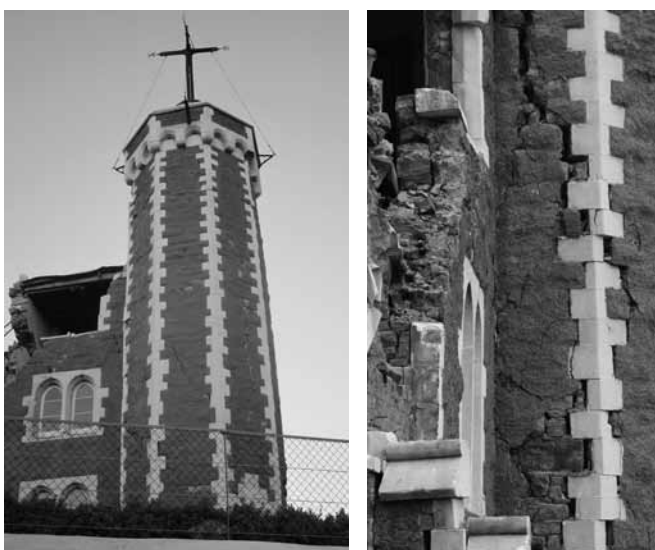
(a) Out-of-plane wall failure (b) Damage to stone tower

*Figure 18: Timeball Station.
Damage in the Timeball tower*
