# Evaluation of the repair on multiple leaf stone masonry by acoustic emission

**Abstract** Aim of this research was to evaluate the possible application of the AE technique to study the response of multiple leaf masonry repaired with different techniques. The results of shear tests carried out on three specimens repaired after failure are presented on an explorative basis; on two of them the acoustic emission (AE) technique was also used. Through a number of sensors and by triangulation, this technique makes it possible to identify the location of the damage, unknown initially, and subsequently to assess the stability of its evolution. Using the AE technique the area of the material where the cracks propagated during shear tests was identified. These analyses made it possible to evaluate the effectiveness of repair interventions through parameters other than stress and strain, and contributed to the identification of the most suitable methodology for their optimisation.

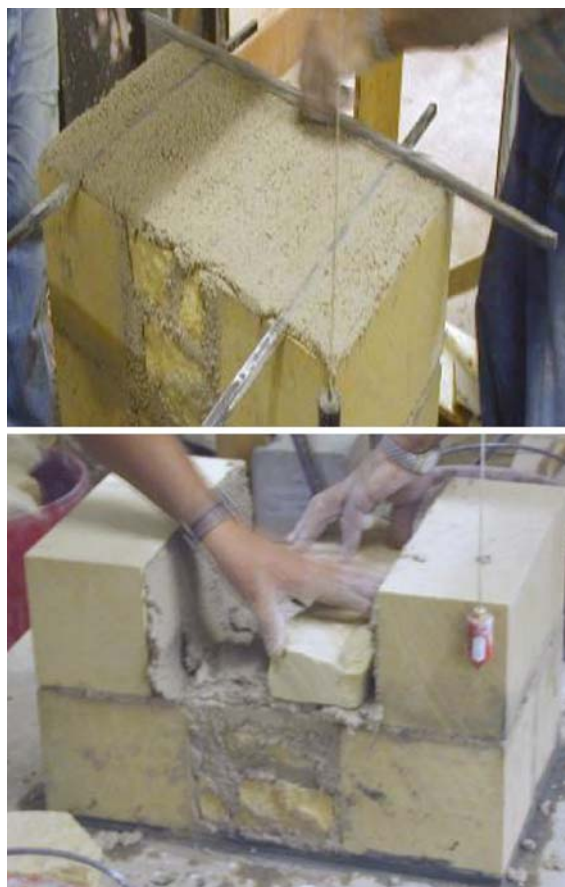
Fig. 1 Phases of construction

Twelve three-leaf stone walls, measuring  $310 \times 510 \times 790 \text{ mm}^3$ , were built at DIS—Politecnico di Milano, by Spadaro srl Contractor—Rosolini, Sicily, so as to reproduce the morphology of the multiple-leaf walls and piers frequently encountered in historical centres (Figs. 1 and 2). The two external leaves, made of stone blocks with horizontal and vertical mortar joints, are connected to an internal rubble masonry leaf made of pebbles of the same kind of stone and connected with the same mortar as the outer leaves [1]. The experimental investigation was aimed to study the compression and shear response of the interface between the masonry leaves so as to achieve some understanding of the bearing capacity of the structure after perfect mutual collaboration has been lost due to a non-uniform vertical action or in-plane horizontal forces.

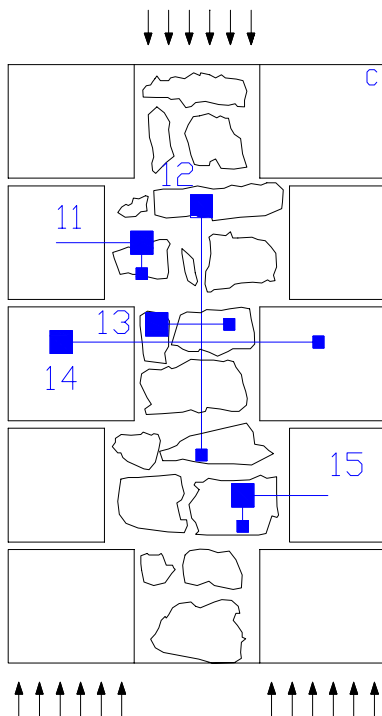
Fig. 3 Loading condition

Eight walls were tested to failure in shear conditions according to the loading scheme shown in Fig. 3. Further details on the complete experimental work can be found in [2, 9].

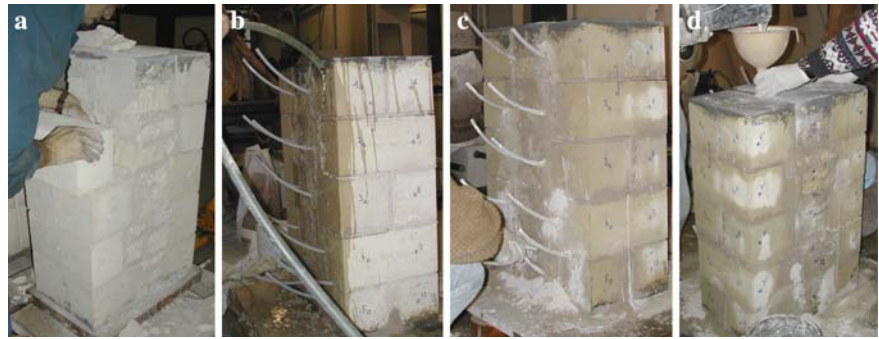
**Fig. 5** Injections in the walls

Once removed from the testing machine and stored in the laboratory, three walls were repaired and subsequently tested again. Before repairing the walls by injection, a partial reconstruction of the outer leaves was necessary as can be seen in Fig. 5a. The repair was carried out by means of grout injections designed to fill the main cracks formed at the interface between the inner and the outer leaves during the test [11–13] and by fitting steel bars. In particular, completely inorganic mixes based on microfine pozzolanic binders (Fig. 5) were used [14–16] and rods, having a diameter of 16 mm and characterised by an elastic modulus of 19500 N/mm<sup>2</sup>,

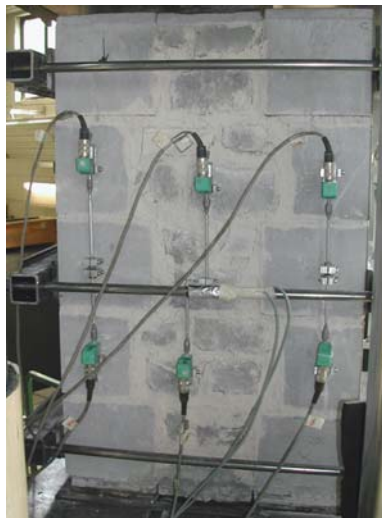
**Fig. 6** Wall repaired with steel rods

were applied by tightening the nuts to a torque of 50 Nm (Fig. 6). This corresponds to a longitudinal action of 15.63 kN on each rod, corresponding in its turn to a total lateral confinement on each wall of 0.37 N/mm<sup>2</sup>.

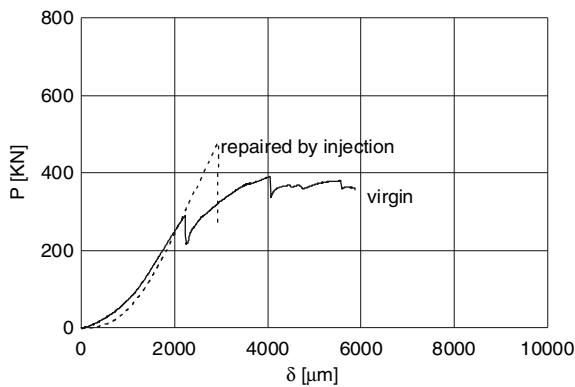
**Fig. 7** PS4 in Serena stone

In the case of specimen PS4, the diagram plotted after the repair repeats the same trend observed before the repair in the branch preceding the failure of the first collar joint and maintains this slope until failure. From a qualitative point of view, the behaviour is more brittle than that of wall PS4 before the repair (Fig. 7).

In the two cases where the repair was made through injections (PS4 and PN4), the subsequent collapse of the two collar joints, that could be clearly observed in the diagrams plotted before the repair, is no longer visible. This is still scarcely evident in the case of the wall repaired only with steel rods (PS6), in which case the diagram shows a small decrease, corresponding to a displacement of 6000  $\mu\text{m}$  (Fig. 8).

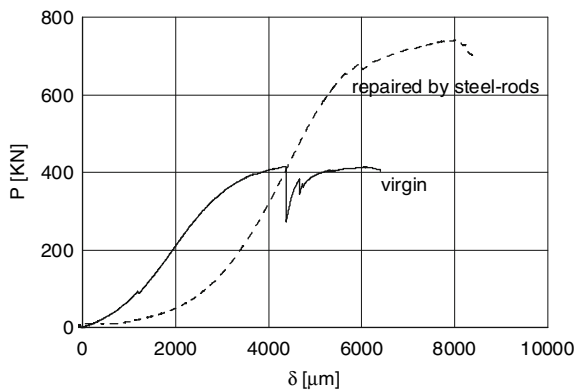
**Fig. 8** PS6 in Serena stone

even after the repair (Fig. 8). This last aspect is probably due to the presence of previous cracks that had not been filled and that, in the initial part of the test, allowed a relative displacement between the inner and the outer leaves. The great ductility of the failure behaviour is probably due to the friction developed at the interface between the three leaves induced by the load from the steel rods, combined with the characteristics of the stone. In fact, the Serena stone is characterised by a higher mechanical strength and, in the presence of lateral confinement, the stones of the outer leaves do not reach locally the failure values, as can be gathered from the crack pattern discussed below. Therefore, on the whole, failure is governed by the rupture of the inner leaf that overall displays a scarcely brittle behaviour.

inner and outer leaves can also explain the very ductile behaviour shown in Fig. 8 and commented previously.

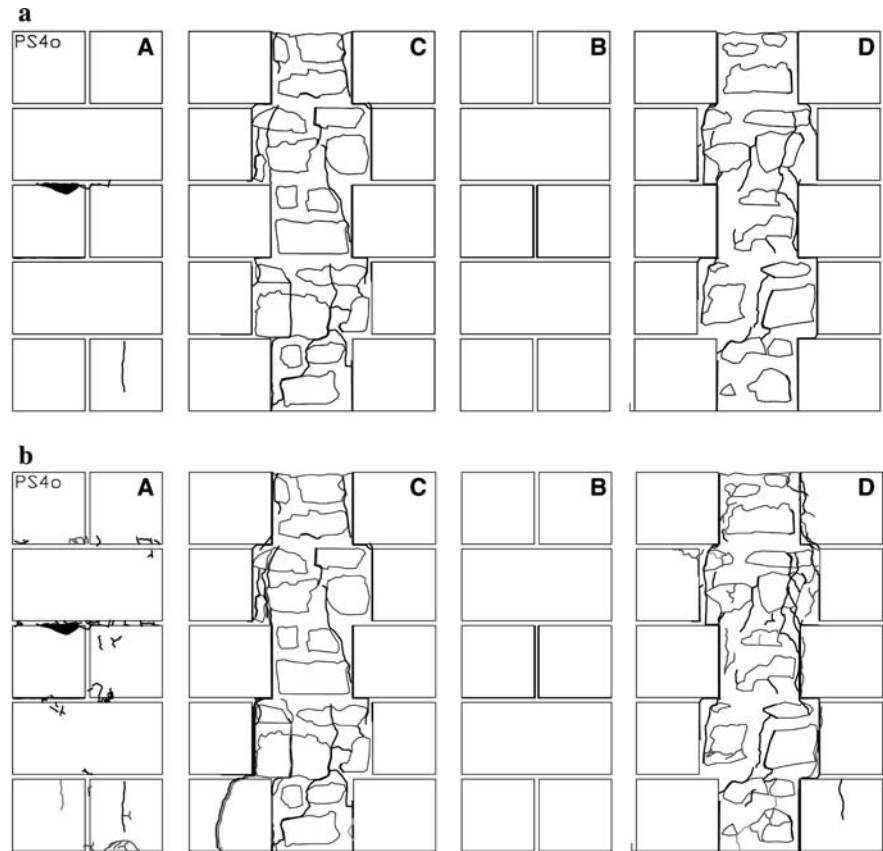
**Fig. 10** Crack pattern in wall PS4 before (a) and after (b) repair

In particular, in the case of prism PS4 (Fig. 10), the tendency to diagonal load diffusion, the collaboration between the inner and outer leaves due to grouting, and the absence of lateral confinement led to the failure of a stone block, at the base of the outer leaf.

From an analysis of the crack patterns (Figs. 10–12), what is seen in the diagrams can be confirmed. In addition, a comparison with the crack pattern of unrepaired prisms can be made: the tests carried out after the repair resulted in the same cracks opened previously opening again and new ones being formed.

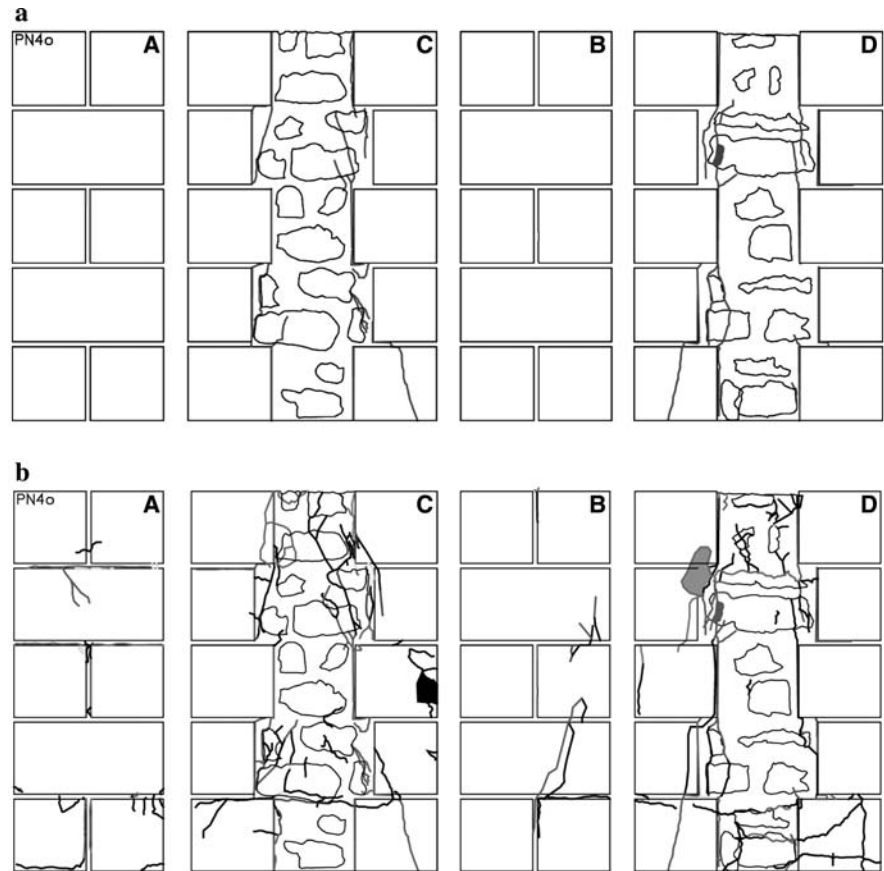
**Fig. 12** Crack pattern in wall PN4 before (a) and after (b) repair

In the case of specimen PN4 (Fig. 12), a greater involvement of the outer leaf took place at failure, when new cracks opened and, in some areas, delamination occurred, together with the propagation in the inner leaf of cracks that sometimes also cut the stone pebbles. In this case horizontal cracks were also visible, both on the outer leaf and on the inner leaf at the base level, due to the compression effect produced horizontally by the presence of the steel rod during the loading phase, given the low strength of the stone.

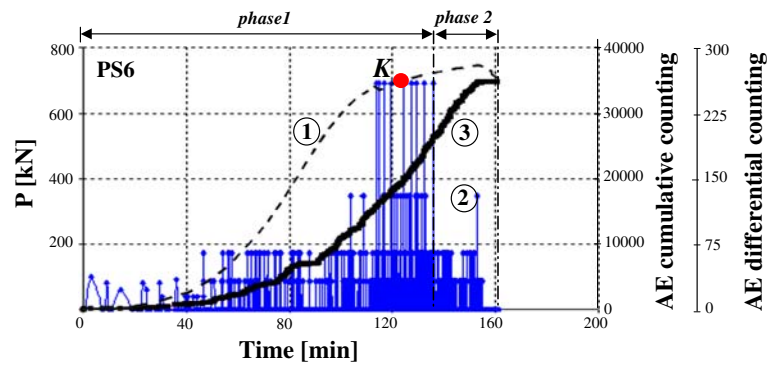
**Fig. 18** Loads versus time curves and AE activity for walls PS6 and PN4

The specimens were loaded under strain control imposing constant rate displacement to the upper loading plate. To obtain a very slow crack growth, displacement rates of  $8.4 \times 10^{-4}$  and  $6.7 \times 10^{-4}$  mm/s were adopted for specimens PS6 and PN4 respectively. Load versus time, cumulative AE counting and differential AE counting (for each minute of the testing period) are depicted in Fig. 18. It can be seen that cumulative counts increase, very slowly at first and then proportionally to the load, reaching a peak in the proximity of the highest load reached in each test. The function representing the differential counts (AE count number per minute), instead, reaches its maximum value in the ascending branch of the load-displacement curves and it reduces quickly to nil in the proximity of the ultimate load. From the diagrams of the differential counts of the AE signals, it is therefore possible to identify two phases in the loading process: a first phase during which the biggest cracks are formed and the material reaches a critical damage condition (phase 1), and a second phase during which the material tends to exhaust its bearing capacity (phase 2).

From the diagrams in Fig. 18, it can also be seen that during the tests on the repaired specimen the material begins to release a great quantity of energy once exceeded the maximum stress level reached in the virgin state (point K identified in the load-time curves). In perfect agreement with the so-called *Kaiser effect* [28], these results are useful to assess in

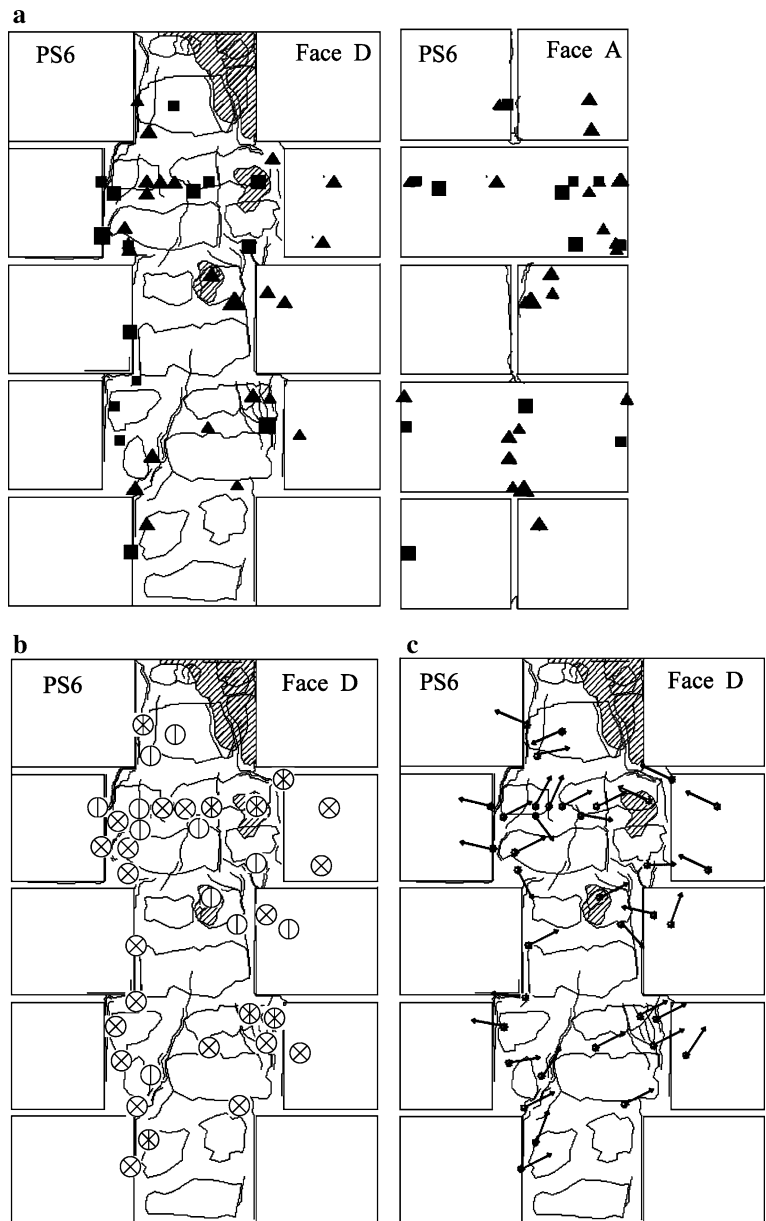
**Fig. 19** AE sources in specimen PS6. (a) Localisation and magnitudes of crack volumes, (b) crack type, (c) crack motion vectors

In particular, during the loading test performed on specimen PS6 (strengthened exclusively with steel rods), 34 AE signal source were identified (Fig. 19). In the localisation process, only the waveforms whose arrival times were recorded almost simultaneously (with differences of the order of microseconds) by the six sensors were used [29]. The moment tensor analysis was also performed on these points. The transmission velocity of the ultrasonic signals through the material was found to be about 1350 m/s, the frequency most often encountered was about 120 kHz. The sources determined during the first phase of the loading test (phase 1) are represented by triangles; the ones determined during phase 2, when the material tends to exhaust its bearing capacity (Table Table 5), are instead represented by squares.

Damage process zone are in good agreement with the considerations expressed in Sect. 3.1. From Fig. 19 it can be seen that in specimen PS6, microcracks are mostly located in the inner leaf, in the zone situated between the two upper braces. A non negligible number of microcracks is also located at the interface between the inner and outer leaves. It should be underscored that virtually all the microcracks identified between the upper braces are located in the tensile zones of the masonry. These zones, according to the diagram in Fig. 14a, are clearly revealed by displacement transducers 13 and 14. Additional microcracks were also identified in the proximity of the zones in tension of the inner leaf by displacement transducers 10 and 12, shown in Fig. 14b.

events are concentrated at the macrocracks identified. If the AE sources are identified by means of a graphic representation where individual crack magnitudes are symbolised, an interesting superposition is obtained between the AE sources with large crack volumes and the failure planes visible to the naked eye (Figs. 19 and 20).

For specimens PS6 and PN4, crack volume magnitudes, broken down by loading phase, are represented according to the notation listed in Table 5. Figures 19 and 20 also illustrate crack types, according to the definition given in Sect. 4.2, and the crack motion vectors reflecting the directions of displacement of the fracture surfaces.

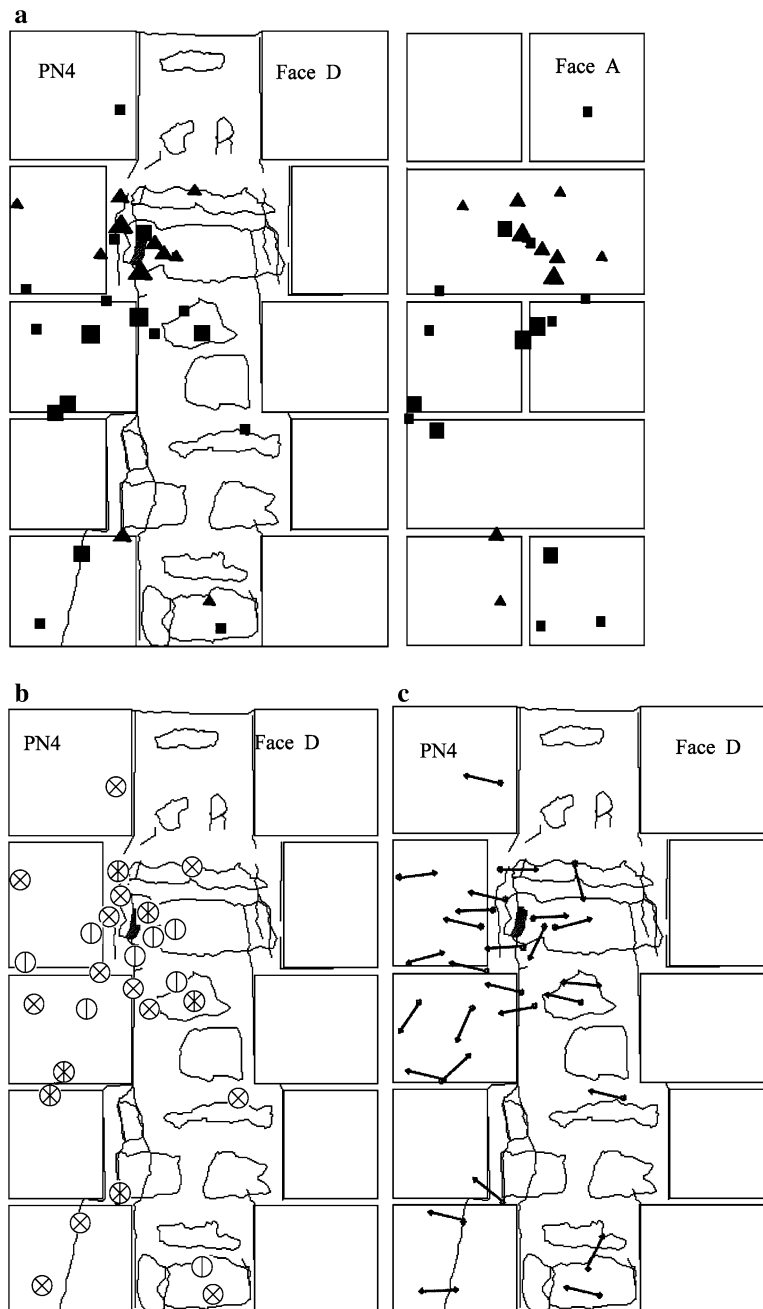
**Fig. 20** AE sources in specimen PN4. (a) Localisation and magnitudes of crack volumes, (b) crack type, (c) crack motion vectors

During the load test on specimen PN4 (repaired with grout injections and steel rods), 32 source points

were identified from AE signals recorded almost simultaneously by the six sensors (Fig. 20). The transmission speed of the signals was found to be ca 980 m/s, the frequency most often encountered was ca 90 kHz.

In specimen PN4, shown in Fig. 20, nearly all the microcracks were identified in the tension zones of the masonry. In this case too, the microcracks were mostly located in the inner leaf, between the two upper braces. According to the diagram in Fig. 15a, these zones were covered by displacement transducers 6 and 2. A certain number of points was also identified in the lower portion of the specimen, and reveal the presence of microcracks in an external Noto stone masonry block.
