STRUCTURAL CONSOLIDATION AND STRENGTHENING OF MASONRY: HISTORICAL OVERVIEW AND EVOLUTION

**Dionys Van Gemert, Filip Van Rickstal, K.U.Leuven, Belgium
Sven Ignoul, Triconsult N.V., Belgium
Eleni-Eva Toumbakari, YSMA, Ministry of Culture, Greece
Koen Van Balen, K.U.Leuven, Belgium**

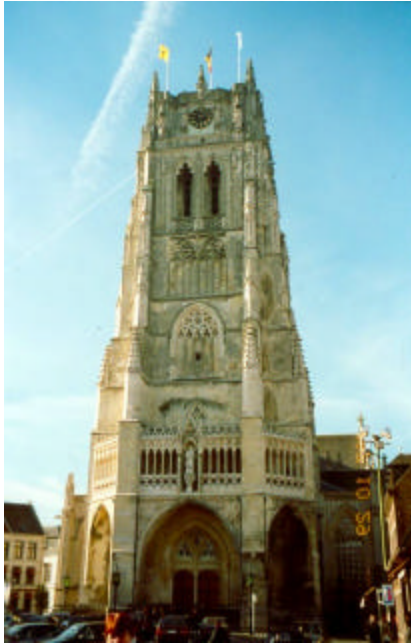
Figure 4: Tower of St. Mary's Basilica at Tongeren

The walls of the tower are up to 4 m thick. The top level was added in 1877-1882. A supplementary supporting brick masonry structure was provided at the inside of the tower, transferring the additional load to the top of the second floor. However, this strengthening measure turned out to be insufficient. Consolidation injections were carried out on the first and second floors, combined with the construction of two reinforced concrete diaphragms above the first and the second floor, as shown in Fig. 5. In a first step the larger holes and voids were filled by means of injection of a cement-based grout. The grout contained slag cement CEM III A 42.5, bentonite stabilizer, a sulfonated naphthalene superplasticizer and water. High turbulence mixing is needed to produce a very flowable and stable grout. In a second step a solvent free reactive epoxy resin was injected to improve the internal cohesion and the adhesion between mortar and stones. An extensive control program was executed to study the consolidation procedure and its performance. Moreover, a lot of research efforts has been devoted to the development of non-destructive test methods, allowing to investigate the internal condition of masonry masses, and to predict the necessary grout consumption [12, 13, 14].

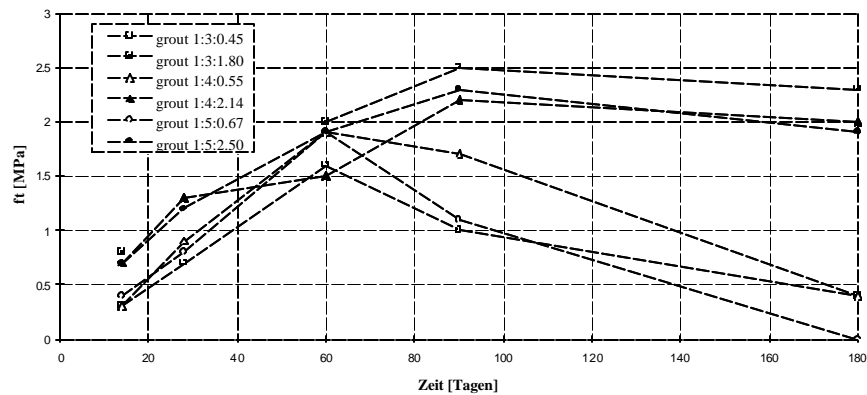
Figure 7: Time-evolution of bending strength of blended grouts

Compositions are indicated as grout 1:3:0,45, indicating the composition in weight parts: 1 part of hydrated lime: 3 parts of Rheinisch Trass; 0,45 parts of Portland cement. The compositions represented in the figures 5 and 6 contain or 10 % or 30 % of cement in the total binder amount.

The development of strength at the beginning is due to and determined by the cement content. This is not surprising, because the hydraulic activity of the pozzolans only

starts after about 4 weeks. In the mixes with 30 % of cement, the initial strength is not related to the lime to pozzolan ratio. Only after 60 days a significant difference arises. After 180 days the compressive strength reaches about 10 to 12 MPa for the 30 % mixes. The evolution of the bending strength shows that a minimum of 30 % of cement should always be present in the grout mix, because otherwise the tensile bending strength, which is also a measure for the bond strength, drops to zero after half a year. This is due to the delayed hydraulic reaction of the lime and the pozzolans, which chemically attacks the initial hydrated structure of the cement fraction, and exerts destructive forces on the hydrated cement skeleton [18].

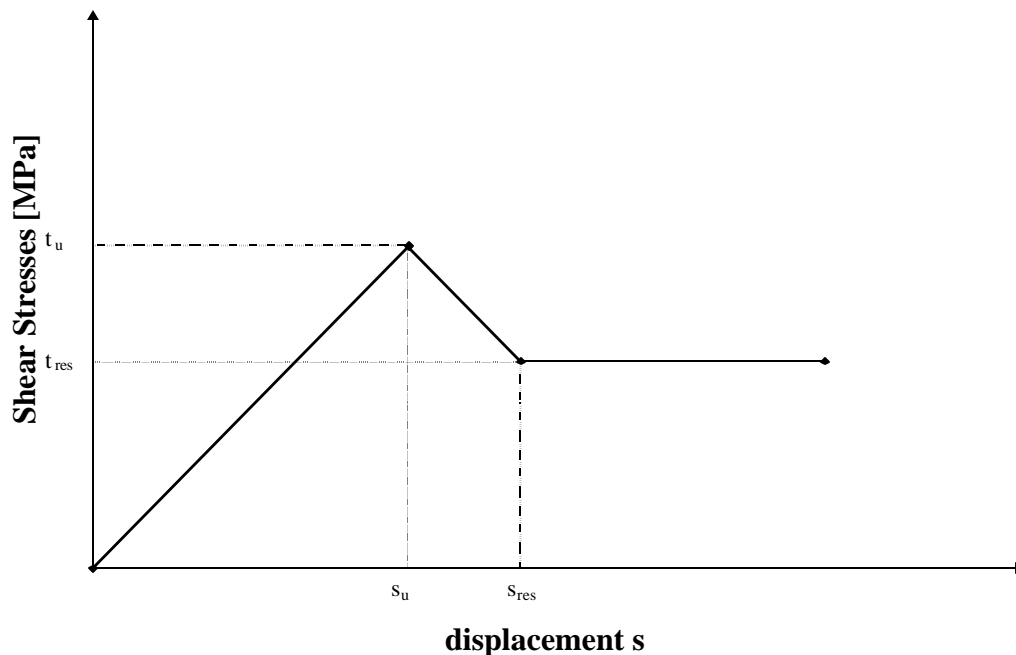
Figure 8: Shear stress-slip relation for grout-substratum interface

The shear bond characteristics for a brick and a limestone substratum were tested in a Casagrande shear box apparatus, which enabled the measurement of shear stress versus slip under specific normal stresses. The general shear stress – slip curve is shown in figure 8. The shear bond characteristics for a brick and a limestone substratum are given in Tables 1 and 2.

The grout composition is 1 part of lime to 3 parts of pozzolan, with 30 % of cement, with addition of 0 or 10 % of silica fume; grout Cb-0 is a pure cement grout. J_u is the shear bond strength at slip s_u in the shear box test. The grouts were injected in test wallets, which were previously loaded in compression till cracking in the post peak zone. The test results are given in Table 3 [18].

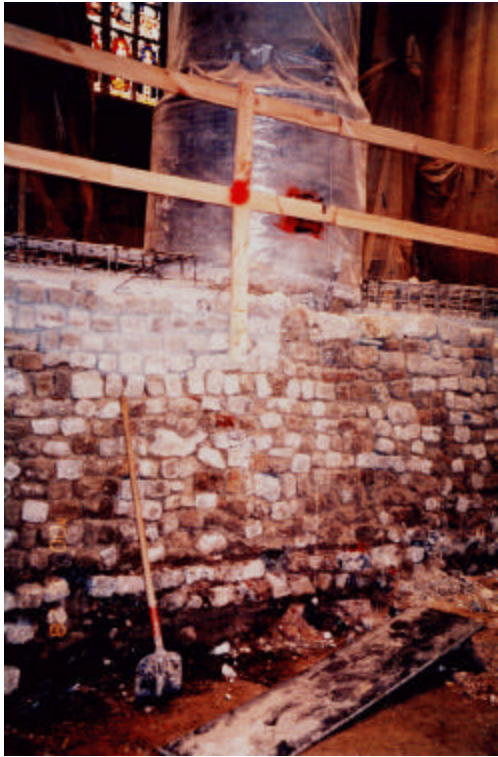
Figure 11: Chain wall between columns

The columns transfer a concentrated load of 1800 kN to the foundation footing. These footings are connected with a chain wall, as shown in Figure 11.
