# **STRENGTHENING OF STONE MASONRY ARCH BRIDGES**

## **THREE LEAF MASONRY WALLS-STATE OF THE ART**

Student: **Vlad Apreutesei**

GUIMARÃES, 2005

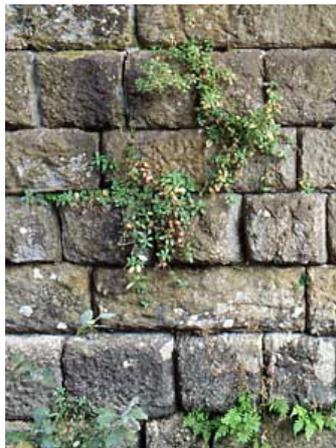
**Fig. 1.4** – Alternate courses

The alternation of masonry units in stretchers and headers in the same course, or the presence of alternate courses of units in stretchers and headers are bonds that the Romans also copied from Greek construction, where they originally appeared when structures built with logs of wood alternately placed crosswise to grant them stability were subsequently reproduced in stonework.

Of the two dispositions, the latter (alternate courses of stretchers and headers) is the most frequent in Roman construction, further proving its systematic nature, well suited to the Roman concepts of planning, efficiency and speedy execution.

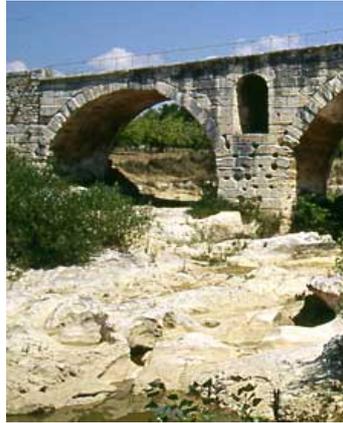
Openings in the piers were quite common probably to improve flow in flood and possibly to reduce weight on the foundations, although some of them were so small that they would make little difference to either flow or weight.

**Fig. 1.5** – Flood opening in pier

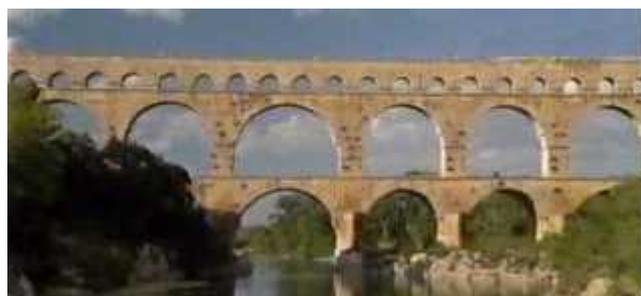
**Fig. 1.7** – Pont du Gard

Exploiting the structural form of the arch, the Romans constructed magnificent bridges and aqueducts all over their empire. One of the most outstanding examples is the Pont du Gard, an enormous aqueduct formed of three tiers of arches and, except the top tier, made from dry stone masonry.

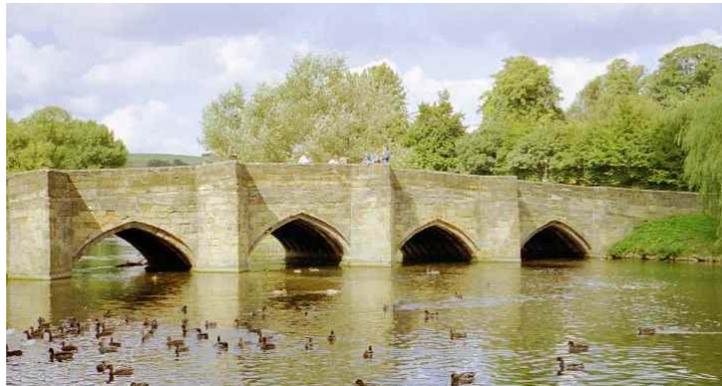
The spans varied from five feet in the case of small bridges to twenty feet or more in a few cases. The first were semicircular with a barrel vault. In the 13th century pointed arches replaced these arches and groined vaults replaced barrel vaults.

**Fig. 1.9** – Pointed arch

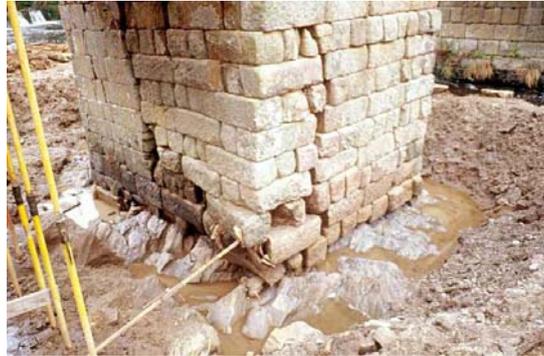
River bed profiles may be determined by poling or by a leadline but it must be bond that a scour hole produced when the river was in flood may have refilled as the flood subsided but that the material will not be compacted and will provide relatively poor support to the foundations.

**Fig. 4.3** – Damaged foundation

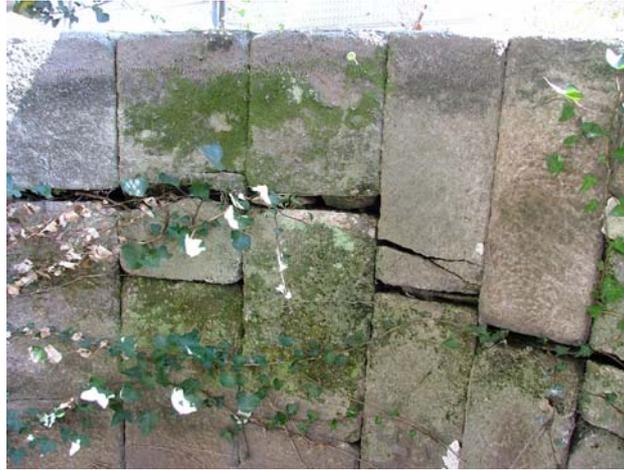
Spandrel walls stiffen the arch ring at its edges. Flexing of the arch ring due to traffic loads will produce shear stresses in the ring where the relatively flexible part with only fill above it is stiffened by the spandrel wall, and these stresses may result in a crack.

**Fig. 4.4** – Splitting beneath the spandrel walls

The effect on load capacity of splitting beneath the spandrel walls is more complex for multi-span bridges. Individual spans may continue to fail as if they are single spans without any spandrel wall influence. The reduction in load capacity which is applicable to multi-spans is however associated with the flexibility of the pier and this is less likely to occur since the spandrel walls will continue to stiffen the piers despite the loss of integrity between the walls and the arch ring.

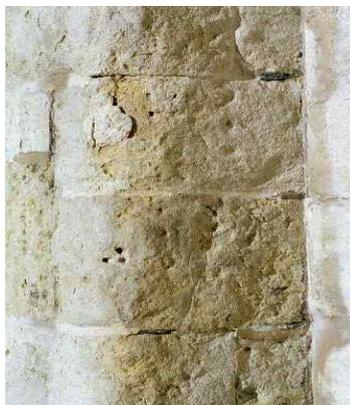
When water is cooled along the surface of the stone, crystallization can cause parts of the stone, usually in flakes, to break off and wash away when the ice melts. The detached piece is often thin, but the shape can be dramatic and noticeable, as the newly exposed stone beneath can be of a different colour than the remaining stone.

**Fig. 4.6** – Stone masonry damaged by freezing

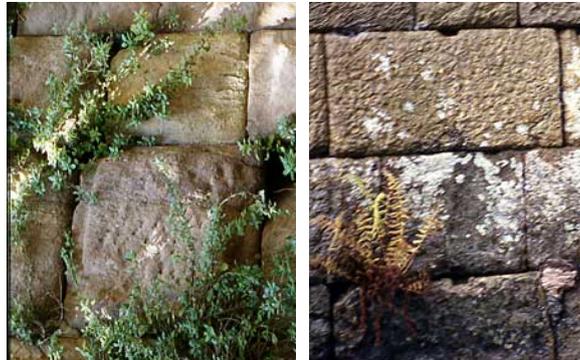
Those in the North are probably familiar with the sight of ivy climbing a stone or brick wall. If left unchecked, climbing plants such as ivy can root in the joints of stonework and cause structural problems. If they stay rooted in the ground, they are mainly harmless and can be cleared off easily.

**Fig. 4.7** – Stone masonry affected by plant growth

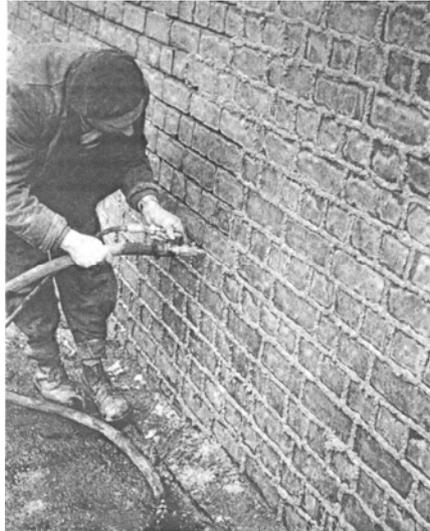
**Fig. 5.1** – Repointing of the joints

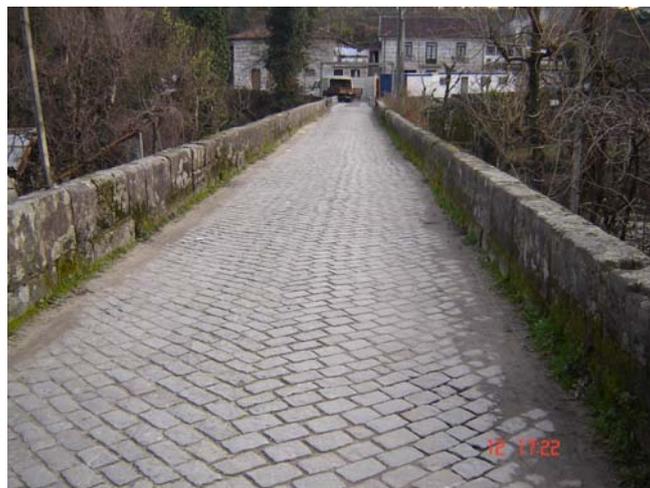
**Fig. 6.1** – Donim Bridge – Road way

The spandrel walls, just as the parapets, were built in stone masonry but successive maintenance works carried out along the years changed some original characteristics. As it can be observed, the parapet was partially rebuilt with concrete blocks as well as the stone of granite paving in the pavement, during the XX century.

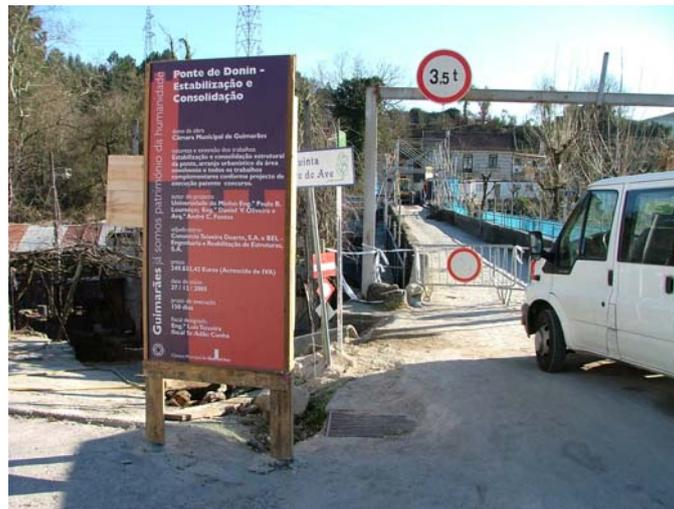
**Fig. 6.6** – Blocked access on the bridge

The strengthening works started with the closing the bridge to all wheel traffic and maintaining the bridge only as a footpath. This measure was required both for stopping the further damage of the bridge and for the constructor to install the necessary equipment.

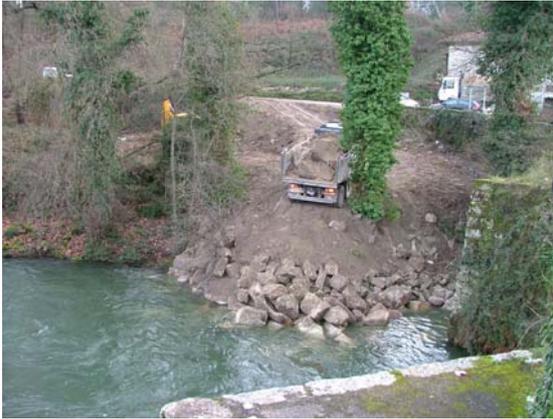
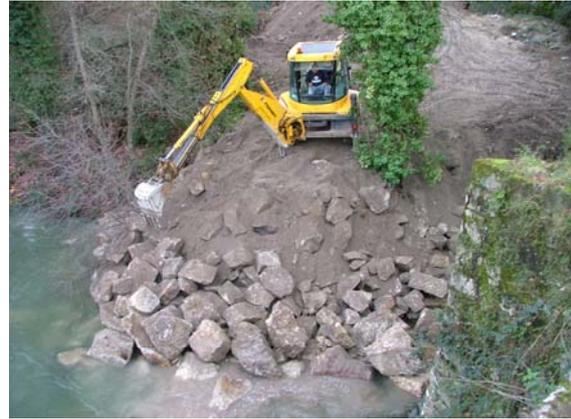
**Fig. 6.7** – Blocking the water flow

Access was gained to the intrados of arches A1 and A3 by blocking the water flow and redirecting it through the middle arch, A2. Trucks filled with heavy stones and sand from a nearby location were unloaded on the both sides of the river Ave close to the water. With the help of a back-acting excavator the rocks and the sand were pushed in the water under the arches until the water level was exceeded with about 1m, and consequently the flow was blocked. As a result of this action the access under the arches A1 and A3 was facilitated and the scaffolding could be erected on solid ground.

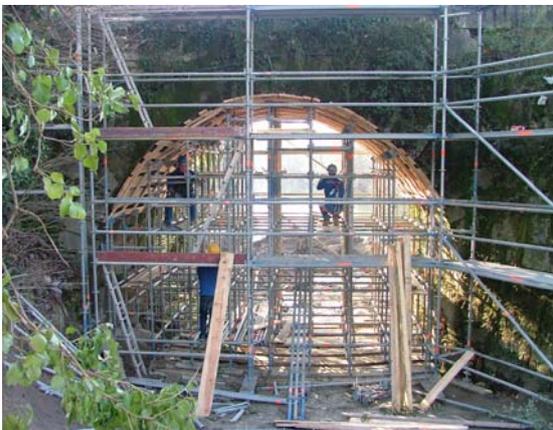
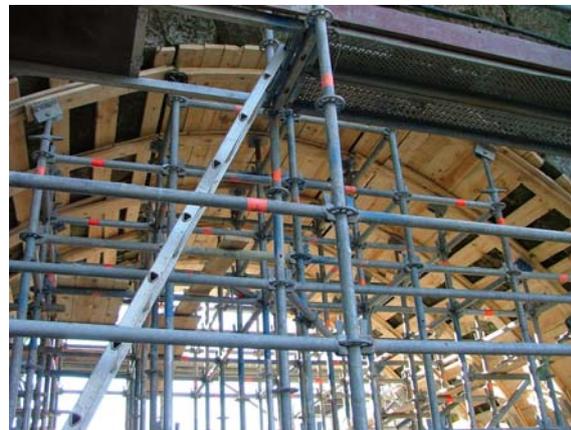
**Fig. 6.8** – Scaffolding

Temporary stability was important since the schemes required the complete removal of fill from the arch A1. A rectangular scaffolding system was erected on the compact soil throughout the entire intrados of the arch. Between the voussoirs and the scaffolding, timber decking had to be placed for a uniform propping of the arch.

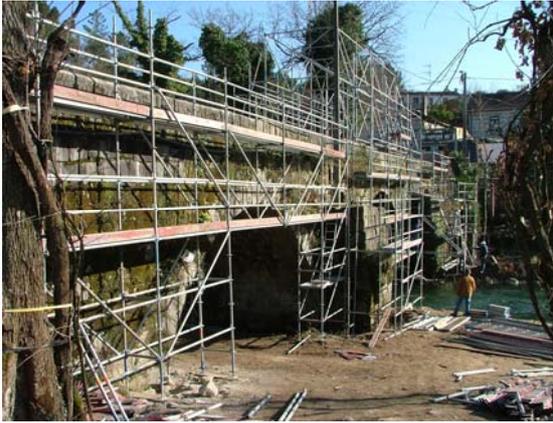
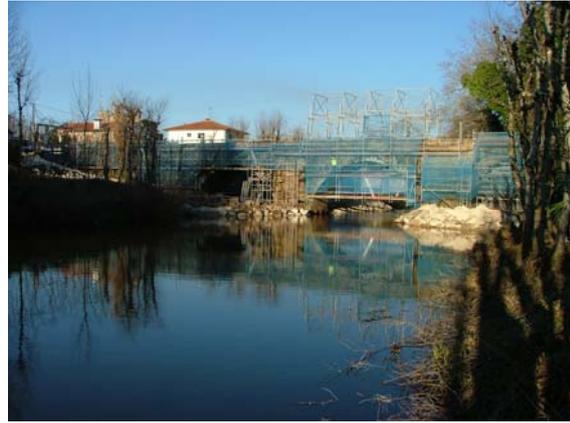
**Fig. 6.9** – Scaffolding

Also for the removal of the vegetation, the access to the external spandrel walls and cutwaters had to be facilitated. Consequently, scaffolding had to be assembled along the whole bridge.

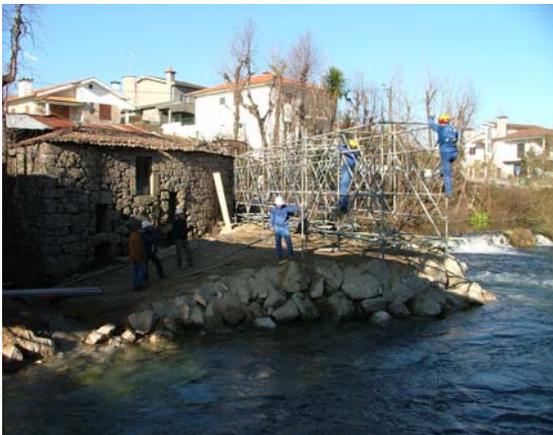
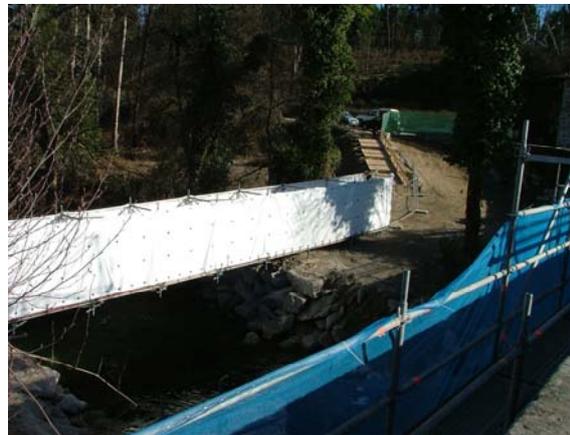
**Fig. 6.10** – Temporary bridge

In parallel with the strengthening works the building of temporary footpath bridge was considered. A requirement for a temporary bridge arose for a variety of reasons such as not redirecting the human traffic to other bridges. One bridge option was considered being feasible, that of a truss overbridge parallel to the existing bridge.

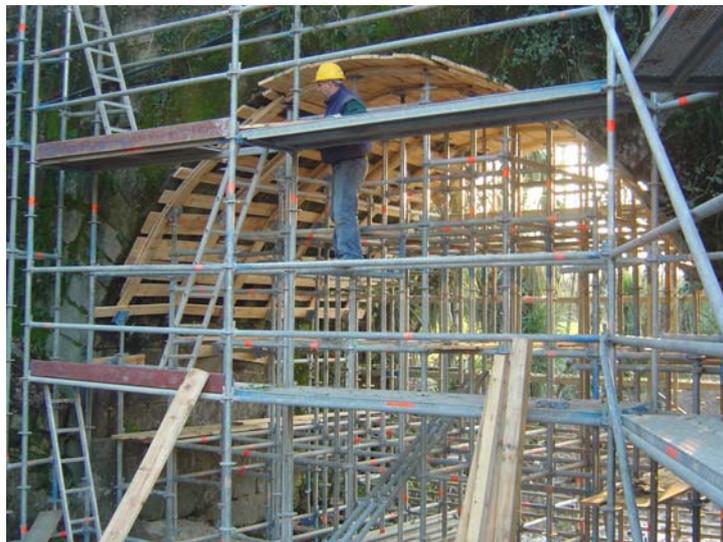
**Fig. 6.11** – Propping the arch A1

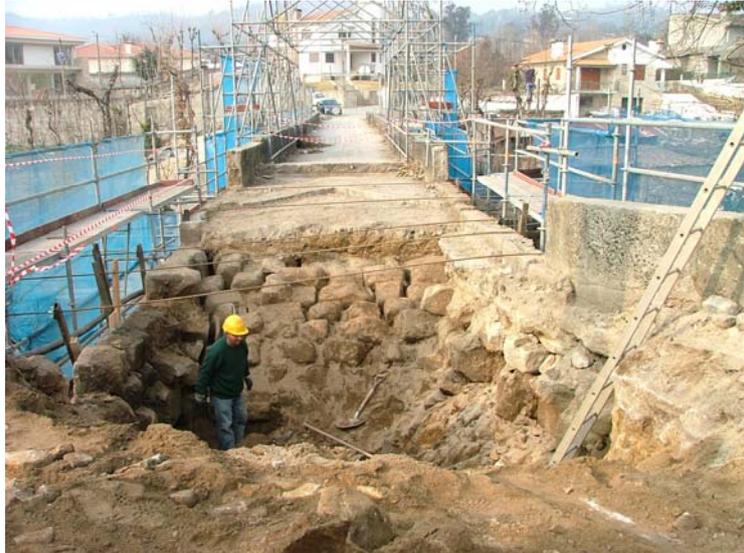
**Fig. 6.12** – Tie bars

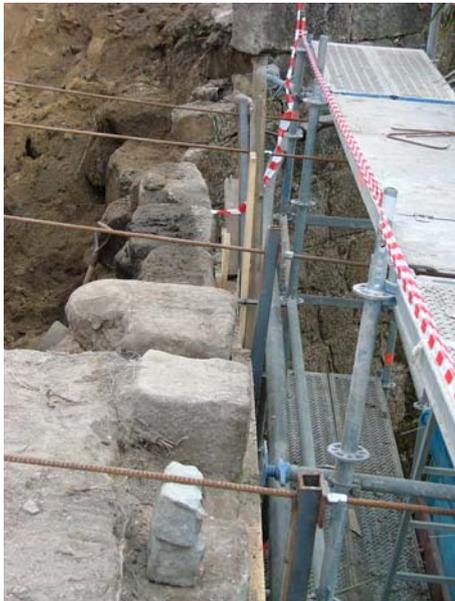
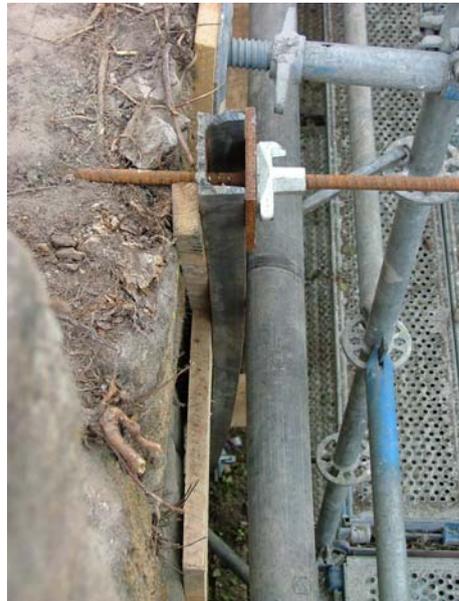
**Fig. 6.13** – Tie bars

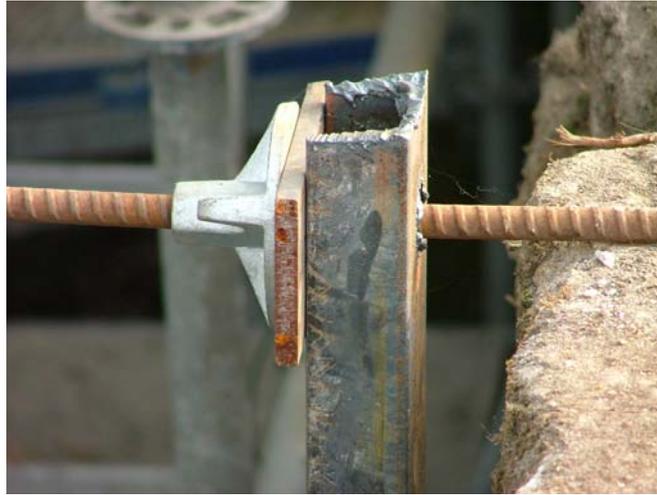
**Fig. 6.14** – Tie bars – Restrain mechanism

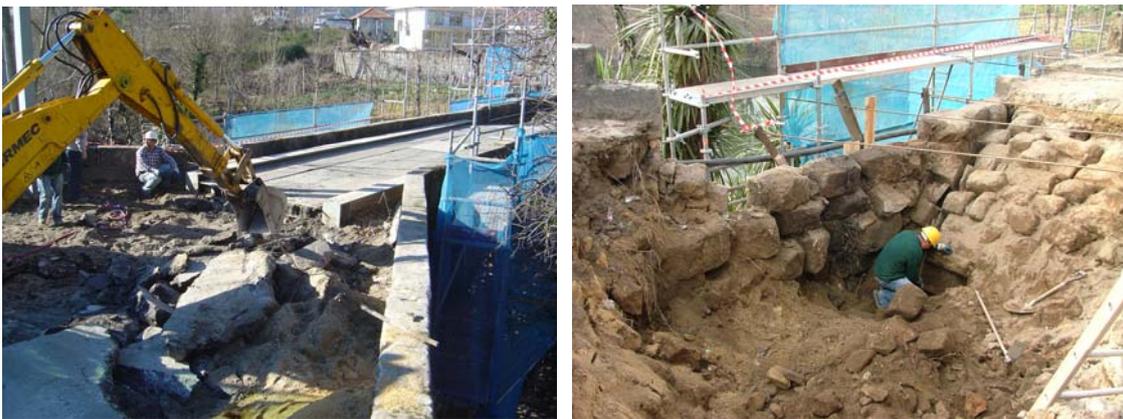
The excavation begun with the dismantling of the existing steel beams and steel deck that were part of an earlier attempt to reduce the loads on arch A1. Then the road pavement made of cubic granite stone was removed. The constructor allowed that the first layers of the fill material to be removed with the back-acting excavator but as it got closer to the arch the mechanical removal was replaced with the manual dismantling of the stones. The reason is that the vibrations and the force of the excavator can cause major damage to the arch such as moving of the voussoirs and widening of existing cracks.

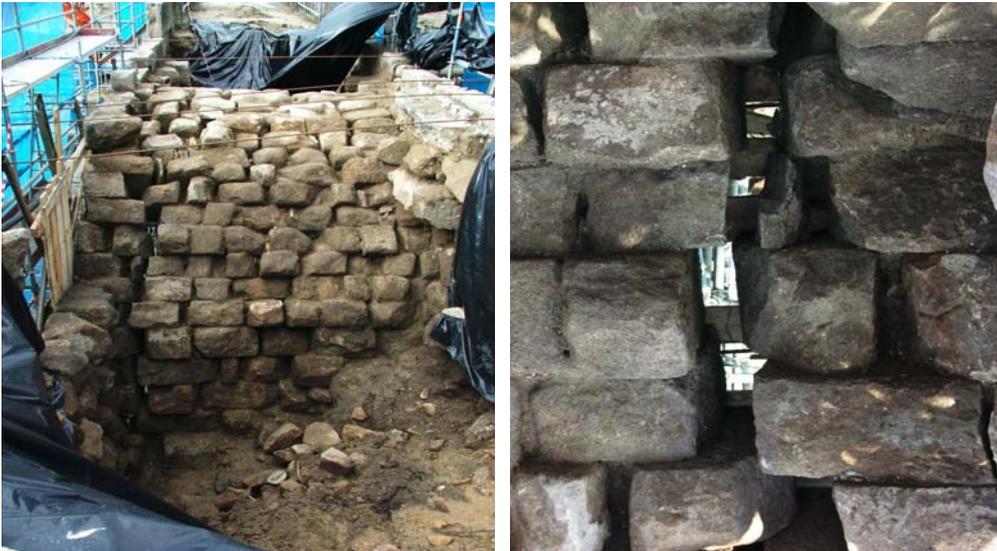
Once the entire mass of the fill material was removed carefully, the enormous longitudinal cracking in the intrados of arch A1 could be obviously seen also on the

extrados (crack width greater than 8 cm). The closing of the joints was performed by tightening the tie bars slowly, along several days.

a) General view; b) Cracks wider than 8 cm

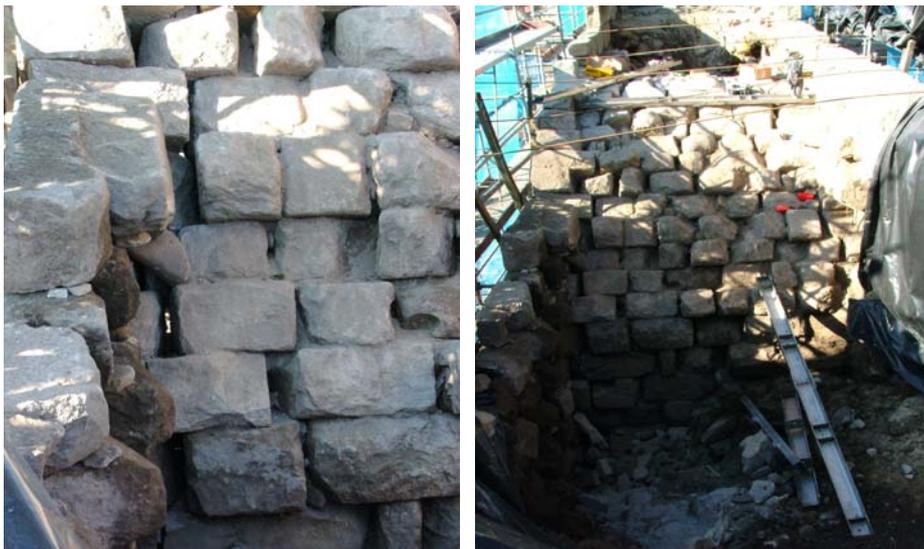
When the gaps reached a desirable dimension, the strengthening solution was implemented. Six stainless steel U profiles were fixed to the extrados of the arch and to both spandrel walls, by means of anchor rods.

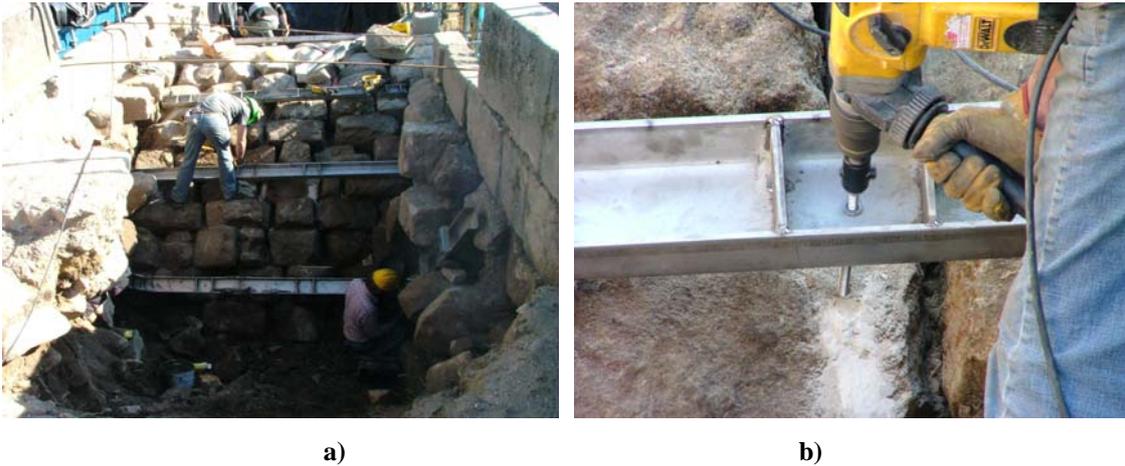
**Fig. 6.18** – Repairs on arch A1  
a) Metallic profiles; b) Drill for the stitching anchor rods

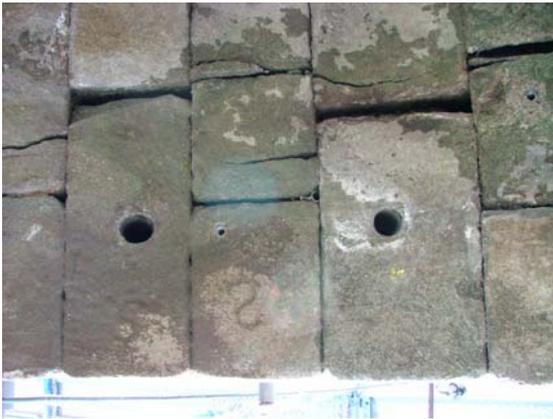
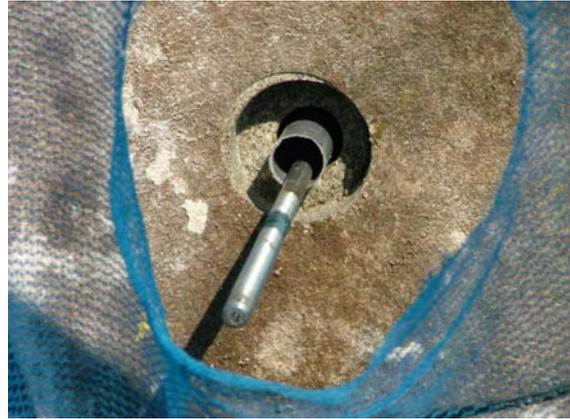
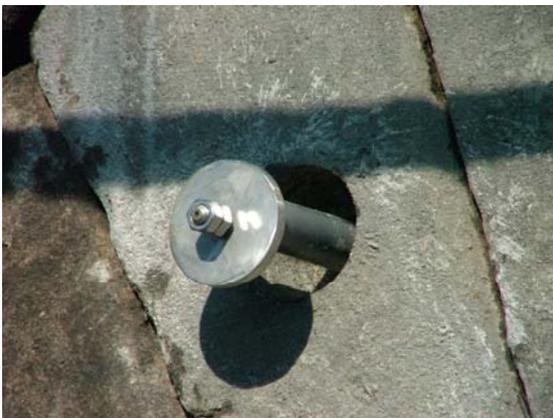
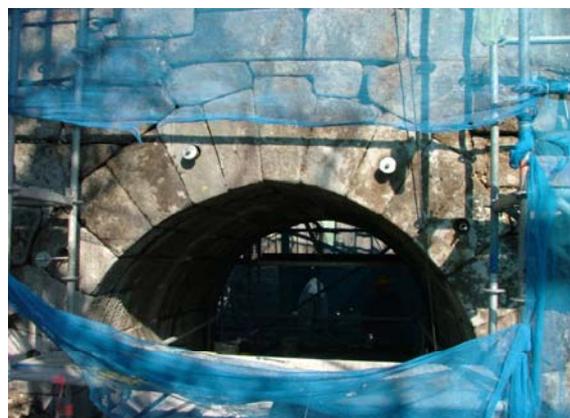
**Fig. 6.19** – Repairs on arch A4

The cracking pattern in the flood arch A4 was not so severe as that in the arch A1. The maximum crack width didn't reach 4 cm. This is why it was not implemented the same strengthening technique as the previous one. The objective was not to return the arch to its original shape, but to prevent any further displacements of the arch and to assure its stability. Thus, it was proposed to use six horizontal anchors across the full width of the bridge, endowed with cylindrical anchorage plates at each side of the arch.

During installation, oversized holes were bored using a rotating cutting device in the voussoirs.

a) Holes drilled in the intrados of the arch; b) Stitching anchor;

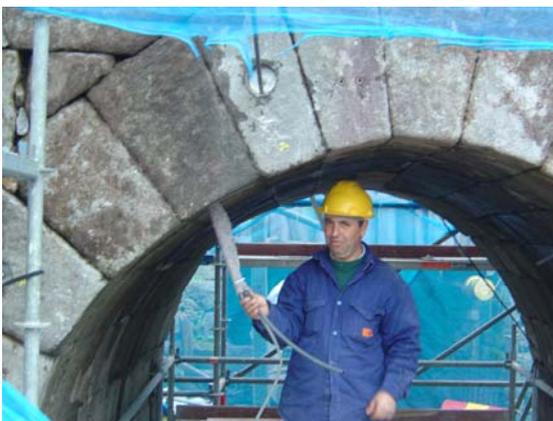
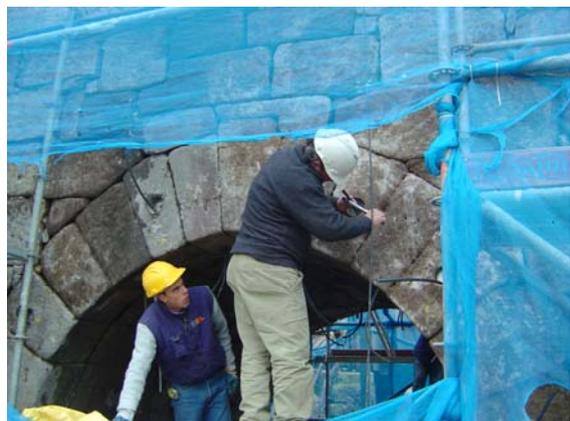
**Fig. 6.20** – Injection process

After the drilling was finished, a sock containing a stainless steel reinforcement bar was inserted into each hole and cementitious grout was pumped under low pressure into the sock. Also, the sock is sufficiently permeable to permit the grout to bond to the masonry and form a structural connection.

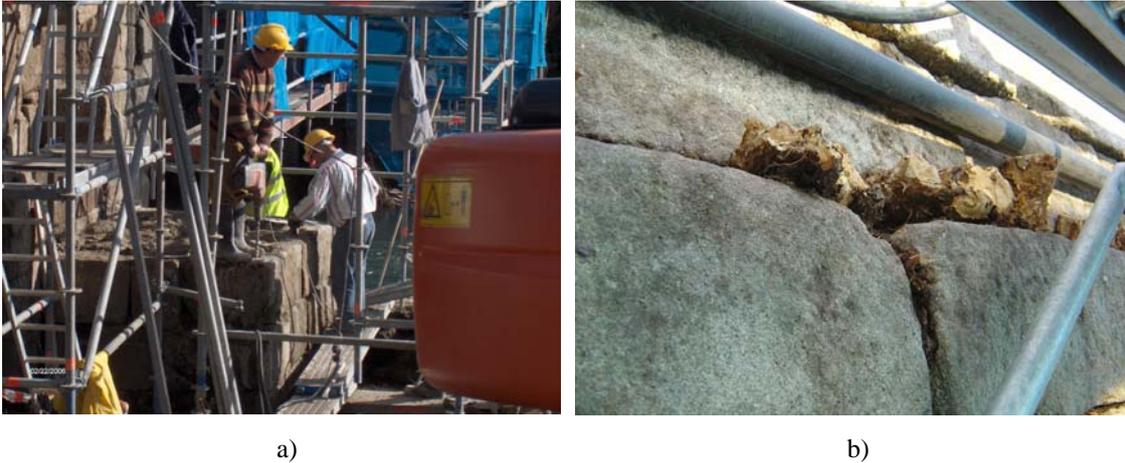
a) Dismantling of the right cutwater; b) Woody vegetation.

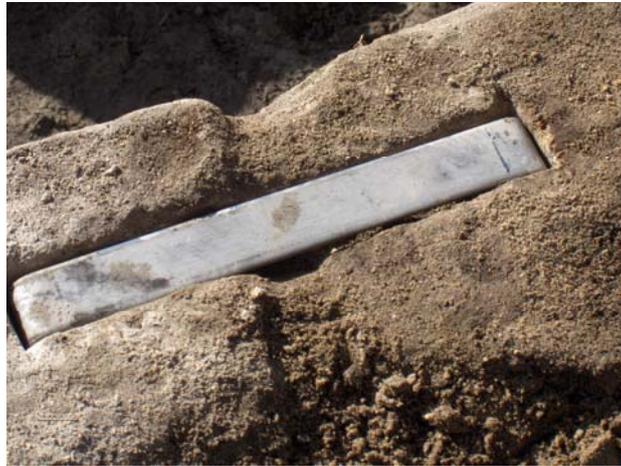
**Fig. 6.23** – Stainless steel cramps

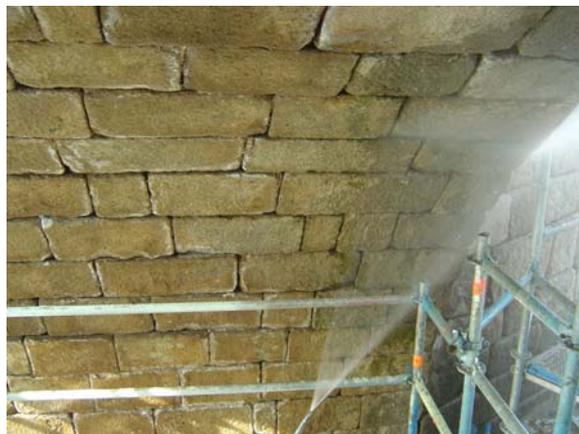
**Fig. 6.24** – Spraying biocide

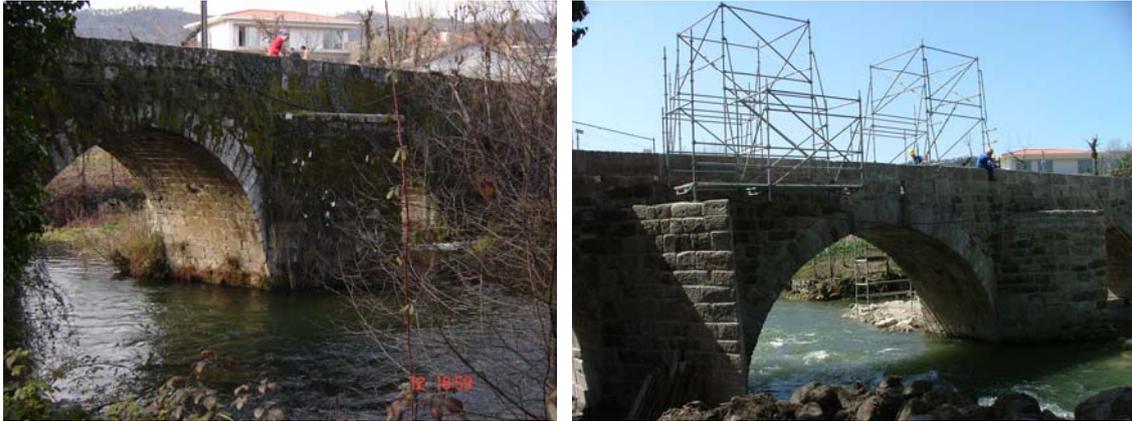
**Fig. 6.25** – Donim Bridge before and after the removal of vegetation

The second stage consisted in pressure spraying a biocide substance on the whole surface of the bridge that will stop the further growth of vegetation.

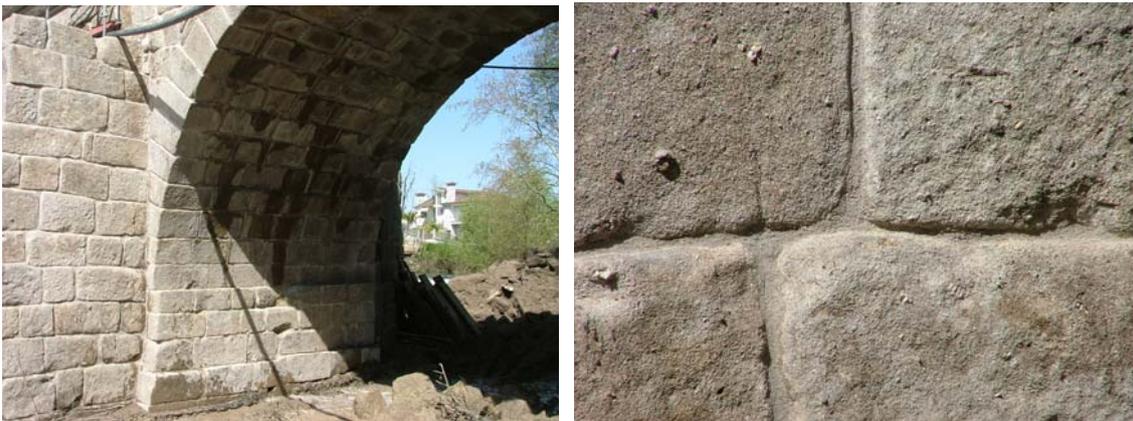
**Fig. 6.26** – Joints repointed with sand-lime mortar matching the colour of the stones

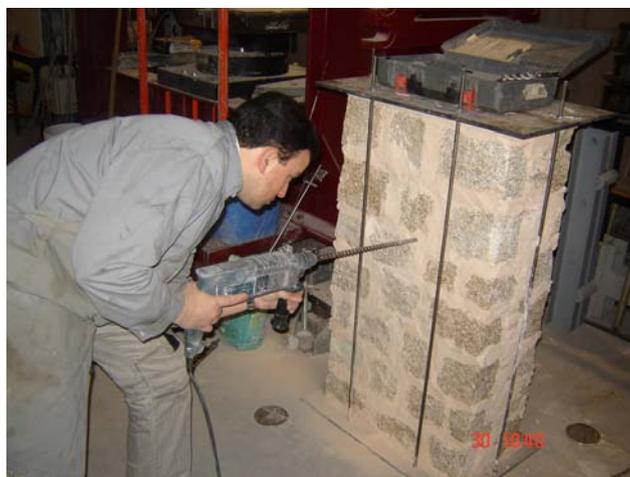
Before grouting, a series of injection holes have been drilled with a diameter of 3 to 4 cm spaced about 35cm. Such holes distribution was arranged to assure the complete injection of the voids and to check the diffusion of the grout during the intervention.

The holes were executed through corresponding mortar joints, where possible; otherwise the stone blocks, that were quite workable, were directly bored.

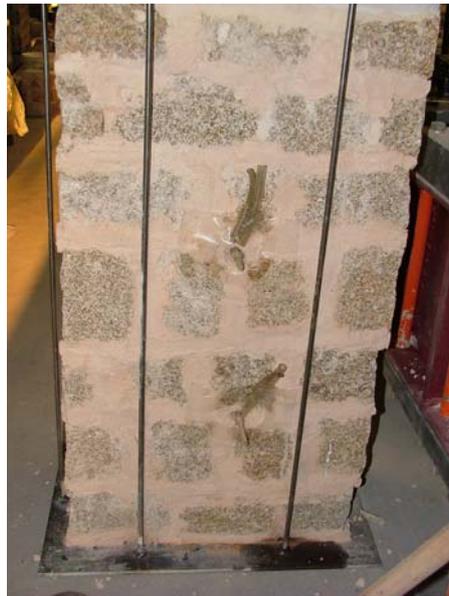
Subsequently, RFP bars and plastic tubes (9 mm internal diameter, 12 mm external) have been introduced and sealed into each hole.

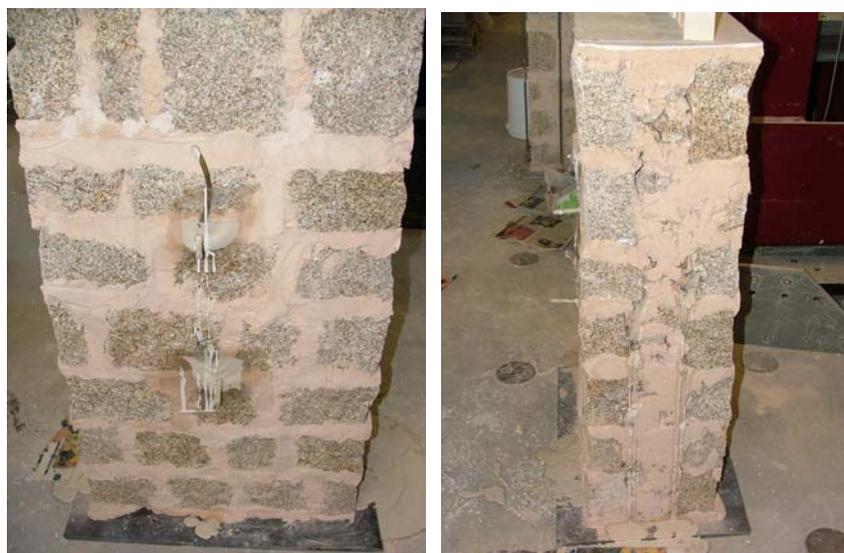
The grouts have been injected under low pressure (around 0.5 atm) into the hoses starting from the bottom of the walls, even if keeping the pressure constant was a noticeable difficulty encountered. The lateral sections have not been sealed and some small outflows were noticed.
