## **Investigations for the knowledge of multi-leaf stone masonry walls**

Francesca da Porto  
Maria Rosa Valluzzi  
Claudio Modena

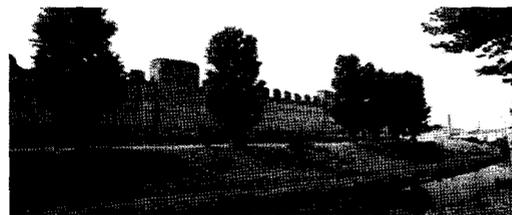
Figure 1  
Example of cyclopean walls: overall view of the town walls of Cittadella (Padova), built in 1220

In the case of stone masonry, due to the several different types, shapes and working processes of the elements, the classification of a wall according to these criteria is not always univocal. Very often, various classifications for the same wall are possible with reference to different parameters, such as the texture of the external leaves or the composition of the sections. The medieval town walls of Cittadella nearby Padua, Figure 1, are an example of this kind. They are a mixed kind of stone masonry, both for the characteristics of the external leaves and of the section (Figure 2 and Figure 3).

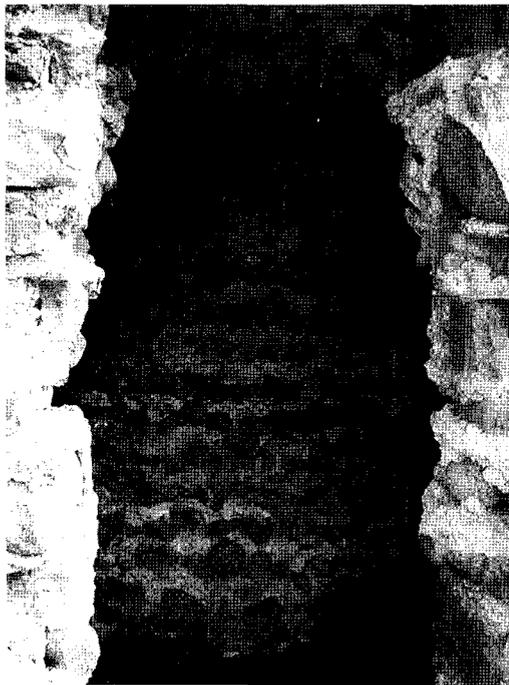
Figure 3  
Detail of a niche excavated inside the town walls of Cittadella. The internal leaf is different from the external ones. It is an «opus concretum», made of regular alternate layers of pebbles with brick pieces and thick mortar beds

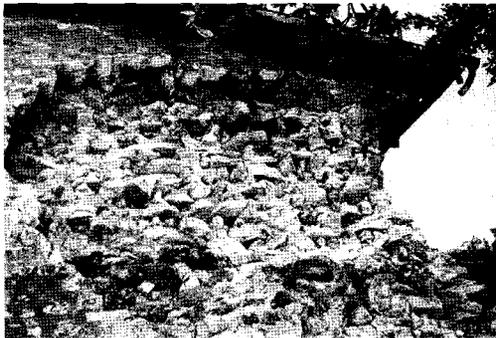
Figure 4  
Expulsion of the external leaf of a stone masonry wall after the Umbria-Marche earthquake (Italy, 1997)

by local crushing phenomena and detachment of the external leaves, due to the non-homogeneous distribution of loads (Giuffré 1993). Under out-of-plane actions, the absence of interconnection among leaves facilitates the development of independent kinematic mechanisms for each wythe and the expulsion of the external leaves (Figure 4). In this case, the out-of-plane collapse, with local or global overturning of masonry (Figure 5), happens for values of applied loads lower than those necessary on monolithic walls (Giuffré 1991).

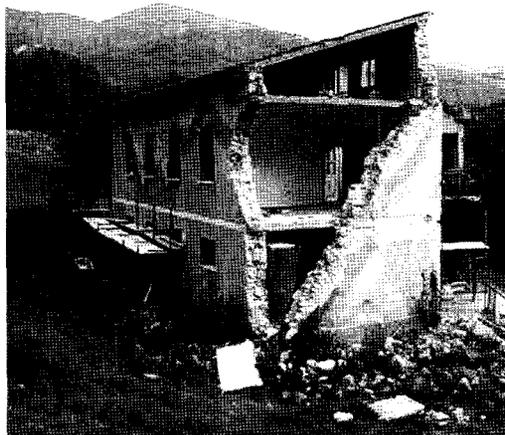
Figure 5  
Global overturning of a stone masonry wall after the Umbria-Marche earthquake (Italy, 1997)
