3rd SUBJECT – Material Characterization

Mechanical Behaviour Analyzes of One Leaf Stone Masonry Walls

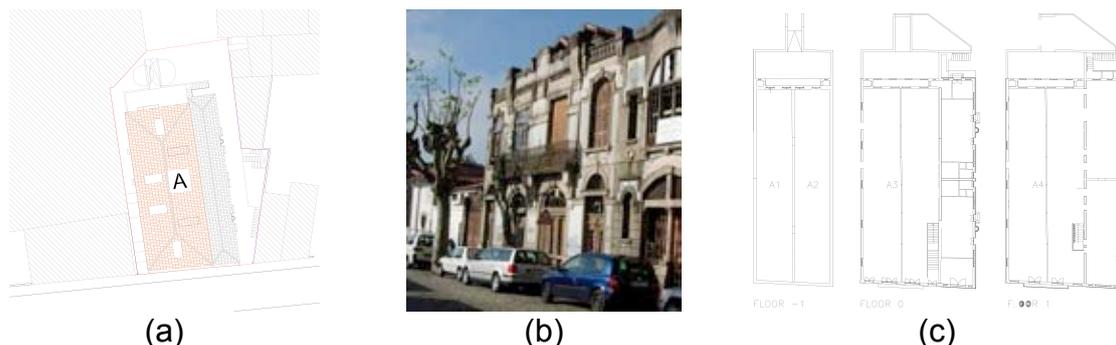
Figure 1 : (a) Identification of the building (b) main facade (c) configuration plan.

The building used as case study, identified by A in Fig. 1(a), is located in the city of Porto and was constructed in 1916 for industrial purposes by a major manufacturer of the city. In 1918, a second building adjacent to the first was constructed, for the factory workers and their families. Later, the two buildings were linked through the opening of a door at the top floor. The building has a rectangular configuration, $11.5 \times 30.0 \text{m}^2$, showing a basement (floor -1), two large floors (floors 0 and 1) and a sloped roof, Fig. 1(b). An internal structural stone masonry wall divides floor -1 in two independent spaces and supports the wooden beams of floor 0, Fig. 1(c).

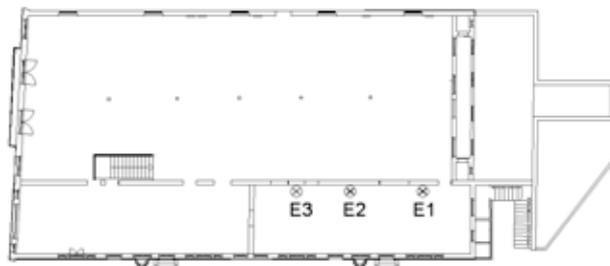
Figure 2 : Location of the surveyed walls (E1, E2 and E3) at floor 1.

processing resorting to computational tools. Fig. 2 and 3 show the elevation and cross-section of three wall panels (E1, E2 and E3, located at the 1st floor), before and after image processing.

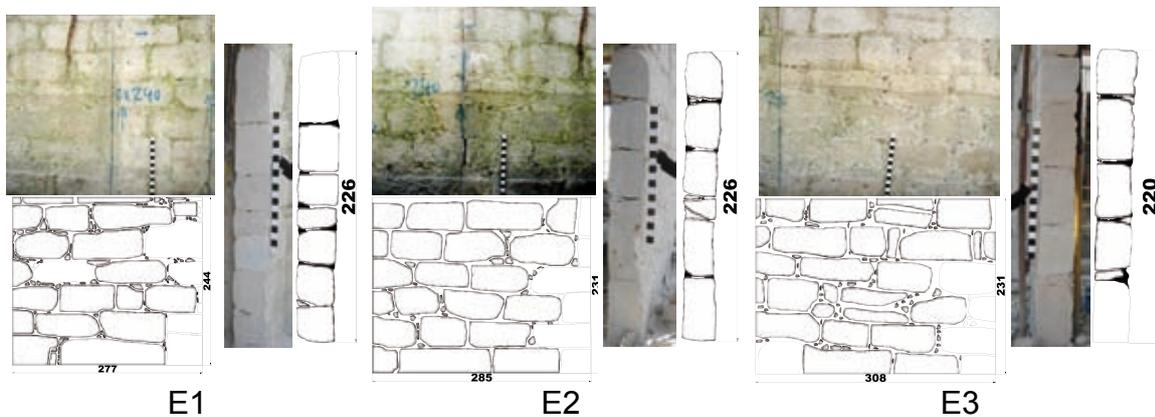
Figure 3 : Elevation and cross-section survey of the walls in Figure 2.

The survey showed that, in general terms, the masonry consists of medium to large size rectangular type stones (50 to 90cm measured diagonally) arranged on a regular alignment, with a significant number of small stone wedges (shims), mortar joints and, occasionally, brick pieces. The stones are in yellow granite. The joints present variable thickness (0.5 to 2cm) and are filled in with cream colour brittle mortar.

The cross-section of the surveyed walls consists of a single leaf of granite stones, 30cm thick, with a widespread distribution of voids, more evident in the midline. In fact, the mortar was originally placed along the border lines, without filling the inside where the voids are quite evident, creating cavities due to the irregular shape of both the upper and lower stone faces in contact. The percentage of the materials measured through the elevation and cross-section was determined from the pictures in Fig. 3. The results are listed in Table 1; for the purpose of this work, the wall constituents are split into stone blocks, stone wedges, mortar and voids. The results show that the materials percentage estimated by just analysing the wall elevation may lead to significant errors due to difficulties on estimating the actual stone blocks size, the joints thickness and the voids volume, when compared to the results and information obtained using the cross-section picture

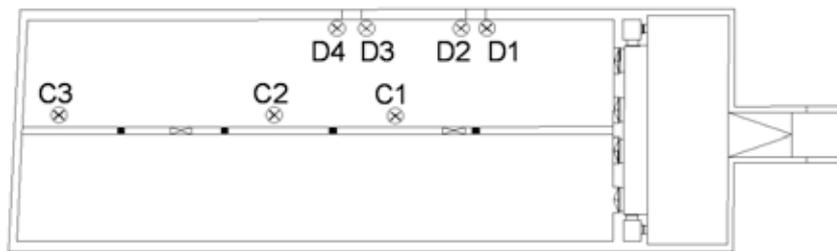
Figure 4 : Location of the surveyed walls C and D at floor -1.

This study included other wall sections located in floor -1, namely the left external wall (Wall D in Fig. 4), which was cut in order to create a 7m span opening, and the inner wall (Wall C in Fig.4), which had to be demolished according to the rehabilitation project. Besides the preliminary *in-situ* analysis, the wall C was sectioned into several panels and transported to the LESE for experimental tests (addressed in subsequent paragraphs). At the floor -1, both walls C and D are made of one leaf stone masonry, 40cm and 50cm thick, respectively, with similar characteristics of walls E. Also in this case, the widespread voids distribution is noticeable. The percentages of the different materials were also determined through image processing of the walls cross-section photos (Fig. 5).

Given the interest to study this type of masonry in detail, the six panels extracted from the 30m long and 0.40m thick wall C shown in Fig. 4, namely four panels 1.2m wide (PP1 to PP4) and two 1.6m wide (PG1 and PG2), were transported to the LESE to be submitted to a series of mechanical tests. All the panels were 2.50m high. The walls were cut down to the foundation level using a diamond saw blade.

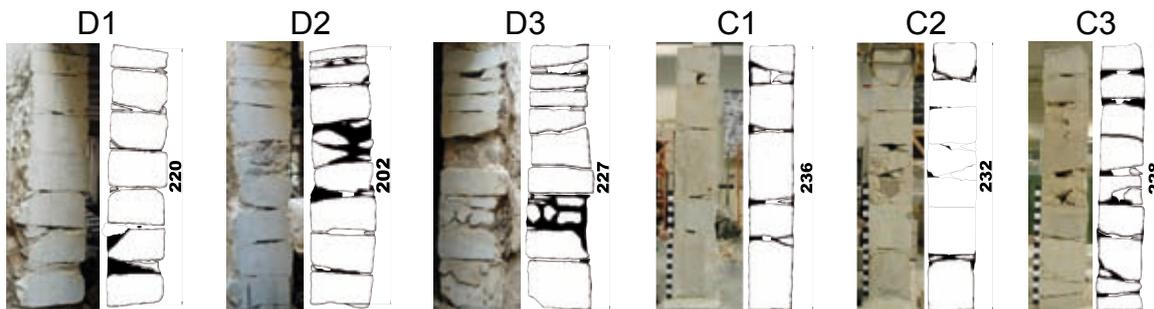
Figure 5 : Geometrical survey of the cross-sections of the walls C and D.

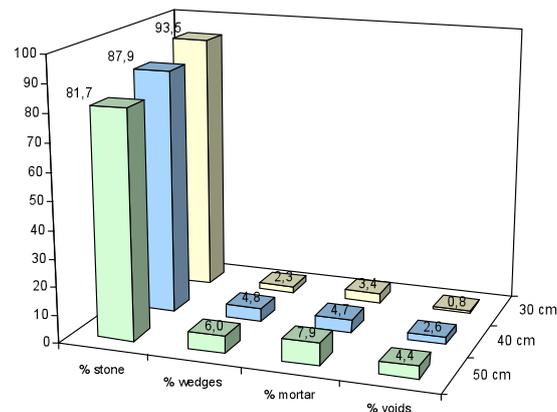
Figure 6 : Evolution of the percentage of material for different wall thicknesses.

The elevation photos were not used for the geometrical survey of these walls due to the considerable portion of mortar covering the joints and part of the stones which unabled the proper evaluation of the stone contours. The results of the cross-sections analysis presented in Fig. 6 show the variation of the different materials percentage for different wall thicknesses (50, 40 and 30cm); a decrease in the wall thickness corresponds to a reduction of the filling percentage.

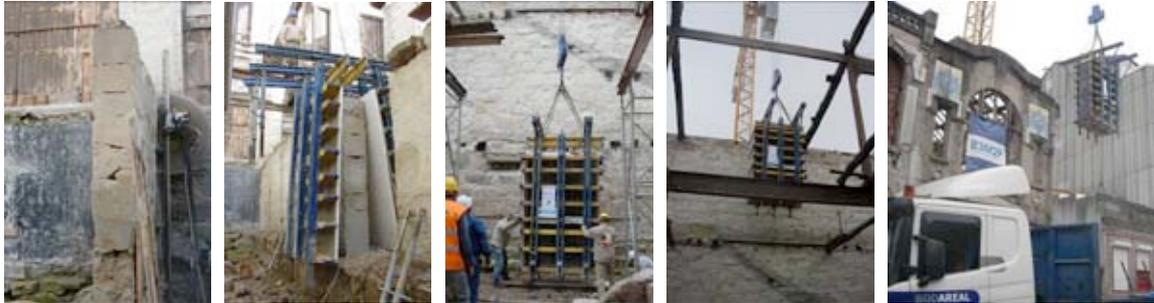
Figure 7 : Panels for laboratory tests (from left to right): cutting, extraction and transportation

contractor (Mota-Engil) helped on the definition of the procedures inherent to the packing (using Doka-Formwork elements) and transportation of the wall. The sequence of the operations is illustrated in Fig. 7.

After making the vertical cuts, three holes were drilled near the base of each panel, for inserting Dividag bars to confine and sustain the exterior containment structure; this structure was placed from the top down to the wall basement and then compressed against the wall through the Dividag bars at the base and three others placed at the top. This procedure was applied to all the panels; the lifting and placing on the vehicle that transported the walls was provided by the crane available on site.

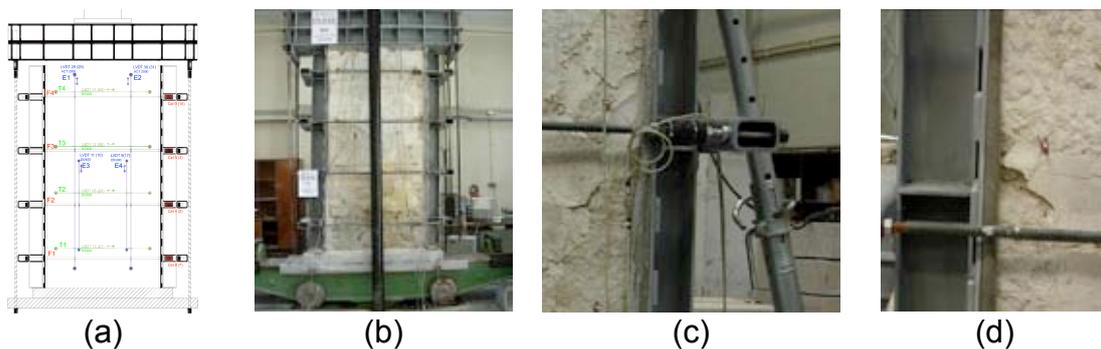
Figure 8 : Compression testing setup: a) general loading and instrumentation scheme, b) wall under testing, c) and d) details of the confining system

structures linked together by 2x4 Dywidag tie rods placed along the wall height and instrumented with load cells (Fig. 8). In order to ensure a good contact between the wall lateral surface and the steel structure, a plastic sleeve was placed in the gap and then filled in with grout.

Aiming at ensuring a uniform distribution of the vertical loads, a very stiff beam made of four HEB200 steel shapes was placed on the top of the wall. The deformation on each wall face was measured by displacement transducers (LVDTs): two for recording the total vertical deformation, two for recording a more local vertical deformation and four to measure the horizontal deformations along the height. In total, 16 LVDTs were used and connected to data acquisition software based in LabView (www.ni.com) and developed at the LESE.

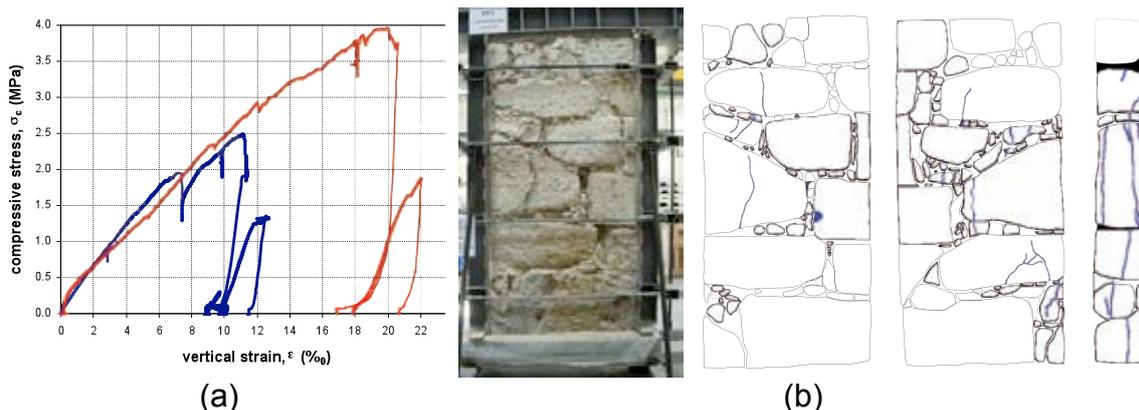
Figure 9 : a) Vertical stress-strain plots for PP1 and PP2 and b) crack patterns in panel PP1.

The analyses of the stress-strain diagrams, with and without lateral confinement (Fig. 9(a)), show that the wall compressive stresses reached 3.94MPa for panel PP1 and 2.50MPa for panel PP2, which reduce, respectively, to 1.87MPa and 1.34MPa after first damage when the lateral confinement was relieved. The diagrams also show that both wall panels have similar deformability.

The cracking pattern observed during the test was mainly vertical, more evident halfway up the wall; the damage became more notorious, with crushing and cracking of some stones, for a stress level of about 1.5MPa (Fig. 9b).

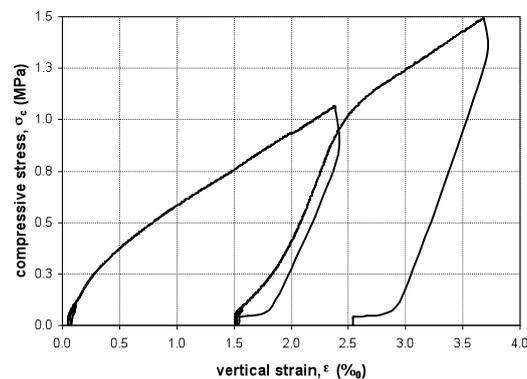
Figure 10 : Axial stress-strain diagrams for PP3 in the first phase of the study.

The study of panel PP3 focused on the evaluation of the elastic modulus on the cyclic behaviour. Two loading-unloading cycles were applied to the confined wall (Fig. 10): the first cycle for a maximum force of 500kN (about 1/3 of the maximum load recorded in the tests of PP1 and PP2) and the second for 700kN. The stress and stiffness for the two cycles are shown in Table 2.

The stress-strain diagram shows that after unloading and reloading, the panel exhibits a small strength reduction but the envelop curve is reached slightly beyond the same point from where it unloaded, which is a sort of “memory” very common of many civil construction materials such as concrete and steel. Moreover, as in the previous cases, during the unloading and reloading stages, the stiffness is considerably larger than the initial one, due to the deformability characteristics of masonry that include very high plasticity; therefore, only a small percentage of the joint compressive deformation and of crushing of contact surfaces between the different elements is recovered. Once again, a very low stiffness was measured in the first loading branch. At this point only a slight detachment of mortar was registered, without cracking. This result underlined, once again, the low stiffness registered by these walls. In order to check the influence of the voids to this result, the joints of the panel PP3 were injected and the wall was tested again.

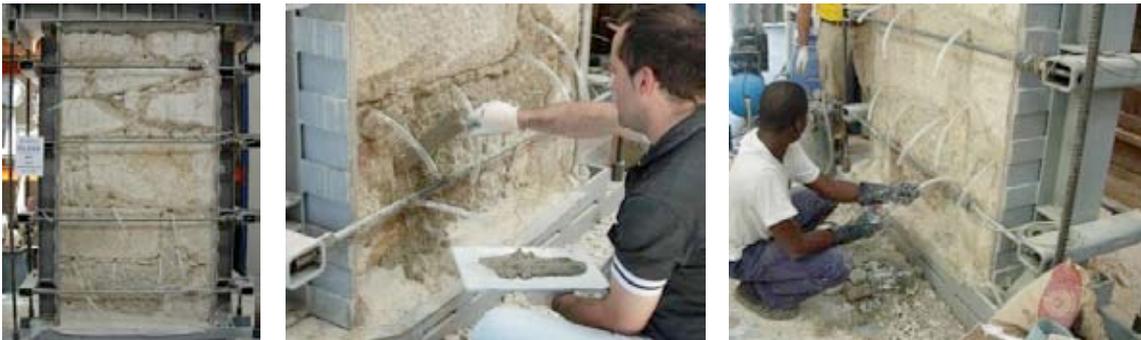
Figure 11 : Injection of the mortar in the panel PP3.

In order to assess the influence of the wall internal voids in the panel stiffness, the wall PP3 was injected with a mortar made of a mixture of hydrated lime, hydraulic lime, sand and water with very poor stiffness and strength characteristics. The operations consisted first, on identifying points to introduce plastic injection tubes in both wall faces, in order to ensure adequate penetration of the mortar to fill the voids. Then the joints were sealed with hydraulic lime and clay mortar (ratio 1:3) to avoid leakage of the injection mortar. The injection was performed at low pressure (3bar), tube by tube, starting from the bottom up to the top of the wall. The voids were considered to be filled in when the mortar reaches the upper tubes. The operation proceeded until the full injection of all tubes on both wall sides was completed (Fig. 11), what took about half an hour and around 85litres of mortar. Given the wall volume (1.17m^3), this corresponds to a void ratio of around 7.3%, considerably larger than the ratio estimated in the survey using the panel cross-section (2.6%). This difference arises from the estimation process which, for instance, does not account for the voids along the vertical joints, as well as for the fact that the injected mortar penetrates into the quite porous mortar of the wall.

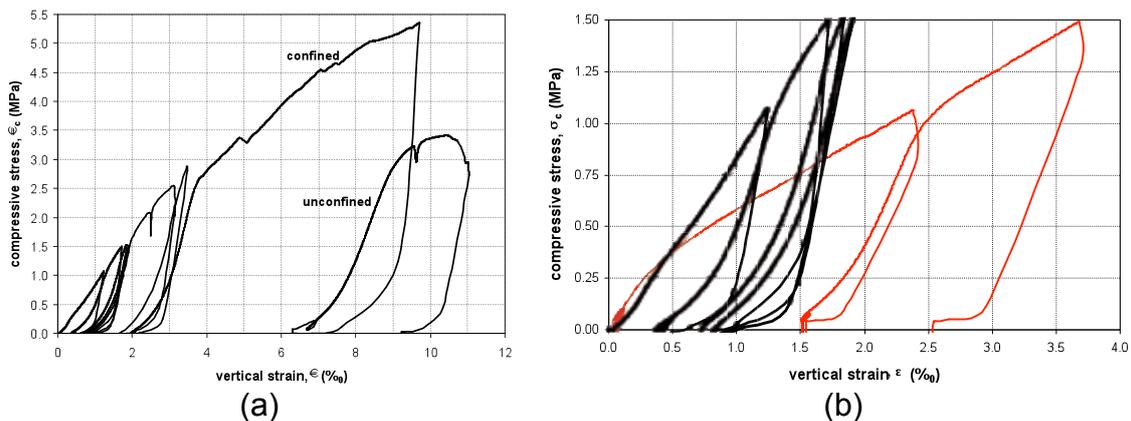
Figure 12 : Results of panel PP3: a) vertical stress-strain diagram after the injection and (b) comparison of the stress-strain diagrams before and after the injection.

After injection, the panel PP3 was subjected to the same loading cycles of the original panel: a first cycle up to 500kN and a second one up to 700kN, the last being repeated three times. Then, the panel was loaded up to a force of 1200kN, unloaded and reloaded twice and, finally, it was driven to failure (or close to failure, since the damage and the stress-strain curves provided that indication, Fig. 12(a)). The wall reached a maximum stress of about 5.4MPa. The test was not driven through the softening phase of the response curve for safety reasons, concerning equipment and staff. Comparing this result with the average values obtained with the PP1 and PP2 tests, it exhibits a strength increase of about 60%. As for the modulus of elasticity for the first and second load cycles, the values were 0.93GPa and 1.09GPa, respectively. Concerning the unloading and reloading curves, they show that the stiffness reaches a

value of 1.90GPa. Similarly to the PP1 and PP2 tests, the PP3 panel was also tested without lateral confinement, leading to the final cycle shown in Fig. 12(a), where the strength was about 3.4MPa.

This analysis shows the importance of the internal voids of the wall, which, once filled in, leads to a significant stiffness increase (almost 3 times), in comparison to the original situation (Fig. 12(b)). Although this is a one leaf wall made of stones of considerable size, the internal voids have a strong influence on the strength and deformability of the structure.

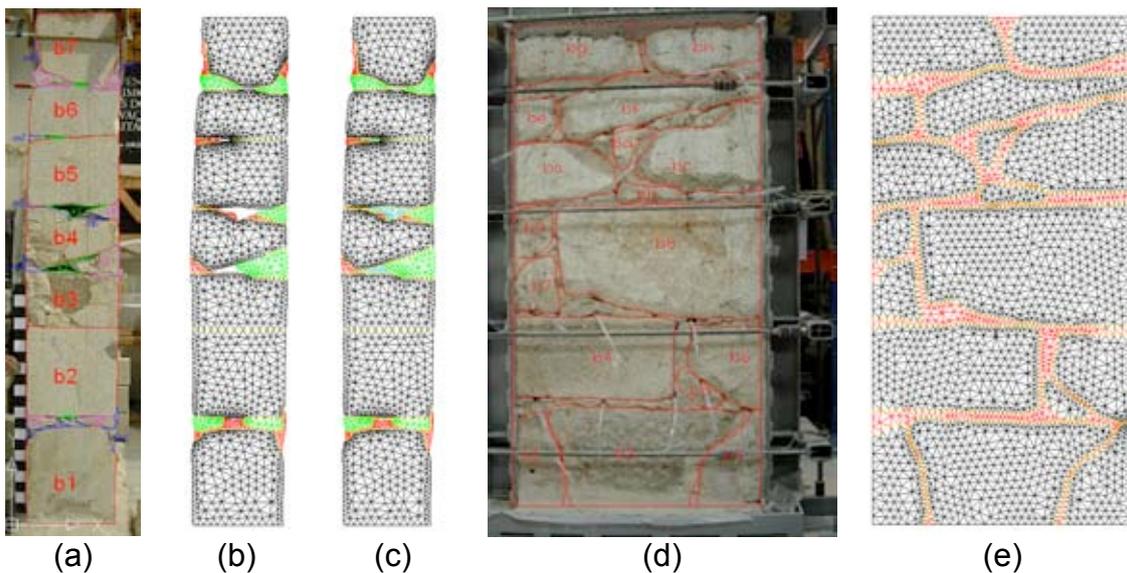
Figure 13 : Numerical models: a) cross-section photo with components' individualization, b) cross-section mesh with voids, c) cross-section mesh with the voids filled in with mortar, d) elevation photo with components' individualization and e) elevation mesh.

Five different types of materials/elements were generated in the cross-section, namely: blocks, wedges, mortar, voids and joints connecting stone-to-stone, stone-to-mortar, stone-to-wedges and mortar-to-wedges (Fig. 13(a)). As for the elevation, no voids were considered, since they are only visible in the cross-section. The materials were simulated by linear elastic behaviour models with no coupling between compression and shear. The cross-sections and the elevation were calculated considering plane strain and plane stress models, respectively. Fig. 13 shows the different components and meshes considered in the three models.

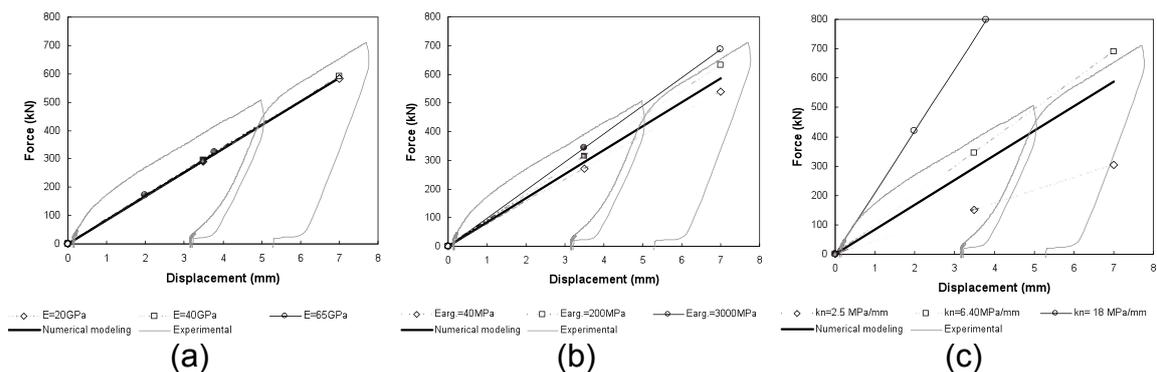
Figure 14 : Sensitiveness analysis: a) stone Young modulus, b) mortar Young modulus and c) joints normal and shear stiffness.

In order to evaluate the sensitiveness of the numerical results to the material properties, a comparative analysis was performed by varying, within acceptable limits, the values of some of the material parameters: the mortar Young modulus (0.04; 0.2 and 3GPa, based in previous laboratory tests developed at FEUP and in [13]), the joints normal and shear stiffness kn and ks (kn = 2.5; 6.4 and 18MPa/mm and ks = 0.35; 0.68 and 0.92, respectively, values obtained in [11, 12]) and the stone Young modulus (20, 40 and 65GPa, values obtained in stones from the same wall and in [14]). This analysis was done comparing the stiffness of the wall by changing only one parameter at a time. The results (Fig. 14) show that the model has a high sensitiveness to the variation of the joints stiffness, but, on the other hand, changing the Young modulus of the stones doesn't change the stiffness of the wall. As for the joints, the results show that the wall stiffness is quite sensitive to the joint characteristics, more than to those of the mortar, and that the characteristics of the interface between the stones and between the mortar and the stones could be the main responsible for the low stiffness of the wall. Moreover, the results also show that a stiffer or softer stone has little influence on the final results.

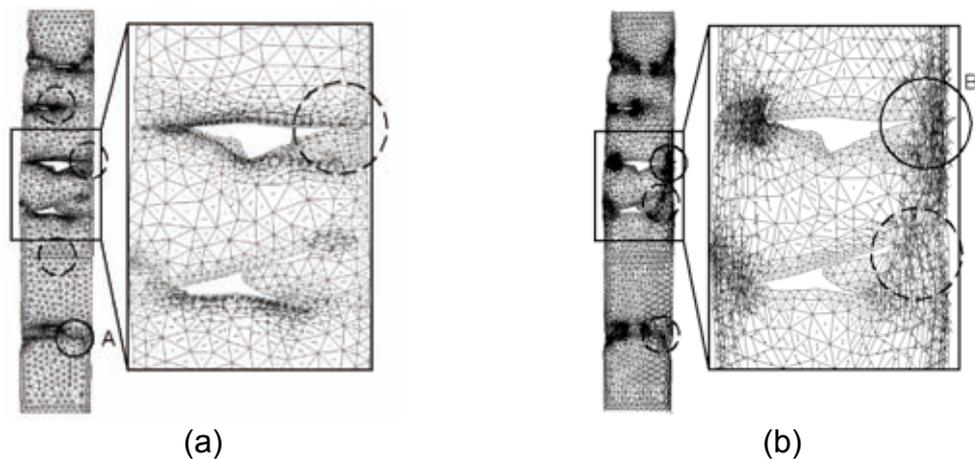
Figure 15 : Principal directions (before injection): a) tensile stresses and b) compressive stresses

Subsequently, and using the properties listed in Table 3, the cross-sections were analysed in more detail. In particular, the principal tensile and compression stresses are presented in Fig. 15 and 16; the area with major concentration of deformations is amplified and the critical points exhibiting larger stress concentrations signalled with a circle. The area where the maximum stress occurs in each case is indicated by a capital letter. The tensile stresses reach a maximum of 3.20MPa (A) and the compression stresses a maximum of 8.47MPa (B), contrasting with the 1.50MPa uniform compression stress applied to the top of the wall. These two maximum stresses occur in the stones.

The existence of the voids enforce the compressive stresses to deviate to the contact points close to the wall faces, causing the stress concentration that explains the large compression stress peak found in B. On the other hand, this stress generates an arch type effect that causes tensile stresses to develop at the lower part of the stones between contact points. As a result, the stones tend to open cracks in the vertical direction in correspondence with the voids.

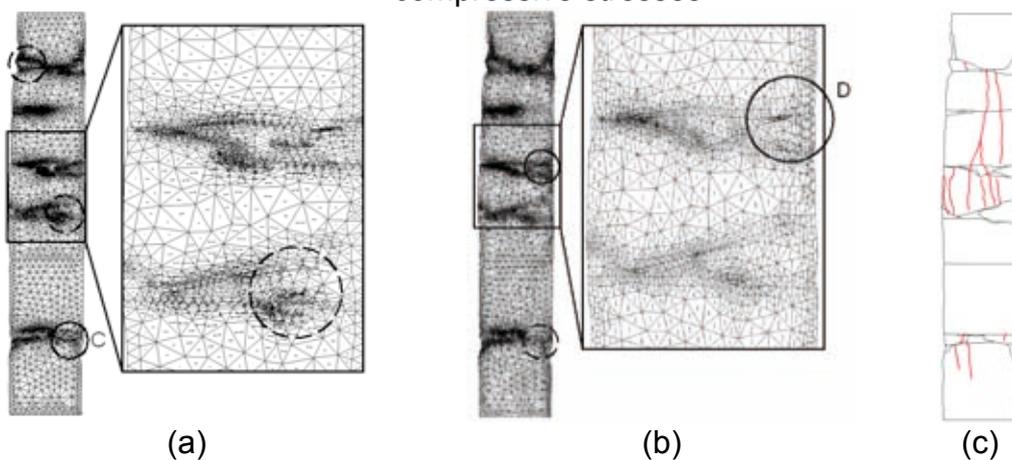
Figure 16 : Principal directions (after injection): a) tensile stresses; b) compression stresses and c) crack pattern after the compression test.

To confirm the influence of the voids in the wall behaviour, the cross-section with the voids filled in with mortar was also simulated. The material properties in Table 3 for the old mortar were also adopted for the new mortar, since in reality the mortar injected in the wall presented poor mechanical characteristics. Nevertheless, the wall stiffness increased 62% to 0.58GPa, (Fig. 17). Although lower than the stiffness determined in the experimental test with the injected wall, 1GPa, this result follows the trend of the experimental results. Moreover, the results in Fig. 16 show that after injection the maximum tensile stress value (C) is similar (3.72MPa), but the maximum compressive stress is 5.29MPa, considerably lower than the value in B. Despite the poor mechanical properties of the mortar, the maximum compression stress dropped more than 35% after filling in the voids with mortar. This result clearly supports the feeling that the voids play a major role in the properties of such one-leaf type walls. The more uniform distribution of the vertical stresses between the blocks and the mortar contrasts with the previous case in which an important concentration of compressive stresses is easily identified in the limits of the voids.

Although the maximum principal tensile stress do not vary significantly, a redistribution of the principal stresses around the voids is identified, leading to lower peaks of tensile stresses in the majority of the sections. In addition, the above mentioned arch type effect, although still existing (the mortar has a much lower stiffness than the stones), has a smaller expression when the voids are filled with mortar, and this may delay the development of cracks in these points. Nevertheless, the final aspect of the cross-section at the end of the test shows that these vertical cracks appear at the weakest zone, Fig. 16(c). These results confirm that the more uniform distribution of stresses in the horizontal cross-sections is the major responsible for the stiffness increase when the voids are filled in with mortar.

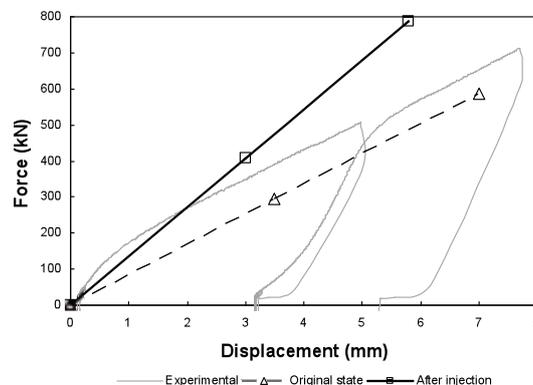
Figure 17 : Comparison between the experimental and wall stiffness calculated based on the two numerical models.

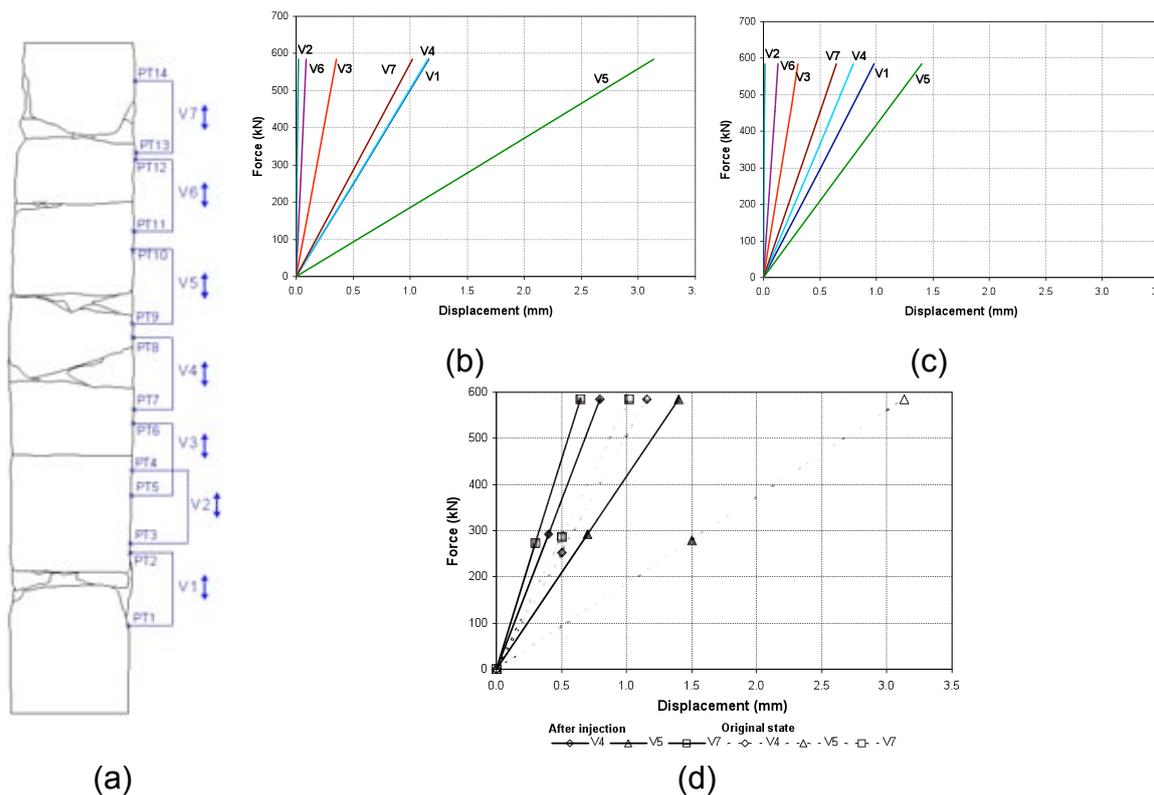
Figure 18 : Vertical displacements of the wall cross-section: a) selected areas, b) displacements before injection, c) displacements after injection and d) comparison of the displacements before and after injection for areas V4, V5 and V7.

In order to determine the wall zones that yield larger contributions to the total deformation, seven areas were considered and the corresponding deformations calculated before and after the injection of the voids, Fig. 18.

The deformation obtained after injection is smaller in all the areas, except in V2 that corresponds to a unique stone with no joints or mortar in between. It is visible that the area V5 is the one that gives a higher contribution to the global deformation, as the contact surface between the stones in this zone is very small, causing a large concentration stress that leads to a significant deformation. The almost null deformation in V2 highlights that the deformation of the wall is essentially due to the joint deformability and that it is independent of the stone properties. This fact supports the conclusions of the sensitiveness analysis. The areas where the displacements variation was higher were those that included larger voids, such as V4, V5 and V7.

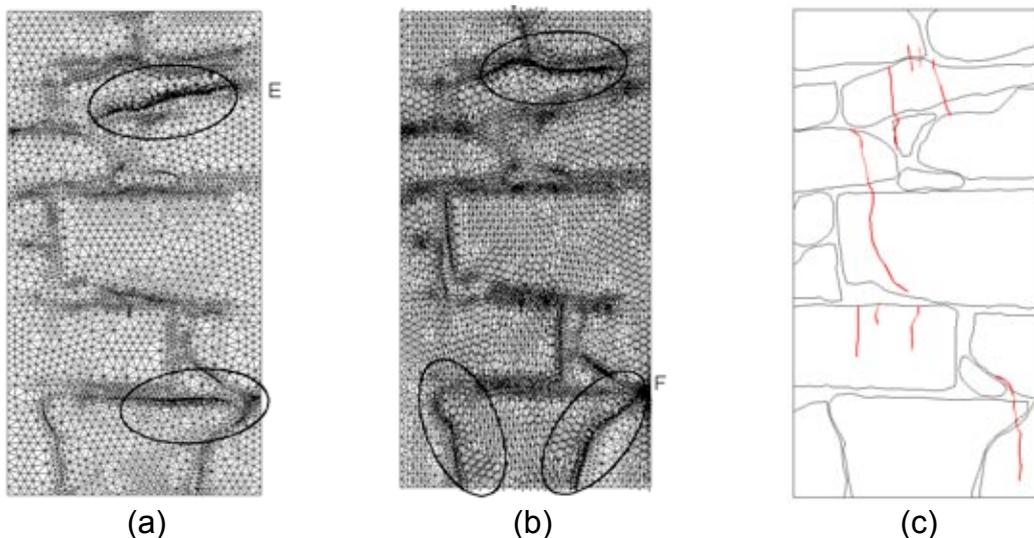
Figure 19 : Numerical results for the wall elevation: a) principal tensile stresses direction; b) principal compressive stresses direction and c) crack pattern after the compression test.

The elevation model results are presented in Fig. 19. The stress concentration is evident in some areas, especially in the mortar and in contact points between stones. In Figure 19(a) the maximum principal tensile stress, 8.90MPa (Zone E), occurs in the place where the first crack developed during the experimental test, supporting the numerical simulation results. Regarding the principal compression stresses, a maximum value of 7.36MPa (Zone F) was reached. Also in this case the arch effects are visible, leading to high tensile stresses in some points and explaining some of the cracks that occurred during

the experimental test. As for the stiffness, although a closer approximation to the results of the cross-section after injection should be expected, it gives a value almost equal to that of the cross-section before the injection, i.e. with the voids. This result underlines the difficulty of simulating the mechanical behaviour of a wall by just using the elevation geometrical characteristics, since the real contact between stones and the presence of voids can hardly be detected. Moreover, by looking at the elevation, and due to the irregular shape of the stone blocks, one is forced to admit a larger thickness of the joints, which means a larger amount of mortar. By analyzing the cross-section and the elevation numerical models, the percentages of mortar plus voids at the cross-section model is around 10%, while in elevation is 15%. Therefore, a more flexible wall is expected when using the elevation model.
