# **STRUCTURAL DEFICIENCY AND INTERVENTION RETROFITTING MEASURES OF RUBBLE FILLED MASONRY WALLS IN ISLAMIC HISTORICAL BUILDINGS IN CAIRO, EGYPT**

Two main case studies in respect of multiple leaf- masonry -walls are studied. The first one as an example for the bearing walls in historical buildings is Wkallah Radwan Bik Al-Fakari. The second one as an example for the retaining wall is Sultan El-Ghourri palace wall remains.

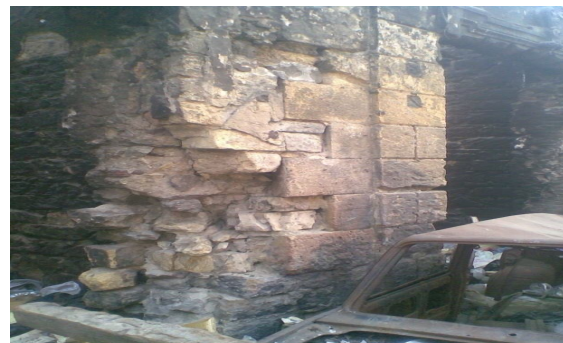
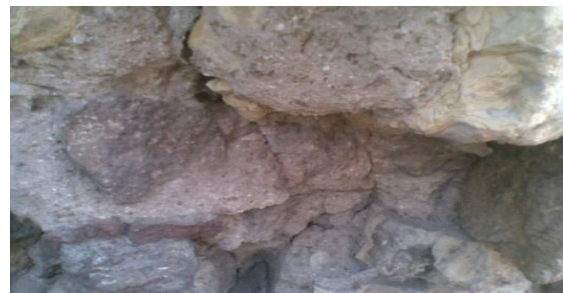
**Figure 1 Construction system of the double faced masonry walls in Islamic monuments in Cairo.**

Rubble filled walls are constructed with two external leaves made of stone or brick with a void of varying thickness between them. The space between the two external leaves is filled with a loose low strength materials made of pieces of stone/brick and mortar.

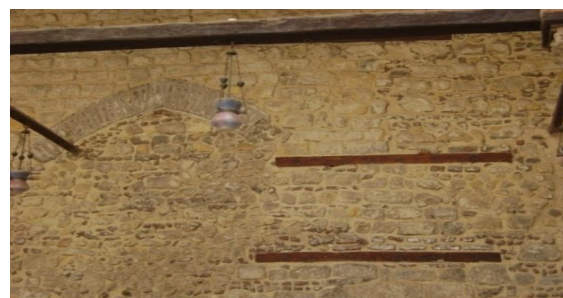
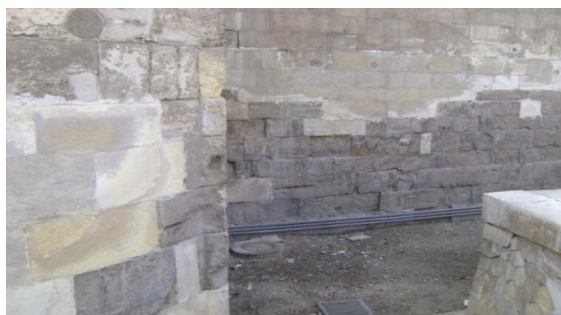
Figure 2 Connection systems and materials of the double faced masonry walls in Islamic monuments in Cairo.

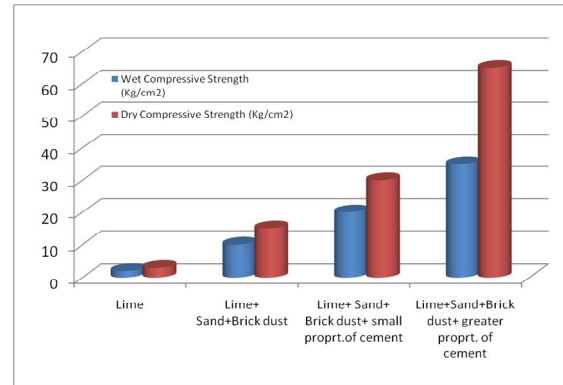
**Figure 6 Physical and mechanical properties of the new hydraulic based lime mortars for restoration and injection of the deteriorated core of rubble infill masonry walls.**

The experimental study referred that the mix of lime+ sand+ brick dust+ greater proportion of white cement 3:1:1:0,5 respectively gave the best results under the mechanical testing. The hydraulic lime based grouts (due to their improved bond properties with the in-situ materials) become more important due to the durability ensured by the use of materials that are compatible with the existing ones from the physical-chemical point of view, (see Fig. 7).

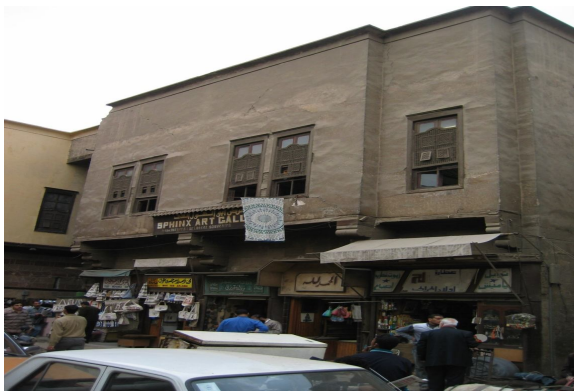
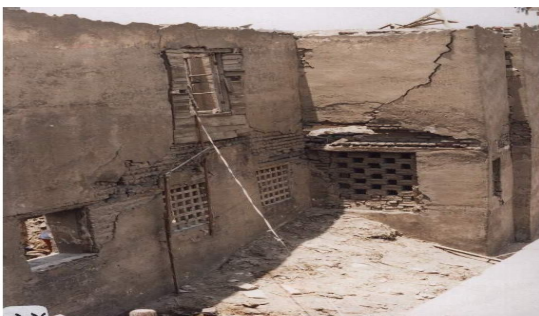
Figure 7 Present state of Wkallah Radwan Al-Fakari, before restoration processes.

An inspection of the *Wkallah* reveals some very severe long-standing problems observed before and after October 92 earthquake. The floor of the *Wkallah* undulates dramatically evidence of very significant foundation problems of the masonry vaults supporting the floor. Attempts have been made in the past to support the sleeper walls supporting the vaults. These attempts have failed. Most of the walls of the *wkallah* exhibit very severe

fractures, as shown in (fig.8). Rising contaminated ground water table caused many problems for the foundations of walls, leading to uneven settlements of the foundations and structure. Further problems in the external walls have been caused by the activities of the shop keepers trying to enlarge the space available for selling their wares. Sections of masonry have been demolished at ground floor level to create this additional space. Many cracks in the walls, as shown in (Fig.8). Vertical and shear cracking patterns intersected the structures as shown in (Fig. 8b). Many problems in arched and vaults, vertical cracks, fractured masonry and fallen key stones. Generally, the damage appears to be most severe on the east south elevation, the west elevation, particularly the North West corner and the four sides of the central courtyard. The north elevation and the east elevation appear to be little damaged (fig. 8a).

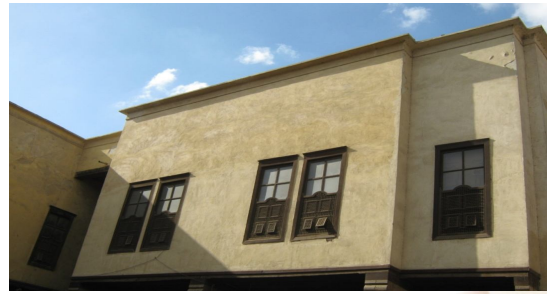
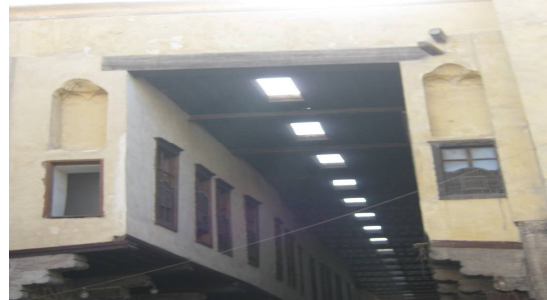
Figure 8 Wkallah Radwan Al-Fakari. After restoration processes.

Description of the restoring works for the existing shallow foundations of the ancient historical wkallah Radwan Al-Fakari: Improving the bearing capacity of foundations under the structures of the masonry by jet grouting techniques led to: The capacity of the supporting elements and materials (jet grouting columns) would be able to take care of the

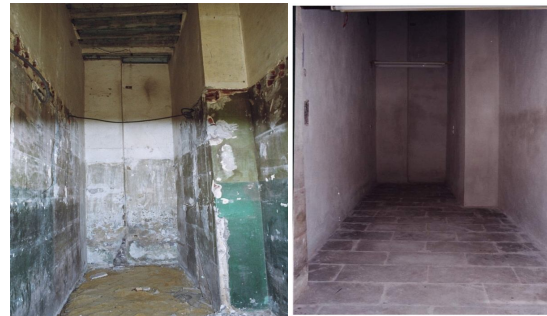
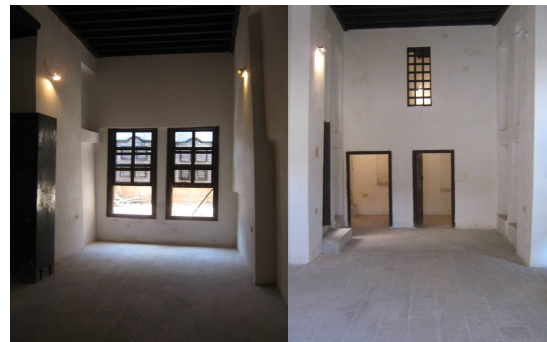
Figure 9 Wkallah Radwan Al-Fakari. During and after restoration processes.

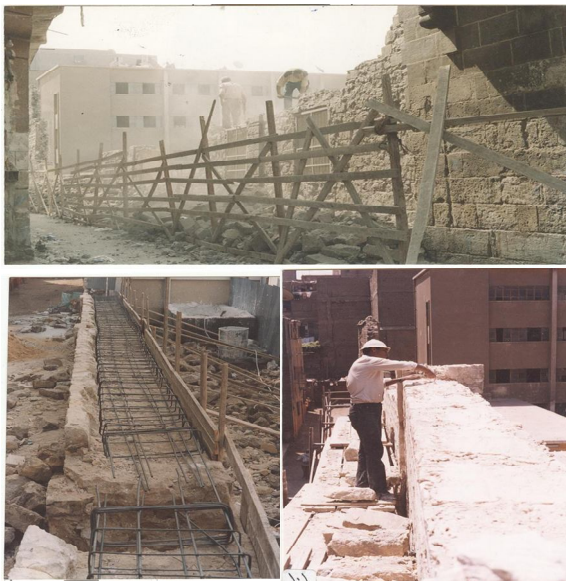
**Figure 11** Present state of Sultan El-Ghouri palace wall remains, during restoration processes.

The observations of the damage of the wall as following: Tilting and settling of wall. Separation and open cracks at the connection of wall with stable areas. This major crack is much wider at the top than at the base. Settlement and movements of wall blocks at the 2 sides of the cracks. Vertical crack at the 1/3 of wall, starts from the top in joints blocks one crack while become two cracks on the bottom and it have outer displacement about 1.5 cm. Horizontal cracks on the platform level behind the outer wall and parallel to it. Deterioration of lime stone masonry of wall as in (Figure 11 and 12).

1. The destruction processes started from top to bottom of the wall with attention to save and reuse of the original rubbles and blocks of limestone after cleaning, sand removal and consolidation.

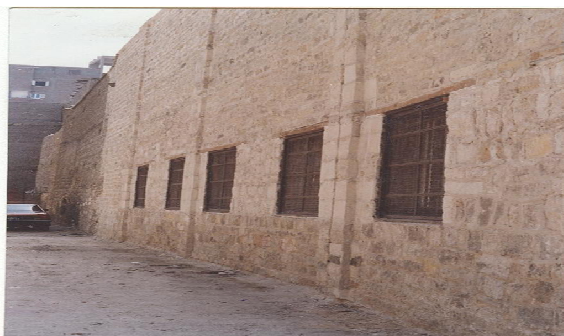
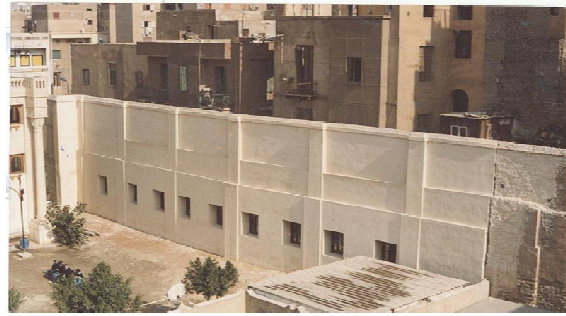
**Figure 12** Present state of Sultan El-Ghouri palace wall remains, after restoration processes.

2. The reconstruction processes started by improving the stability of the massive retaining wall by low pressure injections for filling strata of soil up to 10 m below ground level and making new steel reinforced concrete strip foundation forming a wide and deep foundation base under the high bearing capacity to stop tilting phenomenon and give adequate factor of safety against further seismic events;

3. Rebuilding of the superstructures of the wall from base meter by meter using the original construction materials and the new hydraulic based lime mortars and binders. By this way we restored of cracks in walls, vertical separation and open crack at the connection of wall with stable areas. Restored the horizontal separation crack on the platform level with adjacent old building. Interventions on floor of platform.
