# State of the Art of Research on Historic Structures in Italy

L. Binda and A. Saisi

Dept. of Structural Engineering - Politecnico of Milan. Italy

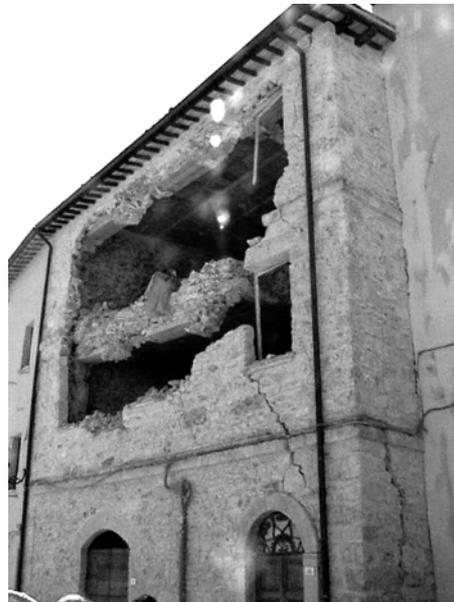
*Fig. 1. Damages after Umbria earthquake to a building repaired by introduction of concrete tie beams.*

The symptoms of damages and their causes should first of all be known. In some cases the correlation is clear (Fig. 1, 2). Frequently the correlation between effects and causes cannot be done without an experimental and analytical investigation (Fig. 3, 4) [Rossi, 1982] [Binda, 1997], [Rossi, 1997].

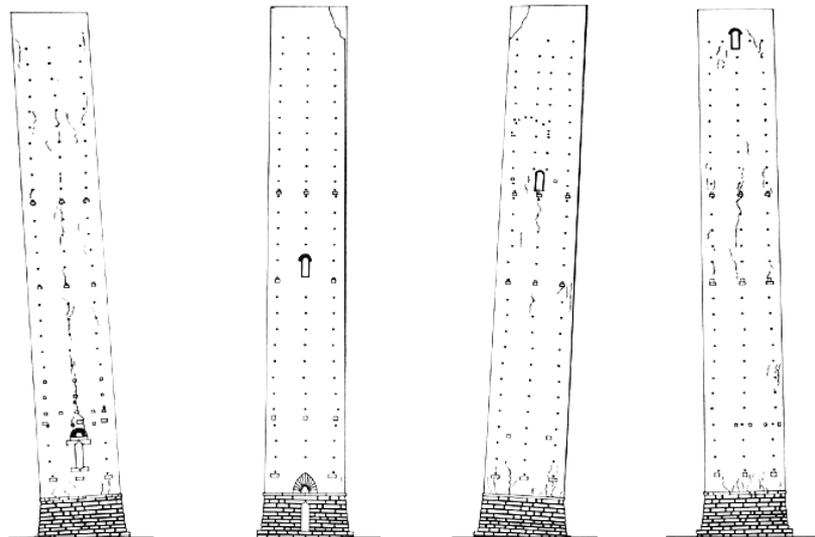
*Fig. 2. The Garisenda leaning Tower in Bologna.*

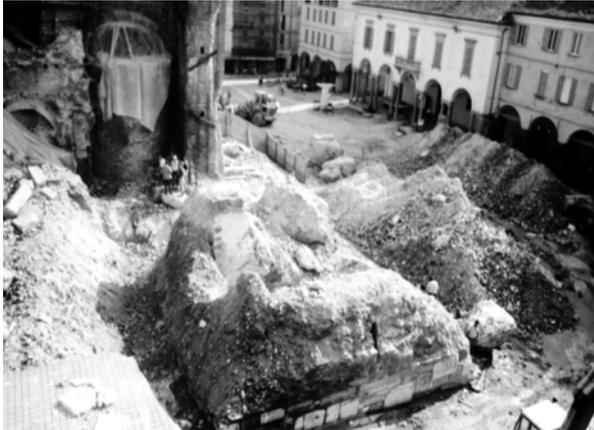
*Fig. 3. The Bell Tower of Pavia after collapse*

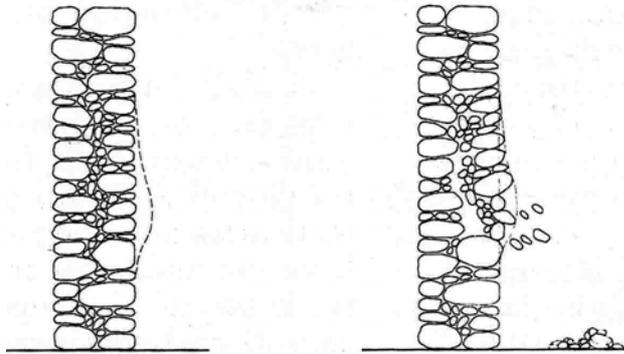
Fig. 5. Deformation and failure of a two leaves wall [Giuffrè, 1993].

The worst defect of a masonry wall is to be not monolithic in the lateral direction, and this can happen for instance when the wall is made by small pebbles or by two external layers well ordered but not mutually connected and containing a rubble infill. This makes the wall to become more brittle particularly when external forces act in the horizontal direction (Fig. 5).

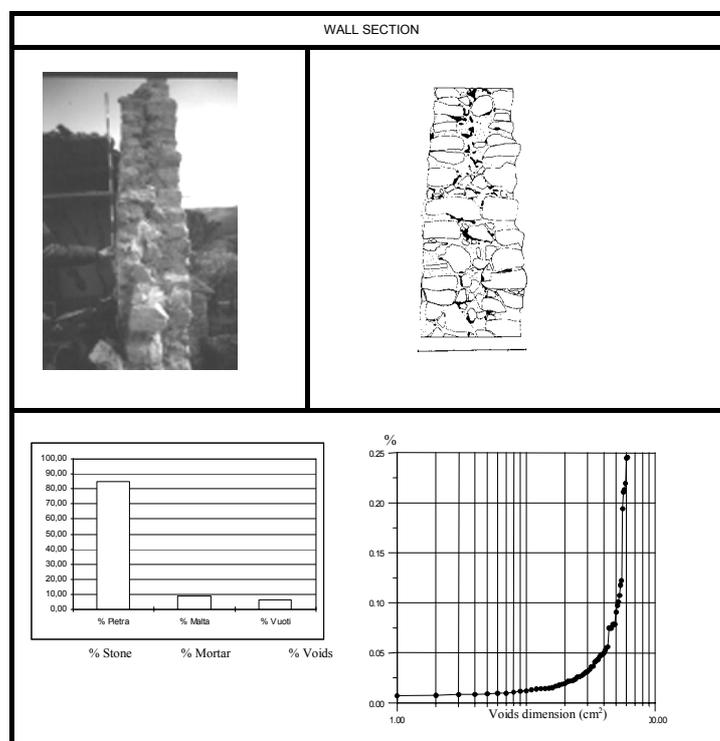
Fig. 7. Form representing the wall section and the void calculation [Binda. 1999].

Other researches were carried out in different Italian region [Abbateo, 1993], [Binda, 1995], [Binda, 1999] studying stonework walls of buildings the internal cross sections of which can be inspected; the operation can be more easily conducted in those areas where the buildings were damaged by the earthquake and have not yet been repaired. The survey consists of a graphic and photographic procedure which includes taking a photograph with a camera having the lens of 50 mm using a tripod which ensures the parallelism between the plane of the photograph and that of the wall; working out the metric survey of the walls first manually and then on a PC; creating a rich data-base organized in tables like that presented in Fig. 7 [Lodigiani, 1995], [Penazzi, 1997], [Binda, 1999].

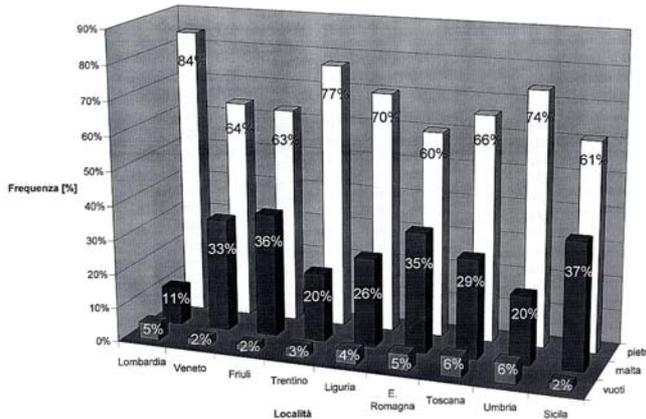
Fig. 8. Percentage of mortar vs. percentage of stones referred to the area of the cross section of stonework walls in various Italian regions.

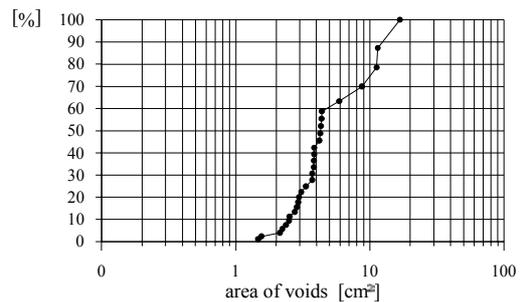
Fig. 9. Size and distribution of the voids within the section of the wall. [Binda, 1997]

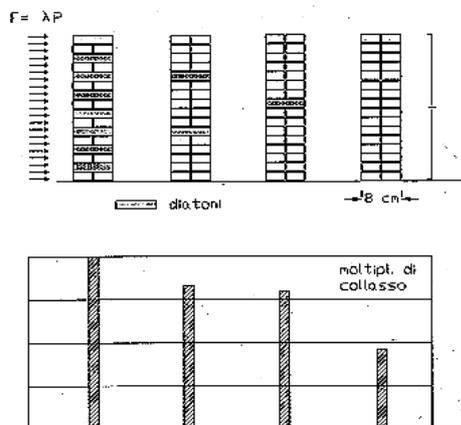
Fig. 10. Diaton influence and stability of the wall [Giuffrè, 1988].

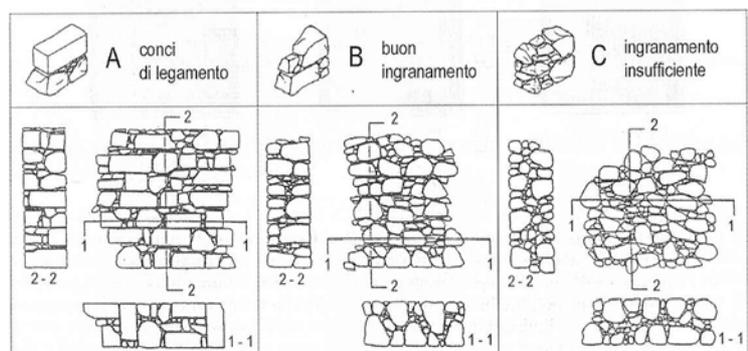
Fig. 11. Example of a section abacus, indicating very good, good and poor connections [Giuffrè, 1993].

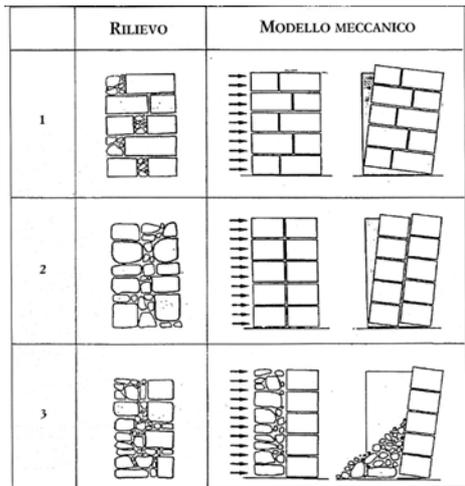
Fig. 12. Qualitative behaviour of a multiple leaf stone masonry [Giuffrè, 1999].

Other parameters can be: dimension of the elements, shape and workability of the stones, masonry texture, mortar quality, mortar quantity, presence of wedges, presence of horizontal courses, presence of leaves connections and diatons, characteristic of the section, homogeneity of the materials. Each masonry behaviour is then qualitatively evaluated (Fig. 12).

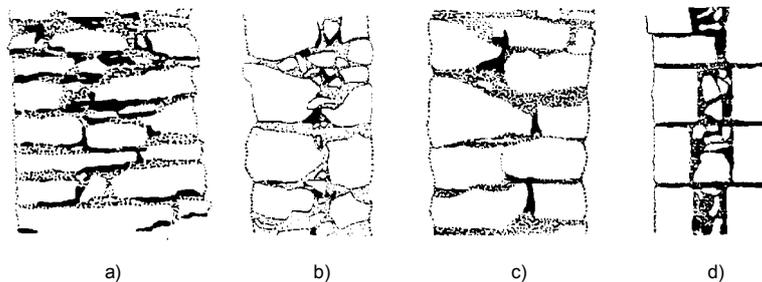
Fig. 14. Classification of the cross sections of stonework walls: a) a single leaf; b) two leaves without connection; c) two leaves with connection d) three leaves [Binda, 1994].

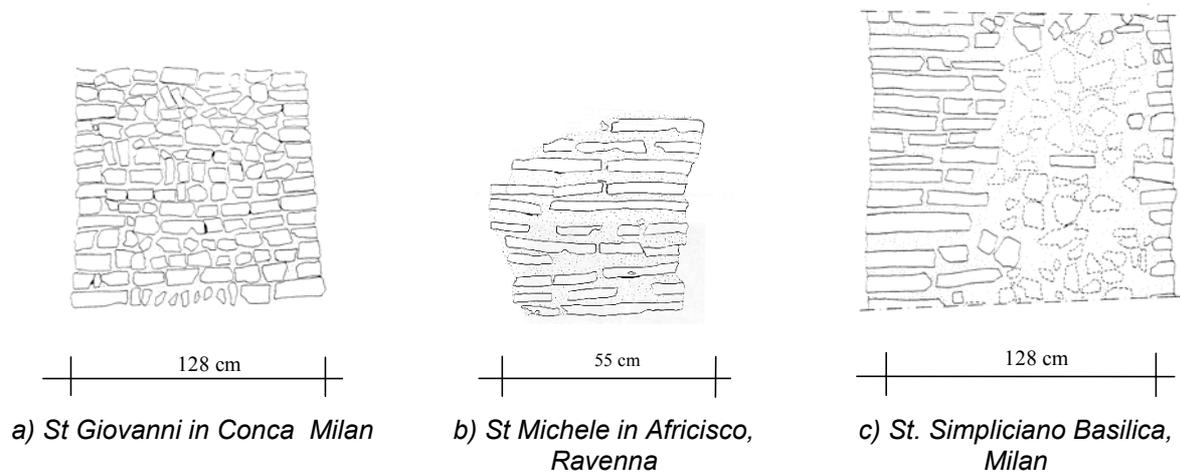
Fig. 15. Examples of brick masonry section [Binda, 2002].

out on Milan Roman walls and on Ravenna Byzantine walls the following classification could be made (Fig. 15): (I) solid walls with thin joints, (II) solid walls with thick joints, (III) solid walls with multiple leaves (with different thickness of the leaves) [Binda, 2002]

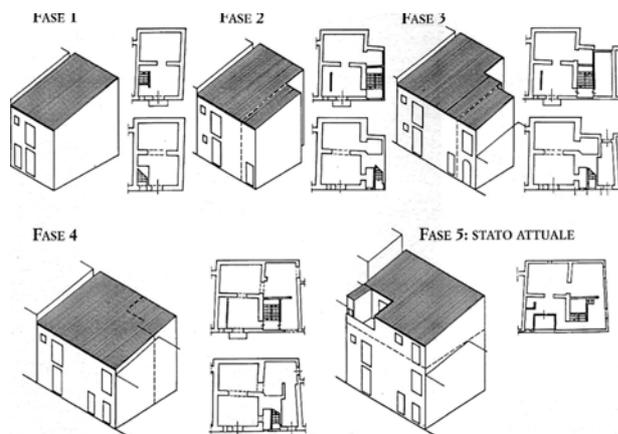
Fig. 18. Typical transformation of a building in Ortigia [Giuffrè, 1991].

The survey of the historic centres produces interesting cataloguing of the building typologies but also of the typical transformation recognised. In fact, each typology but also each transformation (Fig. 18) can lead to specific damages due to the loss of continuity or to

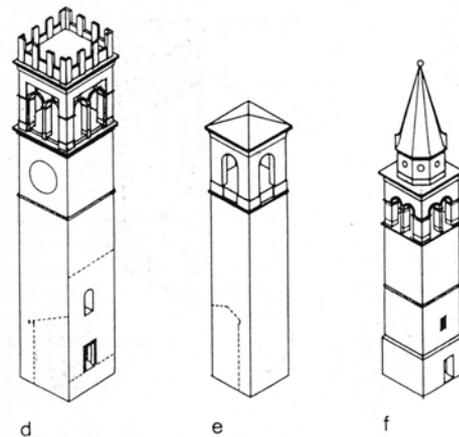
Fig. 19. Example of Bell-Towers in Friuli [Doglioni, 1994].

Dogliani, Moretti and Petrini [Dogliani, 1994] carried out analysis, starting from similar basis, for the Friuli churches and bell-towers (Fig. 19), damaged by 1976 earthquake. The cataloguing of the typologies, structural details and damages was an important tool for successive researches and interventions on seismic area.

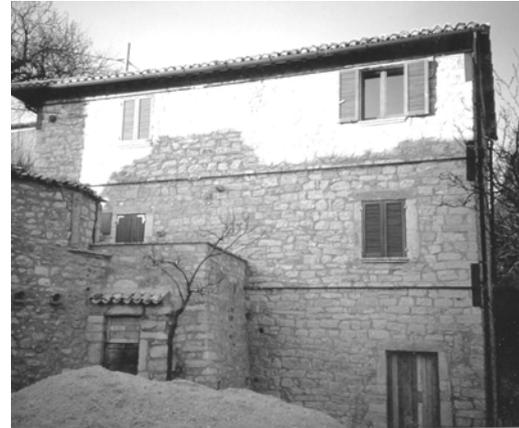
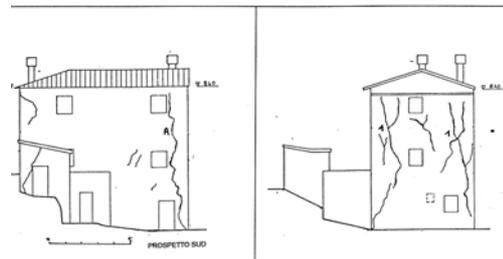
Fig. 21. Crack pattern survey of a Montesanto building damaged by the earthquake [Binda, 2001].

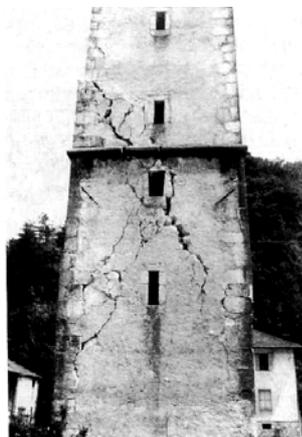
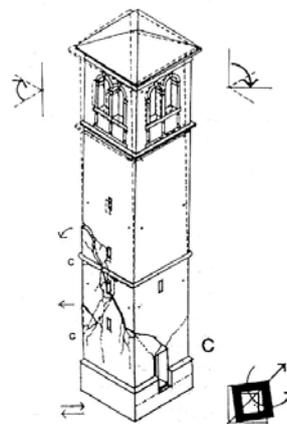
Fig. 22. Crack pattern of a bell-tower and interpretation of the damage mechanism [Doglioni, 1994].

The geometrical survey, including a measure of the loss of verticality or horizontality in the load bearing elements and the type and distribution of cracks in the crack pattern is the first information to be collected; the type of cracks and their geometry can help understanding the causes of damage (Fig. 21). Furthermore the type of cracks and their direction help in interpreting even a mechanism of collapse (Fig. 22) [Doglioni, 1994], [Avorio, 1999], [Borri, 1999].

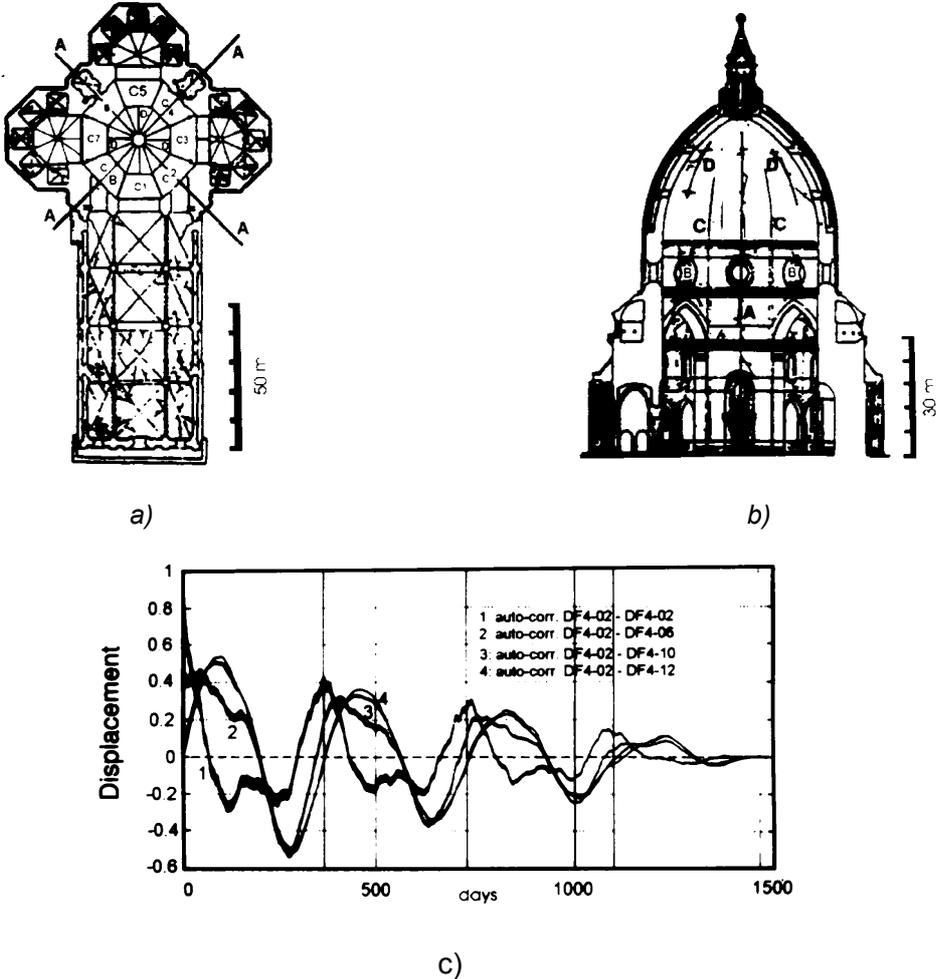
Fig. 23. S. Maria del Fiore, Florence, Italy: a) position of the major cracks denominated A,B,C,D on the dome; plan; b) position of the major cracks denominated A,B,C,D on the dome [Chiarugi, 1993]; c) curves displacement-time obtained as a correlation of the monitored [Bartoli, 1992].

This type of survey is frequently applied to important constructions, like bell towers (Pavia Towers [Macchi, 1992, 1993] and Pisa Tower [Macchi, 1993, 2000]) or cathedrals [Macchi, 2001] and the system may stay in place for years before a decision is taken for repair or strengthening. Fig. 23 shows the evolution in four years of some of the main cracks of the dome in S. Maria del Fiore in Florence (Fig. 23) [Chiarugi, 1993].

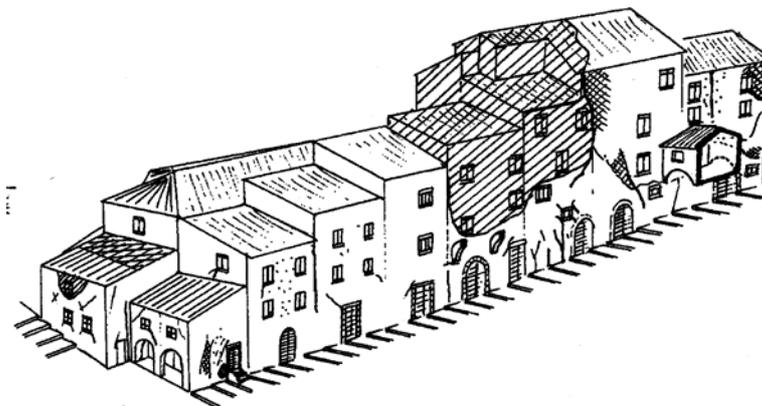
*Fig. 26. Failure of a row of buildings in a Umbria village after the earthquake [Penazzi, 2000].*

The knowledge of the collapse mechanisms in the cases of non repaired and repaired buildings will help understanding the reasons for some failures (Fig. 26), connect them to the construction and material characteristics and suggest more appropriate retrofitting techniques [Lagomarsino, 1998, 1999].

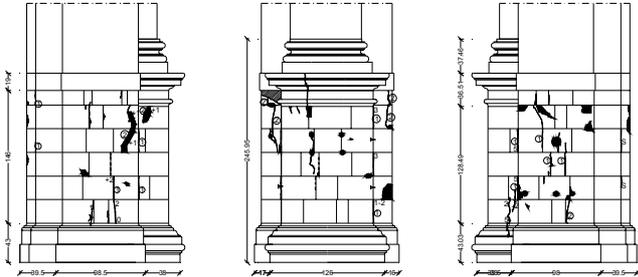
Fig. 27. Typical crack pattern of a pillar under heavy compressive stresses.

Especially important is the survey and drawing of the crack patterns (Figs. 27, 28). The interpretation of the crack pattern can be of great help in understanding the state of damage of the structure, its possible causes and the type of survey to be performed, provided that the development history of the building is already known.

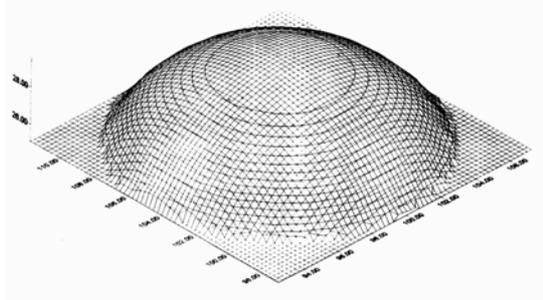
Fig. 28. Photogrammetric survey of the intrados of the dome of St. Vitale at Ravenna - Italy [Binda, 1995].

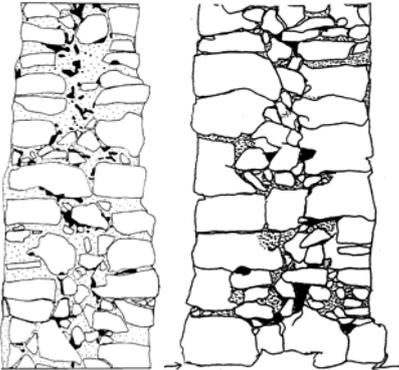
Fig. 29. Survey of stonework sections [Binda, 1999], [Penazzi, 2000].

To understand the morphology of a masonry wall it is important a direct inspection. Sometimes it could be performed by removing few bricks or stones and surveying photographically and drawing the section of the wall (Fig. 29).

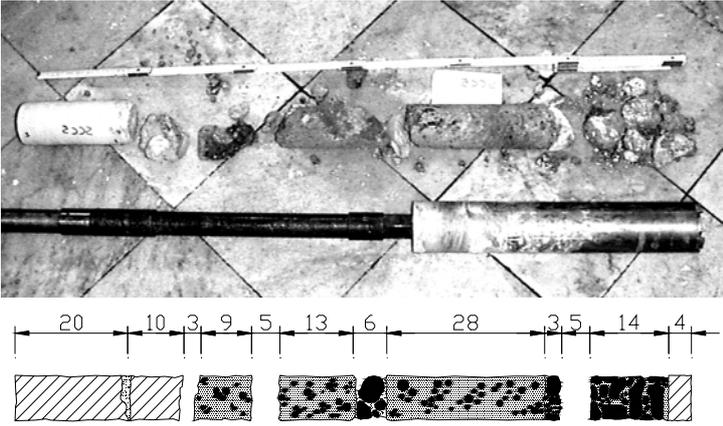
Fig. 30. Drilled core and reconstruction.

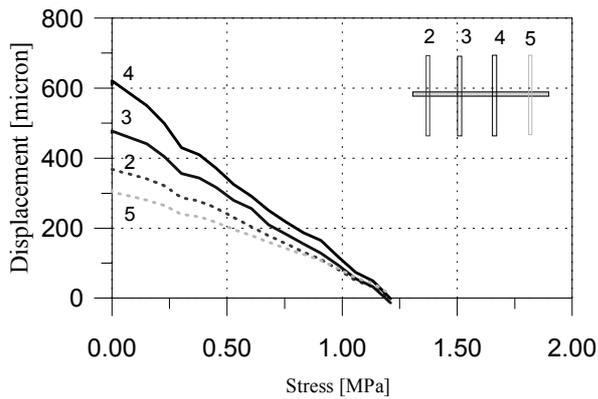
Fig. 31. Single flat-jack tests carried out at the Monza Tower [Binda, 1999].

The determination of the state of stress is based on the stress relaxation caused by a cut perpendicular to the wall surface; the stress release is determined by a partial closing of the cutting, i.e. the distance after the cutting is lower than before [ASTM, 1991]. A thin flat-jack is placed inside the cut and the pressure is gradually increased to obtain the distance measured before the cut. The displacement caused by the slot and the ones subsequently induced by the flat-jack are measured by a removable extensometer before, after the slot and during the tests. The pressure of the hydraulic system driving the displacement equal to those read before the slot is executed is measured (Fig. 31), [ASTM, 1991]

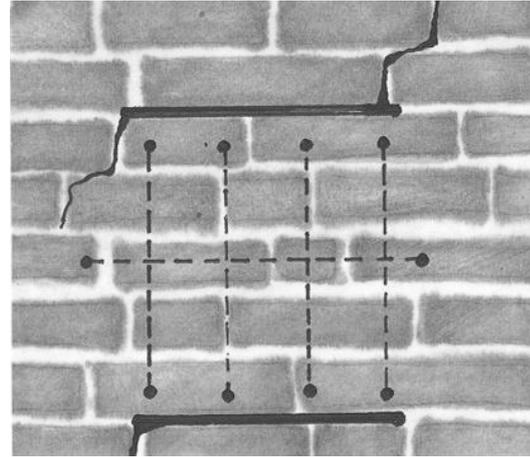
Fig. 32. Double flat-jack test.

The test can also be used to determine the deformability characteristics of a masonry (Fig. 32, 33) [Ronca, 1997], [Binda, 1999], [Bartoli, 2000]. A second cut is made, parallel to the first one and a second jack is inserted. The two jacks delimit a masonry sample of appreciable size to which a uni-axial compression stress can be applied. Measurement bases for removable strain-gauge or LVDTs on the sample face provide information on vertical and lateral displacements. In this way a compression tests is carried out on an undisturbed sample of large area.

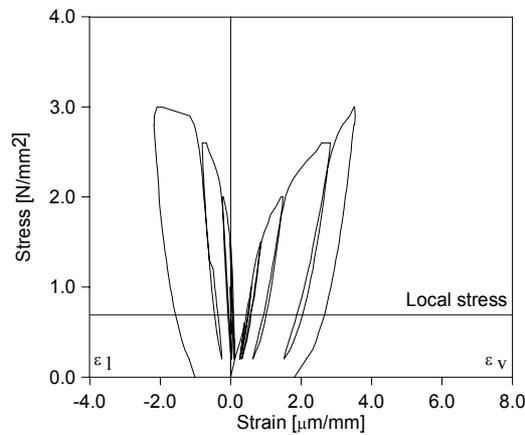
Fig. 33. Double flat-jack test on West side of the Monza Tower [Binda, 1999].

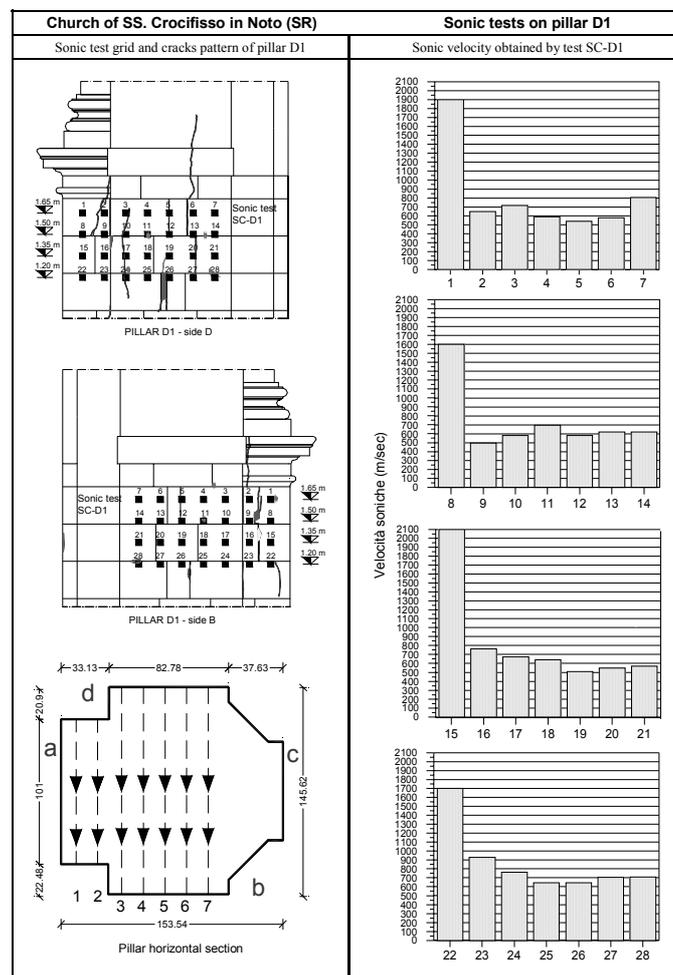
Fig. 35. Crocifisso Church at Noto (Italy): results of sonic tests applied to a pillar

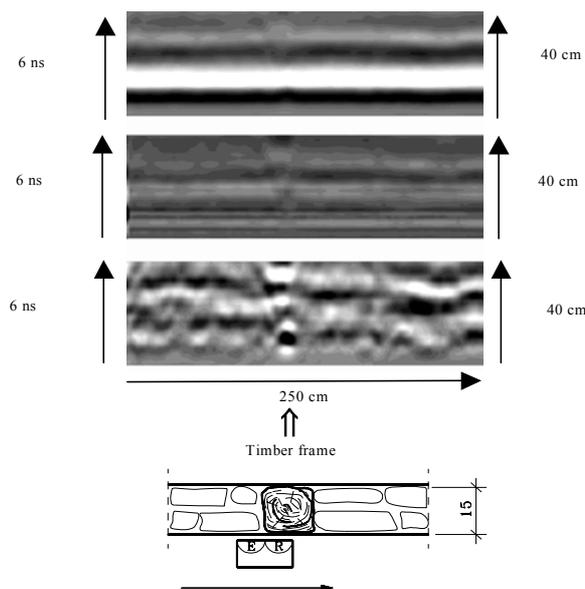
Fig. 36. Localisation of a wooden element in a frescoed wall [Binda, 1998].

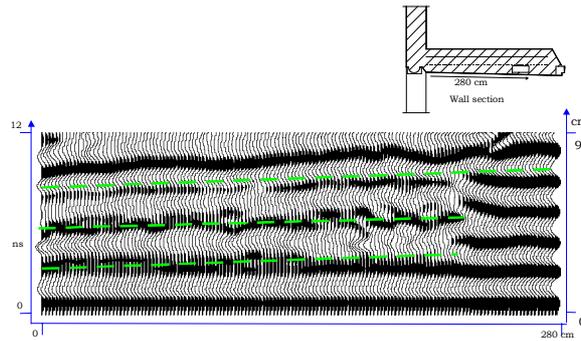
Fig. 37. Radargram of the wall section at the Malpaga Castle. The leaves positions and the presence of a void on the right side are recognisable [Binda, 1999].

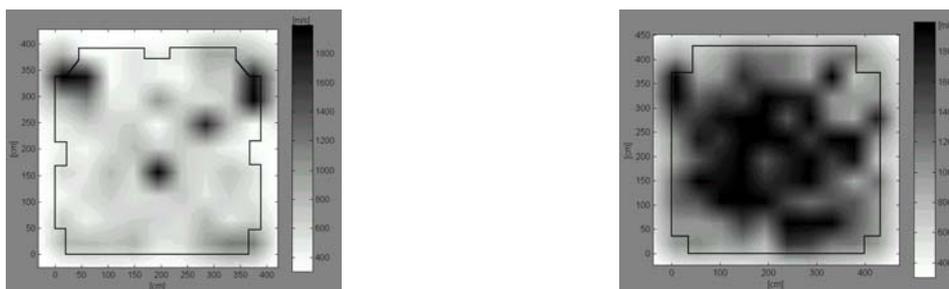
Fig. 38. Pulse Sonic Tomography of a S. Nicolò l'Arena pillar at difefrent heigth [Saisi, 2001].

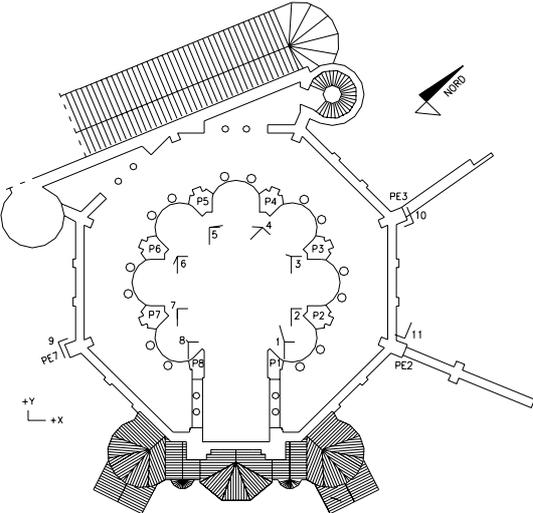
Fig. 39. S. Vitale Church at Ravenna. Total variation of the out of plumb (November 1998-November 1999) [Binda, 2000].

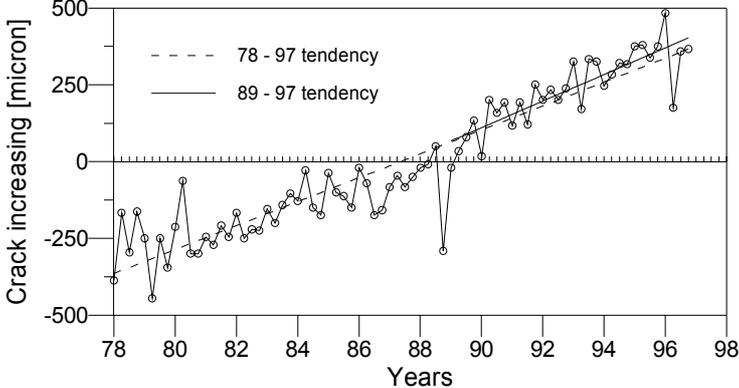
Fig. 40. Crack monitoring made with a removable extensometer at the Monza Tower [Binda, 1998].

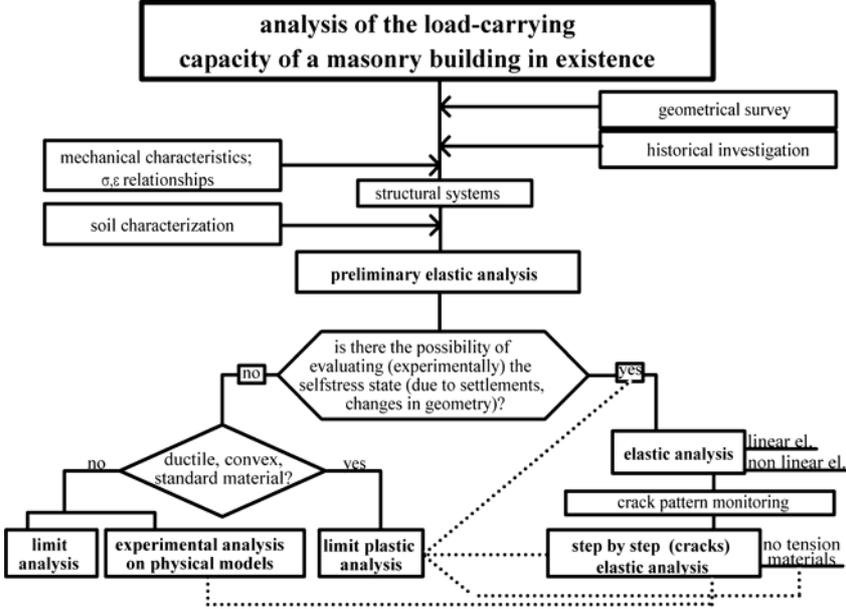
Fig. 41. Phases and alternatives of numerical analysis for an existing structure [Binda, 1983, 1994]

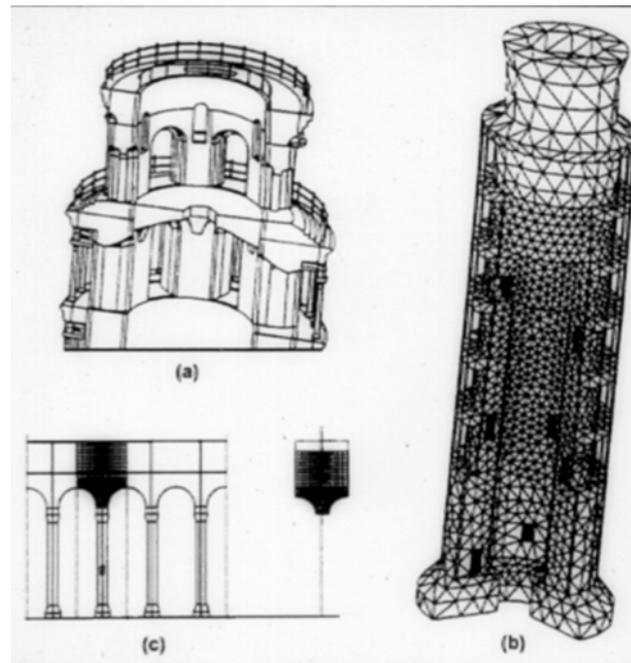
Fig. 42. Modeling of the Pisa Tower [Macchi, 1993]

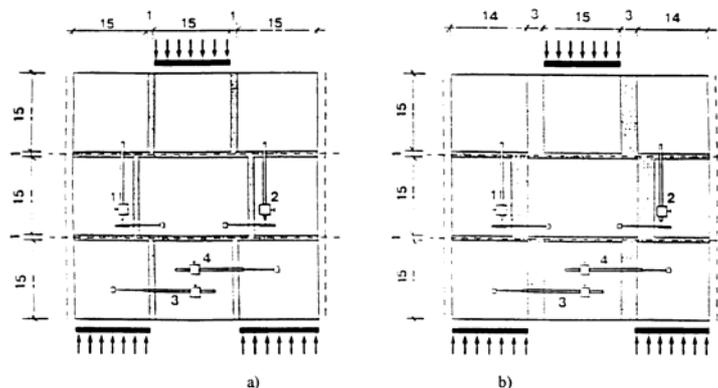
Fig. 43. Specimens subjected to shear tests: a) with blocks offset, b) without blocks offset [Binda, 1993].

The samples (Fig. 43) were then subjected to shear tests obtaining interesting results (Fig. 44). Samples built with the weaker stone (limestone) showed a higher interface shear strength, probably because of the high porosity which gave a better adhesion with mortar. In the cases of panels having a block offset, the vertical joint turned out to be stiffer than in absence of the offset, and the load was mainly transferred through the stone block. Looking at the crack pattern after failure it appeared that in the specimens made with the weaker stone, the upper block collapsed well before the mortar joint failed. This was probably due to the excessive strength of the mortar used, compared to the stone's one.

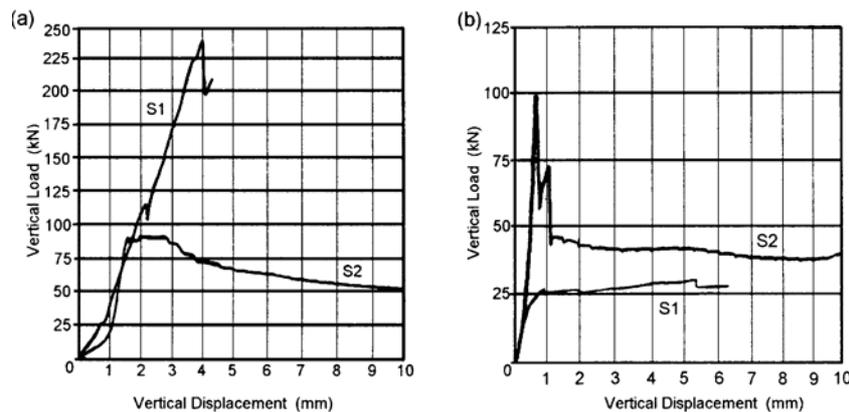
Fig. 44. Results obtained from shear tests on specimens a) with blocks offset, b) without blocks offset: S1 sandstone, S2 limestone [Binda, 1993].

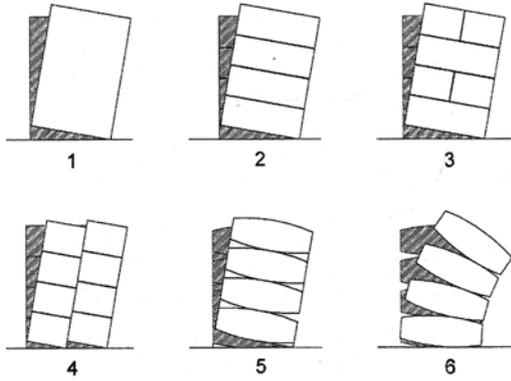
Fig. 45. Failure mechanism of a wall [Carocci, 2001].

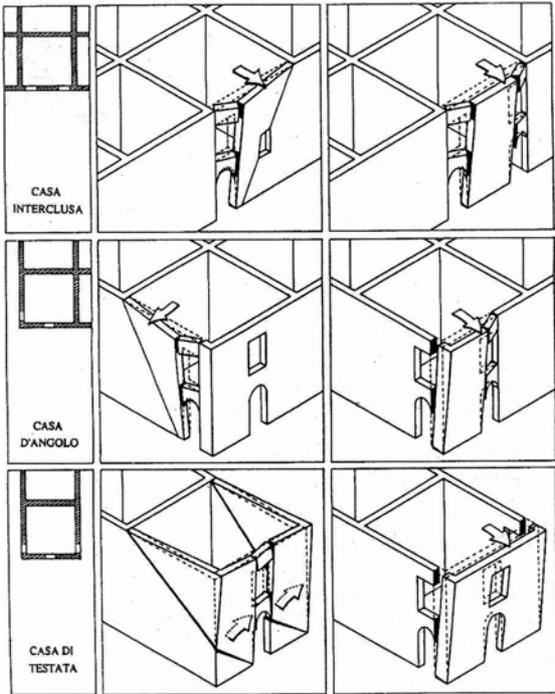
Fig. 46. Failure mechanism of a building inside a row [Giuffrè, 1993].

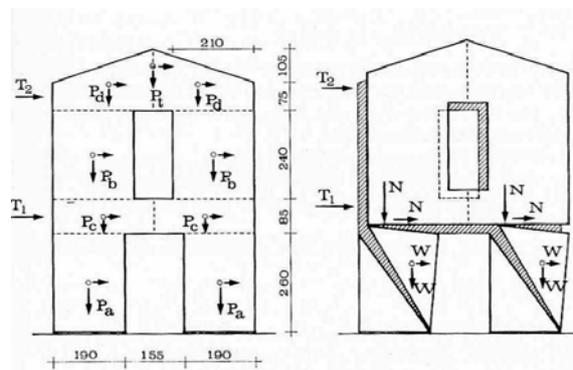
Fig. 47. Macroelements of a facade [Giuffrè, 1991, 1993].

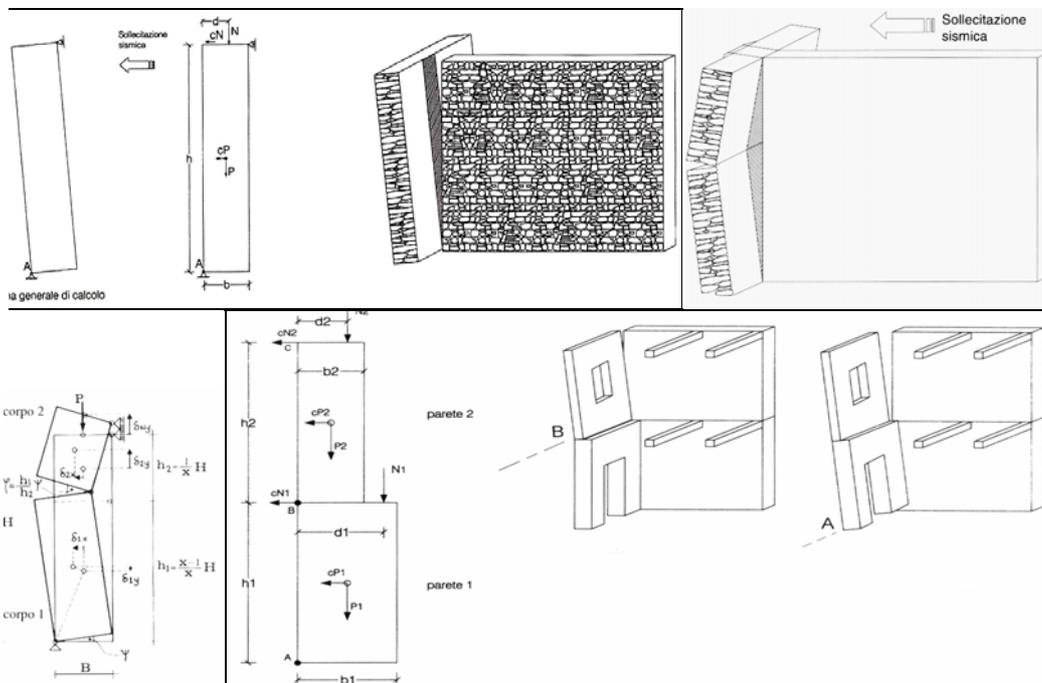
Fig. 48. Macroelements of a facade [Giuffrè, 1991, 1993].

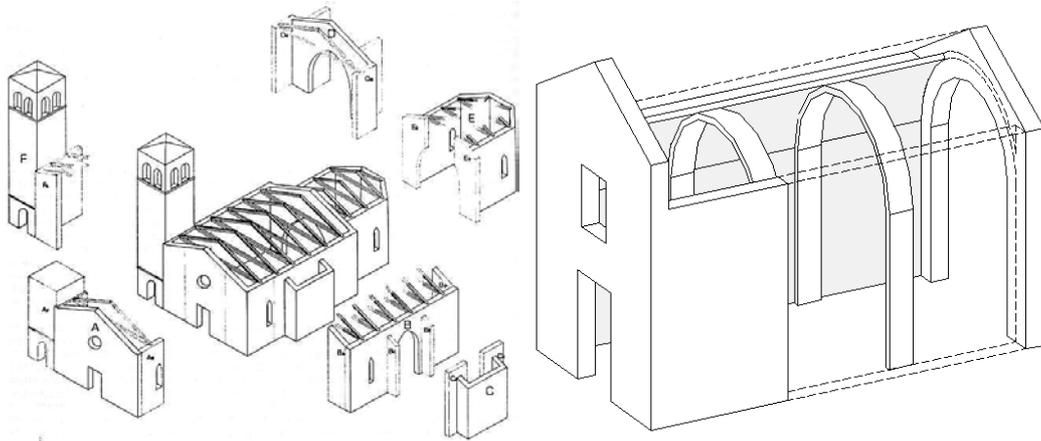
Fig. 49. Church macroelements [Doglioni, 1994] and [Lagomarsino, 1997,1998,1999].

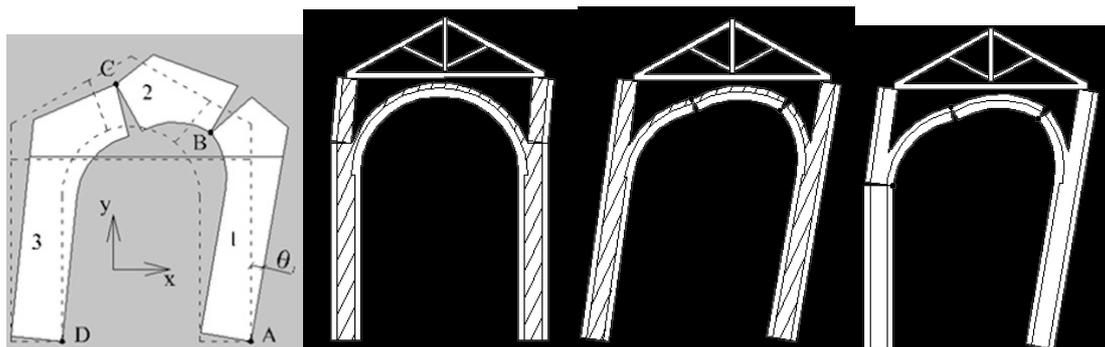
Fig. 50. Failure mechanism of a Triumph Arch macroelements and [Lagomarsino, 1997,1998,1999].

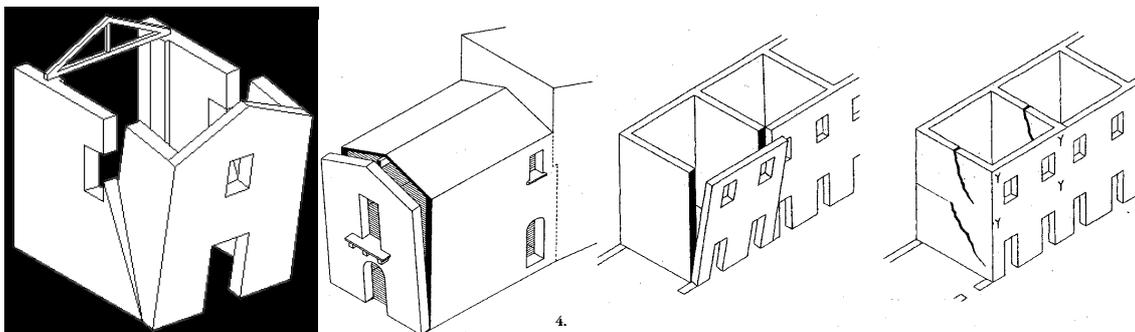
Fig. 51. Failure mechanism of the facade, in a church [Lagomarsino, 1997,1998,1999] and in common row buildings [Giuffrè, 1991, 1993].

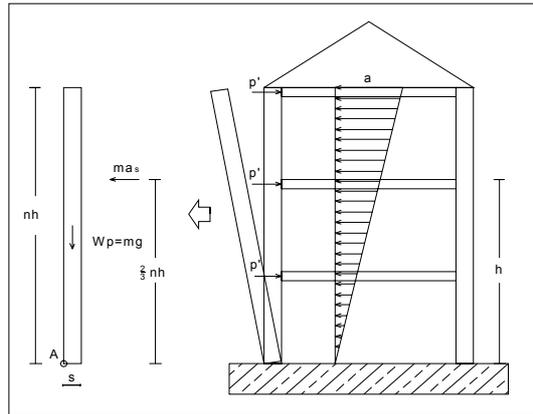
Fig. 52. Overturning mechanism of a facade [Bernardini, 2000]

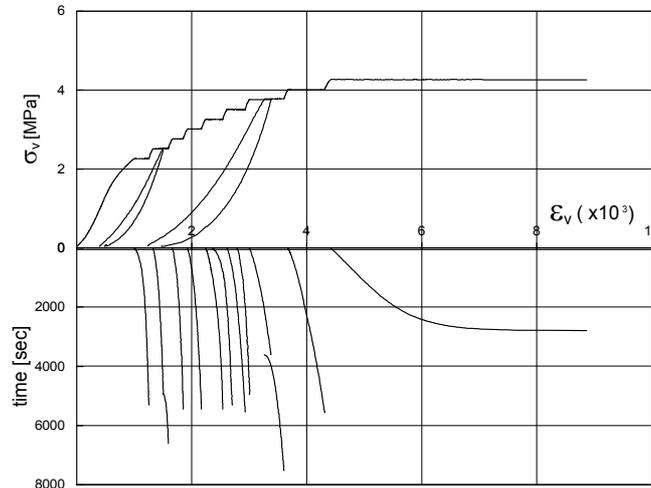
Fig. 54. Result of a test with subsequent load steps carried out on a prism (200x200x500) mm belonging to the crypt of the Cathedral of Monza (Italy) [Anzani, 1999]

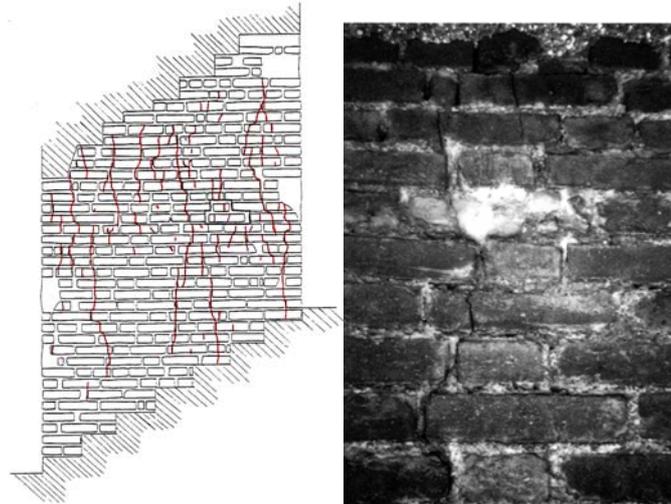
*Fig. 55. Thin cracks at the entrance wall of the Tower of Monza [Binda, 1996, 1998]*

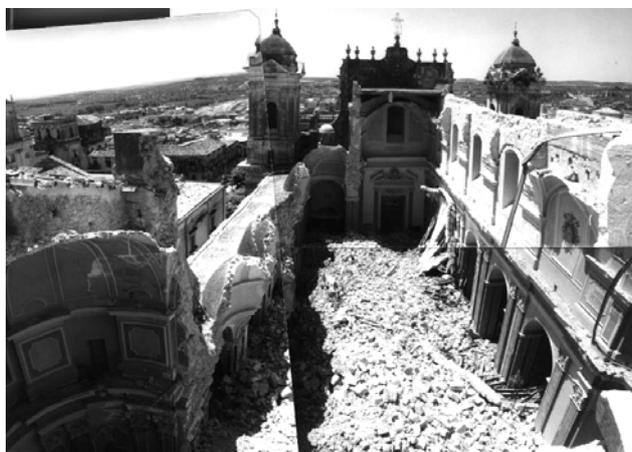
*Fig. 56: The Cathedral of Noto after the collapse [Binda, 1999]*

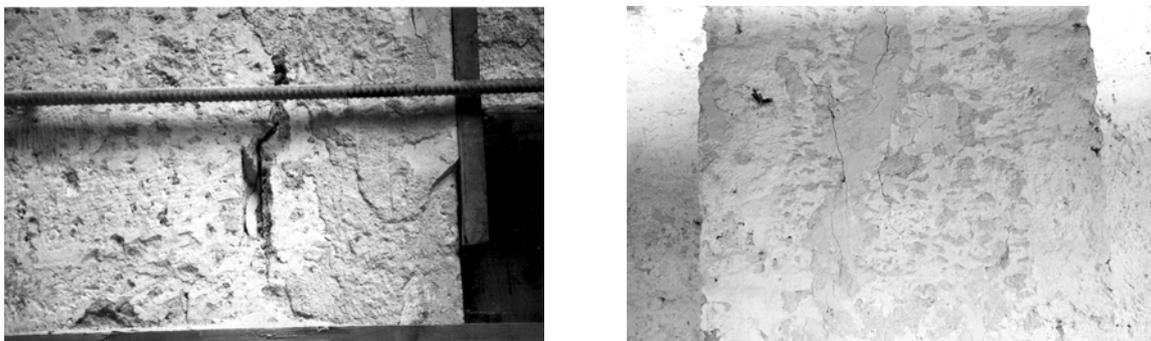
*Fig. 57. Large crack found in a pillar of the Cathedral of Noto and example of a crack filled with gypsum mortar in the sixties [Binda, 2001]*

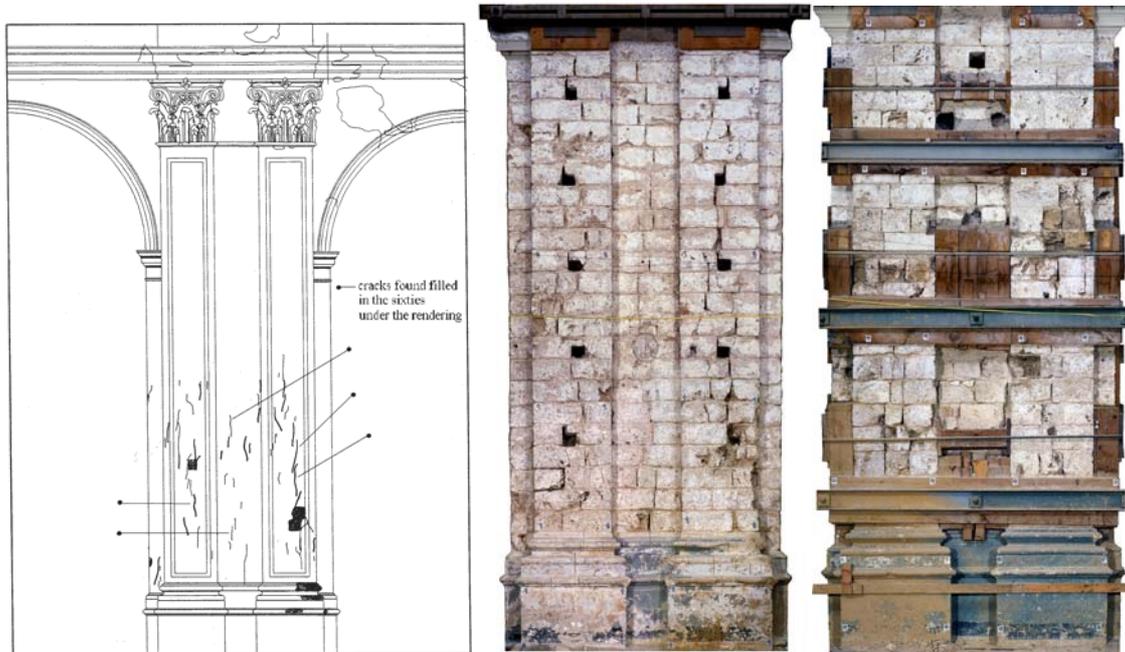
*Fig. 58. Crack pattern survey of a pillar of the Noto before and after the removal of the plaster.*

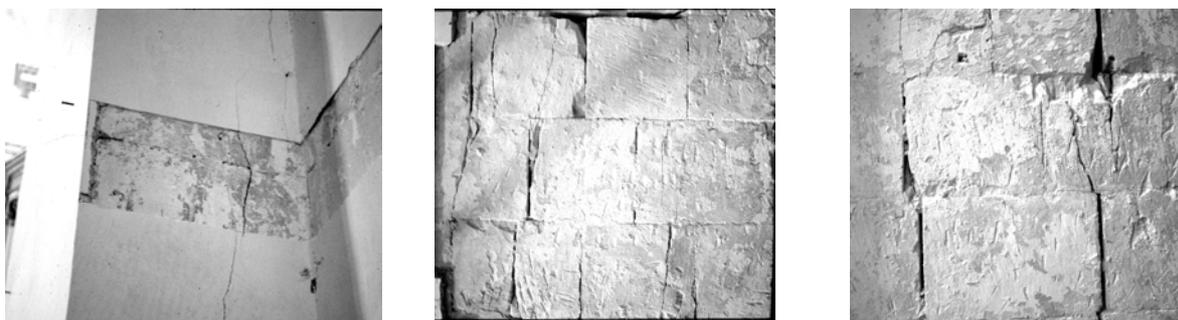
*Fig. 58. The appearance of a crack on the plaster and underneath it [Binda, 2001]*
