PERFORMANCE OF UNREINFORCED STONE MASONRY BUILDINGS DURING THE 2010/2011 CANTERBURY EARTHQUAKE SWARM AND RETROFIT TECHNIQUES FOR THEIR SEISMIC IMPROVEMENT

By: Ilaria SENALDI¹, Guido MAGENES² and Jason INGHAM³

Summary

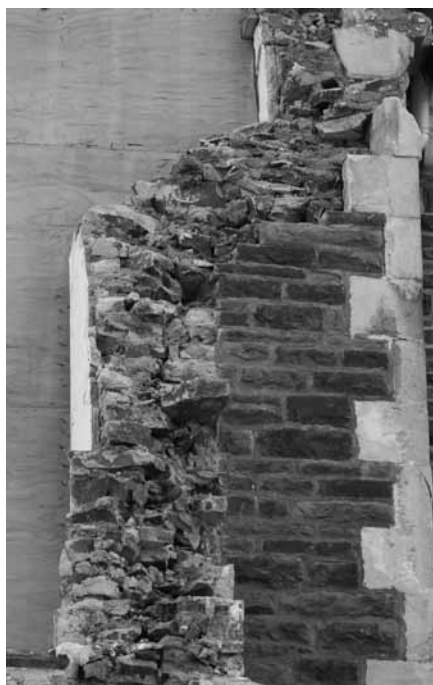
(a) Cramner Court –
3 leaves with rubble fill

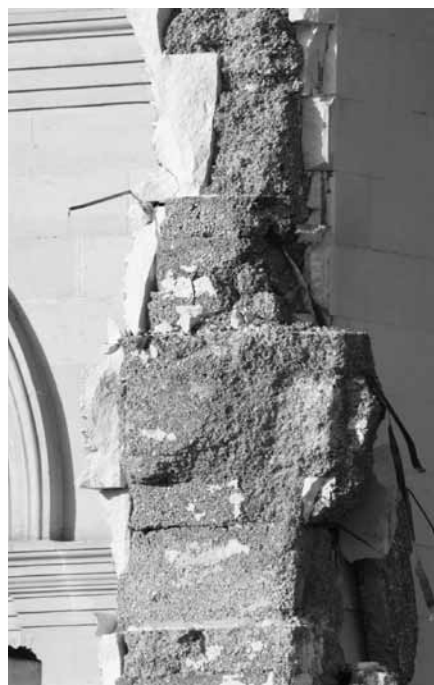
(b) Cathedral of the Blessed
Sacrament – Oamaru stone
with poured concrete

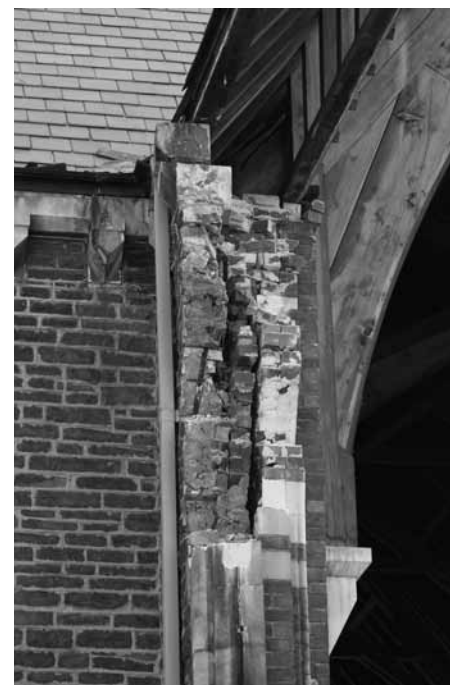
(c) St. Luke's Anglican Church
– stone front façade with
clay bricks back layers

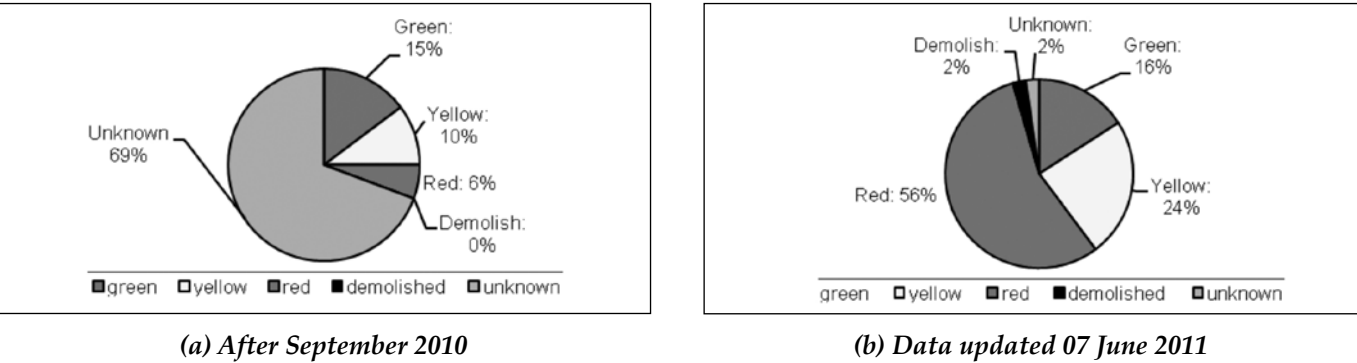
The seismic performance of stone masonry buildings was partially identified by considering the safety assessment data that was collected following the earthquakes that occurred in September 2010 and February 2011. Figure 2(a) and Figure 2(b) show the different percentages of building safety assessments after the 4 September 2010 and 22 February 2011 earthquakes, respectively. From these figures it can be seen that there was a significant escalation of damage due to the continuing earthquake activity in the

Figure 2: Distribution of safety evaluation placarding applied to stone masonry buildings

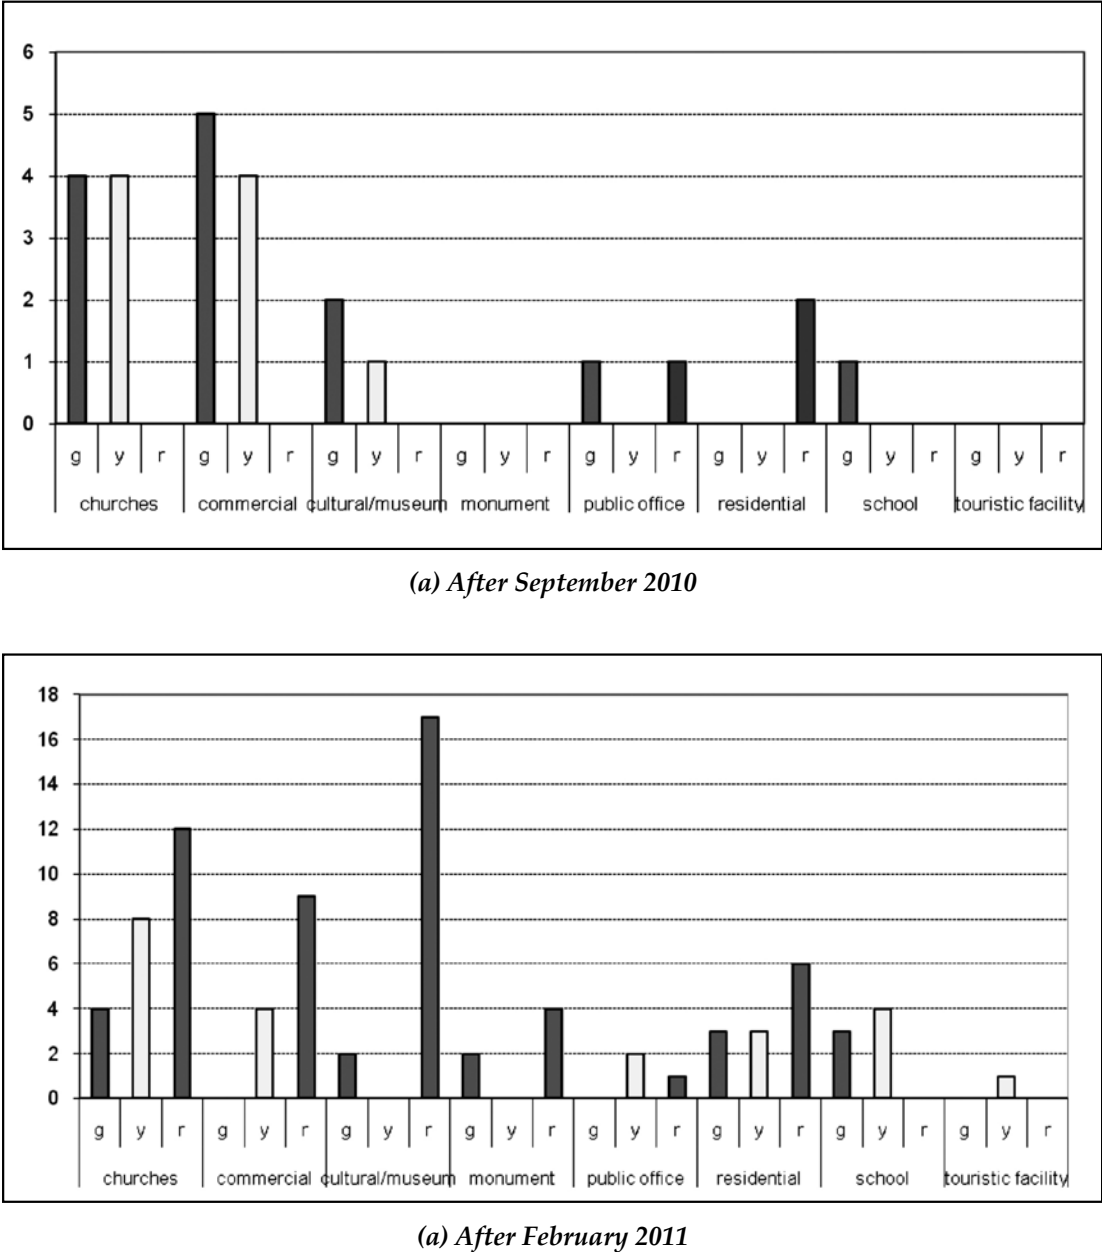
Christchurch region. Figure 3 gives a further breakdown of this data for the two major earthquakes on the basis of building usage. Green placards were assigned to structures that were deemed to be safe to re-enter and required no further intervention; yellow placards were applied to buildings whose accessibility was restricted due to minor damage; and red placards were applied to buildings that were considered unsafe and likely to have a moderate to severe level of damage. At the time of the study reported here, several buildings had been demolished already because of the hazard associated with their damage state.

Figure 3: Distribution of safety evaluation placarding applied to stone masonry buildings differentiated by building usage

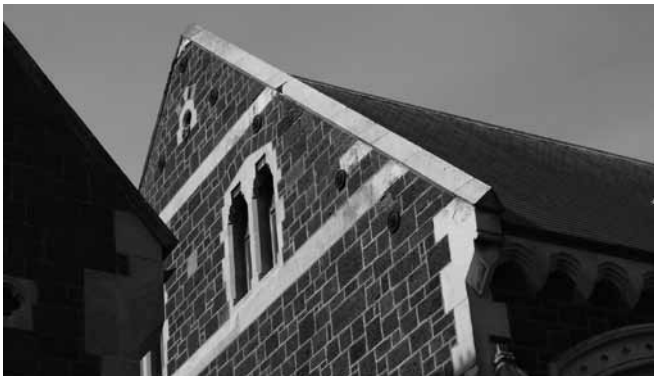
(a) Former Old Girl's High

Two cases are presented to show the different behaviour induced by the presence and effectiveness of anchoring. Figure 13(a) shows the damage resulting from overturning of the gable of the main façade of the former Trinity Church in the Christchurch CBD while the detail in Figure 13(b) illustrates how the anchoring was insufficient in size and spacing to secure the wall in place. Figure 14 shows some examples of successful wall-to-roof anchoring in the Arts Centre building.

*(b) Former Canterbury Engineering Department
Figure 14: The Christchurch Arts Centre, showing successful use of wall-diaphragm anchorages*

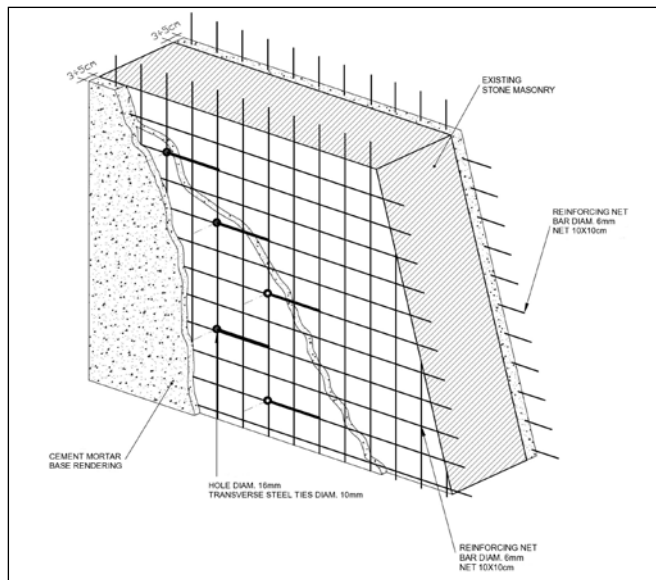
Figure 19: Schematic diagram of the jacketing technique (Mariani, 2006)

Jacketing with fibre reinforced fabrics or plates is normally used in the case of regularly coursed brick or block masonry, rather than with undressed stone and rubble masonry. This intervention technique is most effective when executed on both sides of the wall but by itself does not guarantee transverse connection through the wall cross-section and therefore its effectiveness has to be carefully evaluated. For stone masonry walls jacketing should be considered for cases where stone walls lack significant artistic value but have badly deteriorated with widespread damage.

A technique that has been widely applied in Italy to irregular multiple leaf stone masonry walls and is recommended by the Italian Code (NTC, 2008) consists of positioning a reinforcing net (with bar diameters ranging from 6 mm to 8 mm) on both faces of a wall, connected by frequent transversal steel ties, and then applying a cement mortar based rendering (see Figure 19). The same technique can be undertaken to connect load-bearing and shear walls and to close large cracks. However, due to the non-homogeneity of irregular stone masonry walls, and the cost and difficulty of connecting the two outer faces, execution of this technique on site

Because this technique substantially increases wall stiffness, partial interventions could be detrimental to overall structural response and so variations in stiffness should be accounted for when evaluating the response of the retrofitted structure. Furthermore, for effective performance using this retrofit technique it is necessary to ensure that there is adequate transverse connection across the wall cross-section, by providing suitable overlapping of the reinforcement net at the corners. Also, it is important to ensure that oxidation of the steel nets is avoided by providing a sufficient cover to reinforcement and to control water ingress.

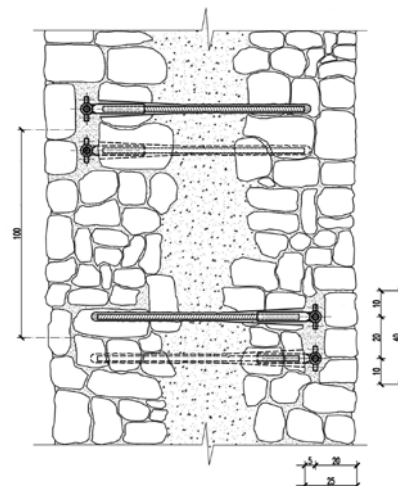
(a) Reinforced injections to connect outer layers of a three-leaf stone masonry wall

Reinforced injections are suggested for buildings having façades with a particular artistic and historical value, as the technique is less invasive than jacketing. Reinforced injections are designed to both strengthen structural elements (by acting as header units connecting the different stone and rubble leaves) or providing proper interlocking at corners or between orthogonal walls and connecting damaged parts of the wall that are separated by cracks (see Figure 20). Compressive and shear strength of structural elements are increased, as well as the 'box-type' structural behaviour of the masonry building.

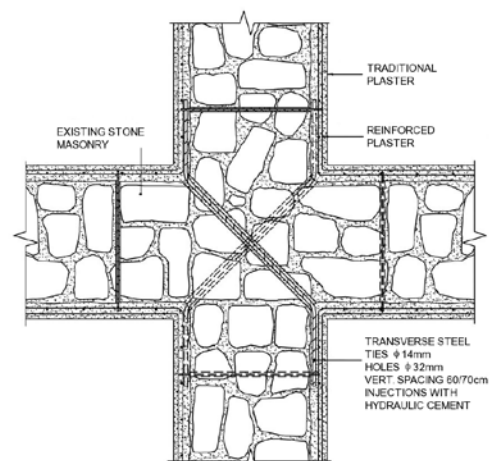
(b) Transverse tying at the intersection of two perpendicular walls

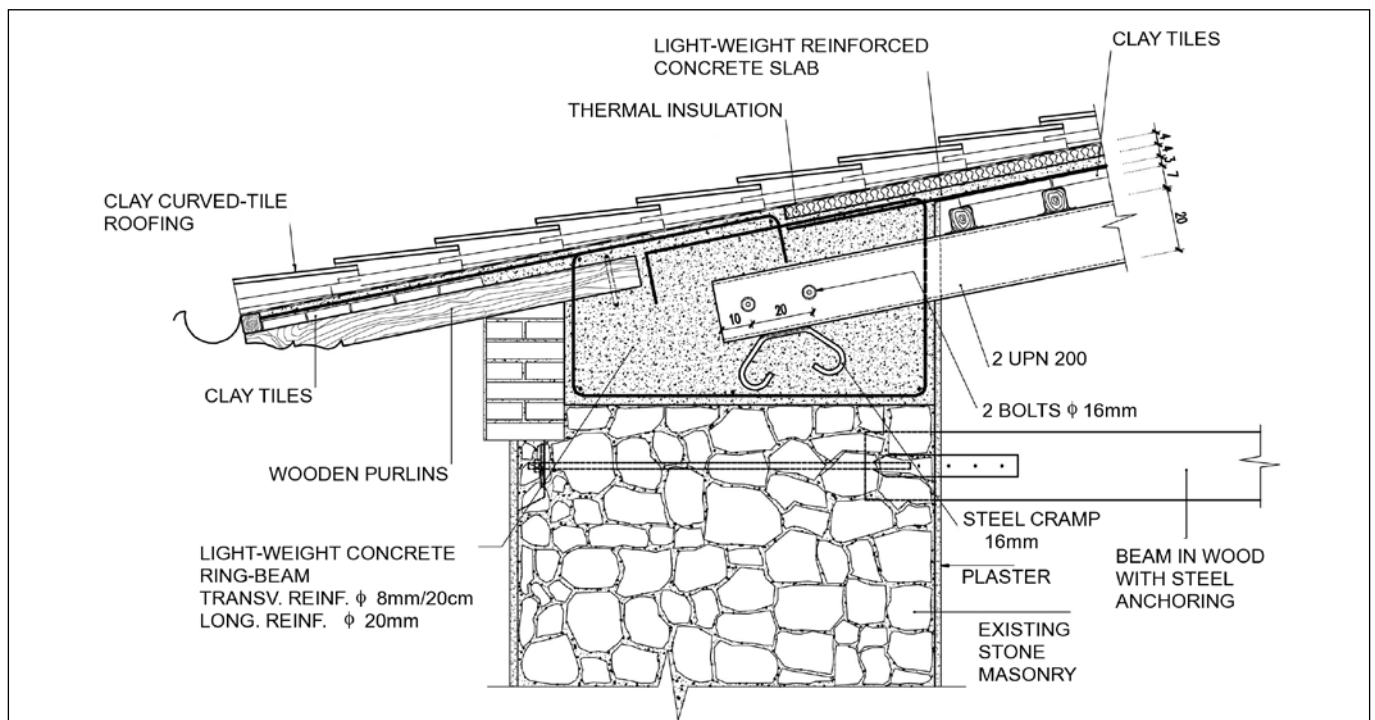
Figure 21: Details of a reinforced light-weight concrete ring beam at roof level and wall-to-floor anchoring (Mariani, 2006)

Ring beams (or tie-beams) at the summit of masonry walls (see Figure 21) are an effective solution to connect the walls in a region where the masonry is less cohesive due to the limited amount of compression from gravity load, and to improve the interaction of the wall and roof. In contrast, ring beams at intermediate levels within the thickness of the wall are to be avoided (especially if the wall is constructed of random rubble masonry), given the negative effects that openings in rubble can produce on the stress distribution of the wall leaves.

The ring beam or tie beam type of intervention has been commonly applied in Italy in past decades. However, the Umbria-Marche earthquake in 1997 (Corradi et al., 2002) demonstrated that excessive burdening and stiffening can cause concentration of tensile stresses that are detrimental to structural performance, particularly when using reinforced concrete ring beams (Mariani, 2006). Hence, the design of ring beams should account for both connectivity between walls and the seismic loads on horizontal and vertical structural elements to ensure adequate global structural seismic response.

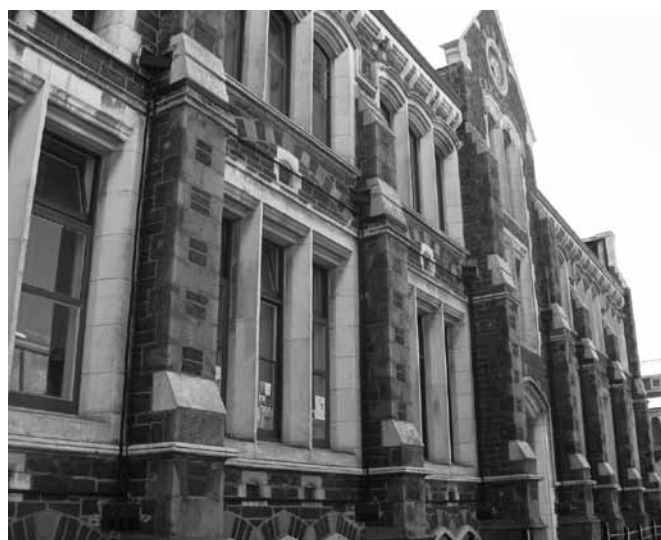
Post-tensioning is not a common retrofit technique in Europe, although in New Zealand there were several examples of good seismic performance of unbounded post-tensioned stone masonry construction during the 2010/2011 Canterbury earthquake swarm, as in the case of the Great Hall and the Chemistry Department buildings of the former Canterbury University in Christchurch (see Figure 22).

(a) View of horizontal and vertical unbounded post-tensioning

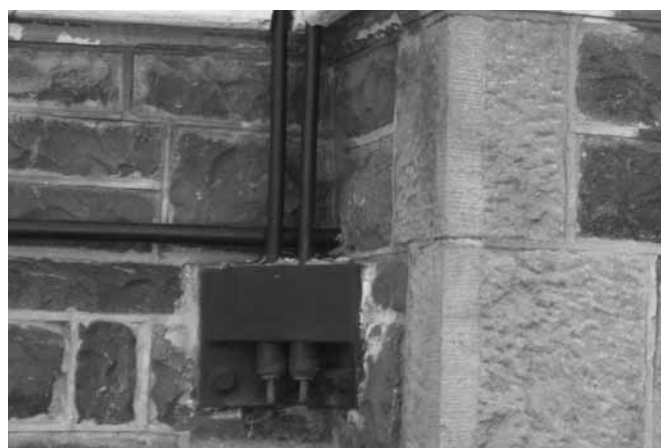
(b) Detail of tendon anchorage
