# Design and evaluation of hydraulic lime grouts for the strengthening of stone masonry historic structures

A. Kalagri · A. Miltiadou-Fezans · E. Vintzileou

Received: 5 August 2008 / Accepted: 7 December 2009  
© RILEM 2010

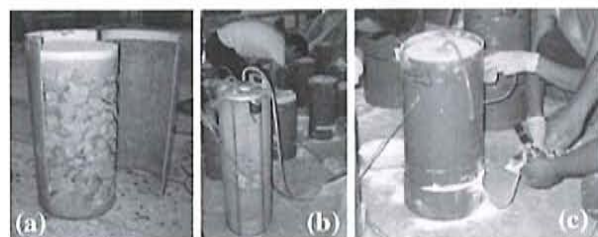
**Fig. 2** a UngROUTED cylinder, b and c injecting the cylinders

The specimens (placed in their moulds) were injected at constant pressure of ~0.75 bar, using specially manufactured equipment (Fig. 2b, c). The injections were performed from the bottom of the moulds; the time needed for filling each cylinder and the consumed volume of grout were recorded (Fig. 3). These recorded data show that the injectability of grout in the infill material, expressed as the approximate average filling time, was quite satisfactory and fit well with similar data reported in the literature [6, 11], taking into account the greater dimensions of the specimens used in the present
